## ANATOMY OF CANAL GEO-CONSTRUCTION DIFFICULTIES

### PROJECT

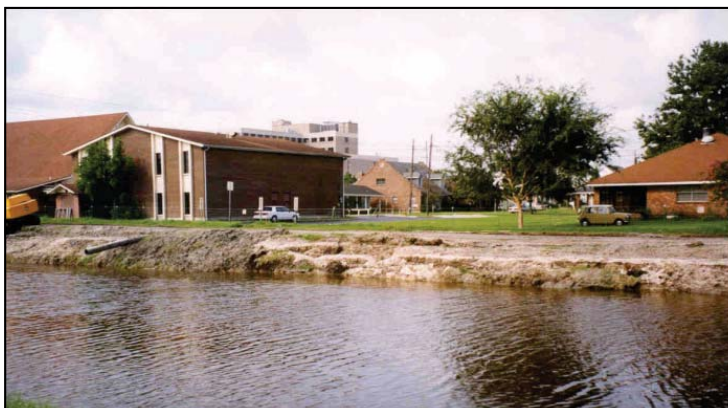
In the initial stages of construction the contractor began excavating the canal bottom in order to install the required geotextile and stone. While performing this work in subaqueous conditions, the canal slopes began to fail (See Figure 3). Because of the unstable conditions

FIGURE 3: FAILED CANAL BANK DURING CANAL

MEA determined that the instability discussed above was the result of overloading of the banks from canal excavation, unwatering and construction loads. The specifications, however, provided no limitation to any of these factors or sequence of work. Yet the engineer performed no investigation to determine whether or not the work was feasible, given the method of construction provided in the plans and specifications. In this case, the owner/engineer considered such a feasibility study during design as an unnecessary effort and left it to the contractor to accomplish the work. In this case, the contractor had much less engineering background to assess the viability of the specified methodology. Despite requiring no engineering submittals, the engineer's response to the difficulties the qualified contractor was having was "means and methods are the responsibility of the contractor".

MEA determined that given the circumstances of this project, the engineer, in developing the plans and specifications, should have answered the question as to whether or not the work, the anticipated means and methods were feasible, and under what restrictions it should be performed.

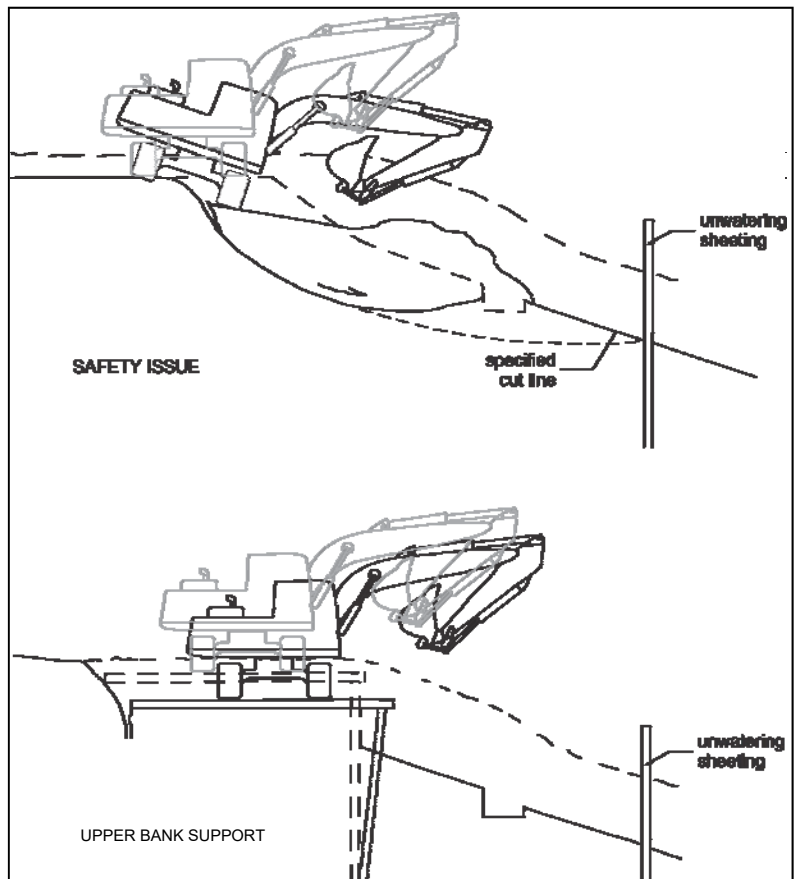
worker safety became an issue, and given that the failure occurred underwater, conditions would only become more adverse once the canal slope was dewatered to install the apron concrete (See Figure 4). This concern resulted in the contractor installing pile supported mats to the equipment on the top of the bank (See Figure 4). Also, because of the instability, even with the use of this upper bank support, the contractor shortened the length of the cofferdams to reduce the exposure to adverse conditions (See Figures 4 and 5). As a consequence, considerably more time and effort was required to complete the project.

FIGURE 4: SAFETY CONCERN OVER UPPER BANK IN STABILITY AND INSTALLED SUPPORT TO ADDRESS THE ISSUE

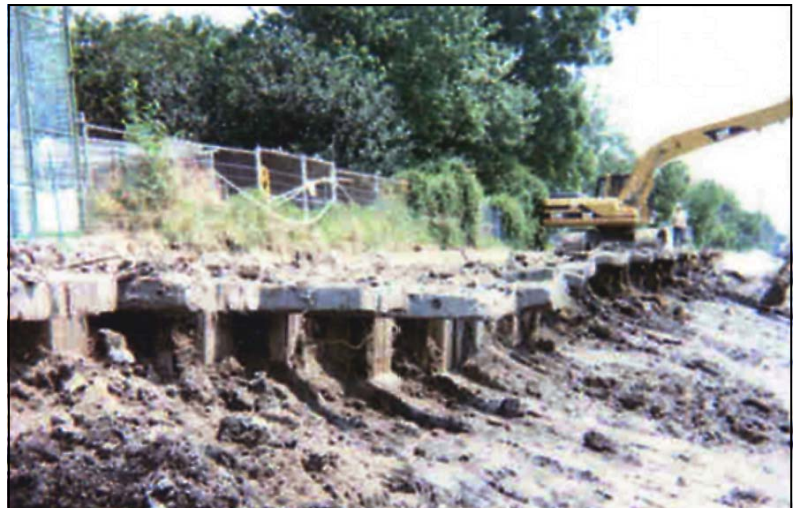
FIGURE 5: EQUIPMENT SUPPORT MOVED DOWNWARD AND OUTWARD DURING DRY SLOPE CONSTRUCTION
