INVESTIGATION OF EXCESSIVE FILL SHRINKAGE FROM EMBANKMENT CONSTRUCTION

MARINO ENGINEERING ASSOCIATES, INC.

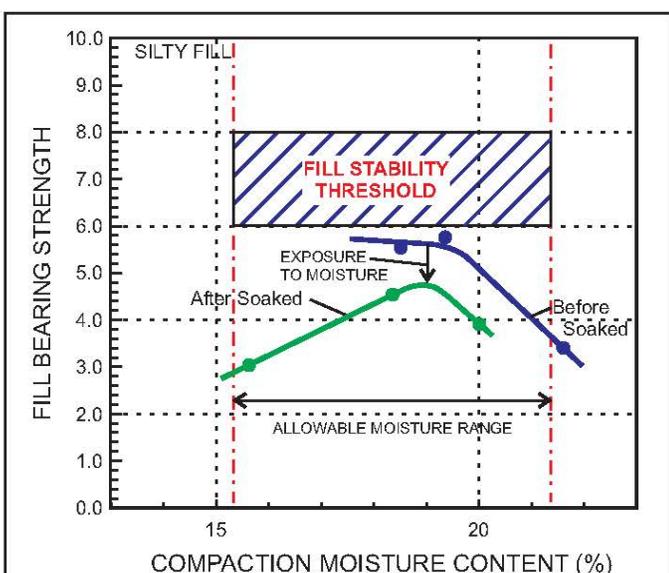
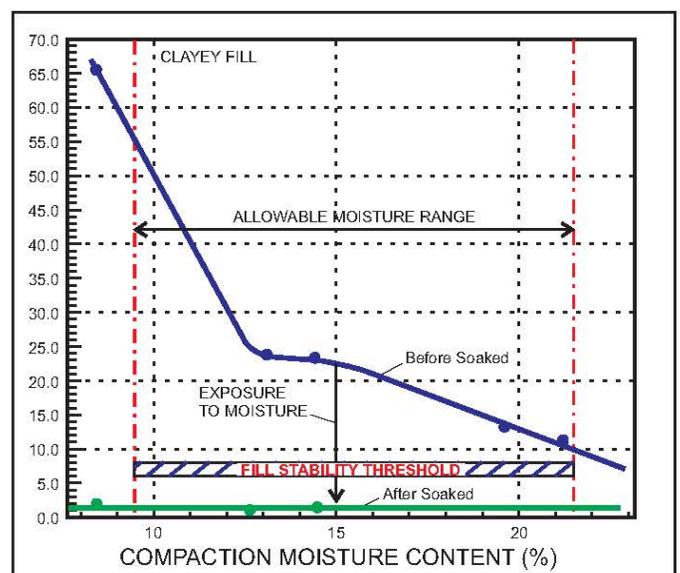
More interesting, however, was the cause for the unexpected and significant foundation settlement and the greater than expected shrinkage from compaction. The culprit was found to be the instability of the placed borrow material, even though it was compacted to specifications. Lab tests showed that when compacted to within specification, the various borrow-to-fill soils would be too weak to support the necessary construction traffic (see Figure 2). This fill instability resulted in the need to extend the wet fill lifts along the entire project

FIGURE 2: FILL STRENGTH WHEN COMPACTED UNDER CONDITIONS ALLOWED IN THE SPECIFICATIONS

In addition to extending fill lifts along the project levee, the borrow material had to be dried to levels less than what was allowed, and compacted to greater densities in order to create at least some stability. About 5% of the fill compaction shrinkage occurred due to the densification of the borrow requiring a higher percent compaction than was specified.
