## 500 FT. ASSEMBLY PLATFORM ON CONCRETE PIERS HEAVES

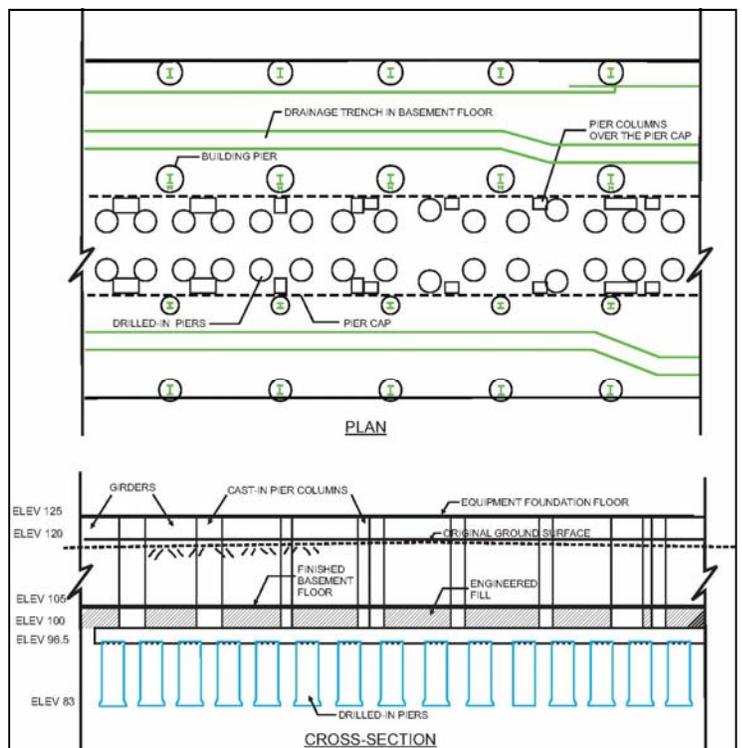
FIGURE 1 PLAN AND CROSS-SECTION OF THE FOUNDATION FOR THE ASSEMBLAGE TRACK IN THE MANUFACTURING PLANT

Due to the tight tolerance required for the production machinery, a massive foundation system consisting of concrete drilled piers was installed in the ground to minimize settlement. The foundation constructed to support the assemblage track consisted of 102, 5-6 ft. diameter, belled, reinforced concrete cassions installed about 25 ft. deep. The large diameter belled cassions were needed to insure that the compression of the pier itself and supporting ground from the manufacturing load would be minimized. The tops of the cassions were structurally connected by a 3.5 ft. thick, 25 ft. wide, and 500 ft. long reinforced concrete cap. A plan and cross-section showing this foundation system is shown in Figure 1.

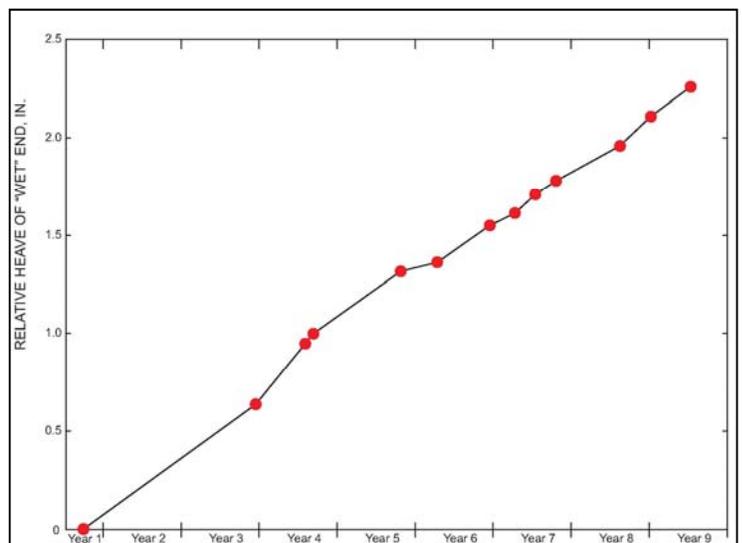
FIGURE 2 PLOT OF THE UPWARD MOVEMENT OF THE MACHINE ASSEMBLAGE TRACK OVER TIME

However, it was later discovered from level surveying that the concrete pier foundation was in fact moving upward, not settling. A plot of the differential upward movement along the assemblage track over about 8 years is shown in Figure 2. Figure 2 shows there has been a fairly constant rate of upward movement over the monitoring period of about 0.25 in./yr. The potential for ground swell from moisture absorption was also considered in the design but was underestimated. The ground swell potential was primarily based on testing of the more shallow, less dense, soil-like materials which had higher moisture contents.

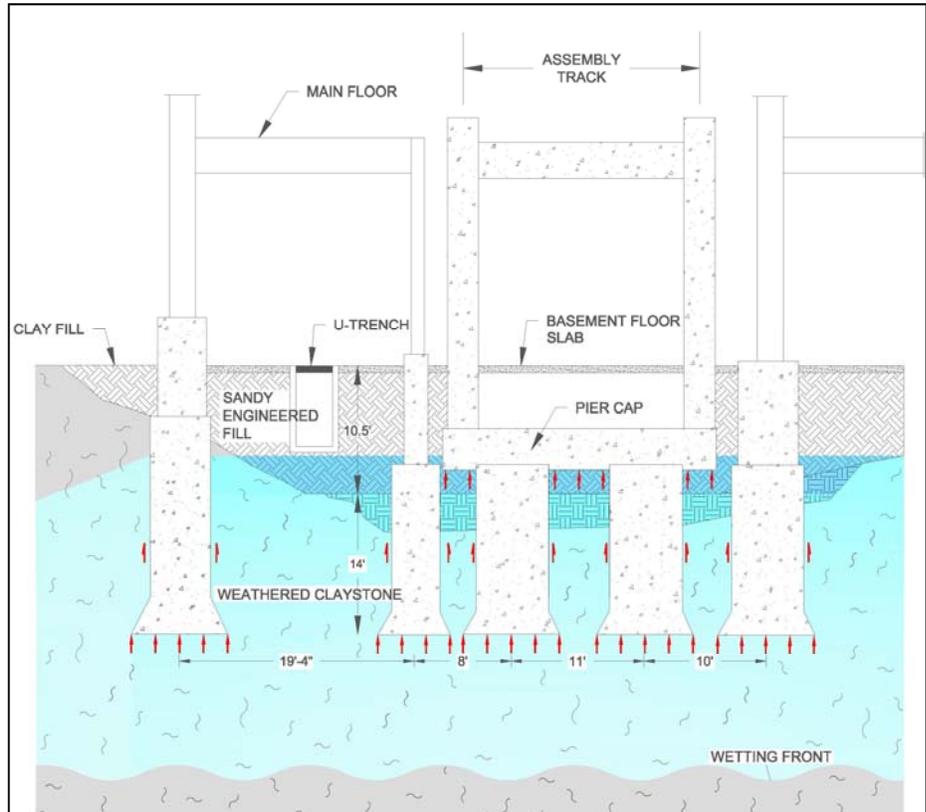
FIGURE 3 ILLUSTRATION OF THE DOWNWARD ABSORPTION AND WETTING FRONT IN THE SUBSURFACE CLAYSTONE MATERIALS

became more compact (or denser) and drier. These claystone conditions were non-optimum given that part of the manufacturing process resulted in disposing of the processing water onto the basement floor on one side of the assemblage track (the wet end). This processing water would flood the basement floor and seep into the subgrade. Consequently, the subsurface claystone materials were constantly exposed to processing water which became perched in the sandy engineered fill (see Figure 3).

The other important factor which was underappreciated was the ability of the perched process water to be absorbed to depths well below the bottom of the belled cassions. This is also illustrated in Figure 3. As this water was being absorbed down to the wetting front, the claystone materials swelled upwards in spite of the significant download foundation loads. Based on in-ground measurements, upward movement was detected to depths of about 6-7 ft. below the pier bottoms at the wet end of the assemblage track (or a depth of about 31 ft.). Under these site conditions, combined with results of swelling tests performed at depth, downward movement of the wetting front (or greater depths of moisture penetration) would be expected. Historically, even deeper wetting fronts have been reported at sites with similar rock conditions. It should be noted that use of the term “active zone” would be a misnomer in this case as the surface was not subjected to evapotranspiration.

This project site was initially poorly investigated and analyzed. If swell tests were run on the lower foundation materials it should have at once become apparent that the swell potential and the depth of the wetting zone for the subsurface claystone materials were much greater. Because site conditions result in a “closed system” (i.e. no surface evapotranspiration), the depth of moisture penetration would be much greater than typically expected and thus deeper heaved conditions would exist. As a result, greater address of the heave potential was required. Misidentifying building foundation heave conditions can present difficult remediation options. They are better addressed before construction and thus worth a more expert design evaluation.
