500 FT. ASSEMBLY PLATFORM ON CONCRETE PIERS HEAVES

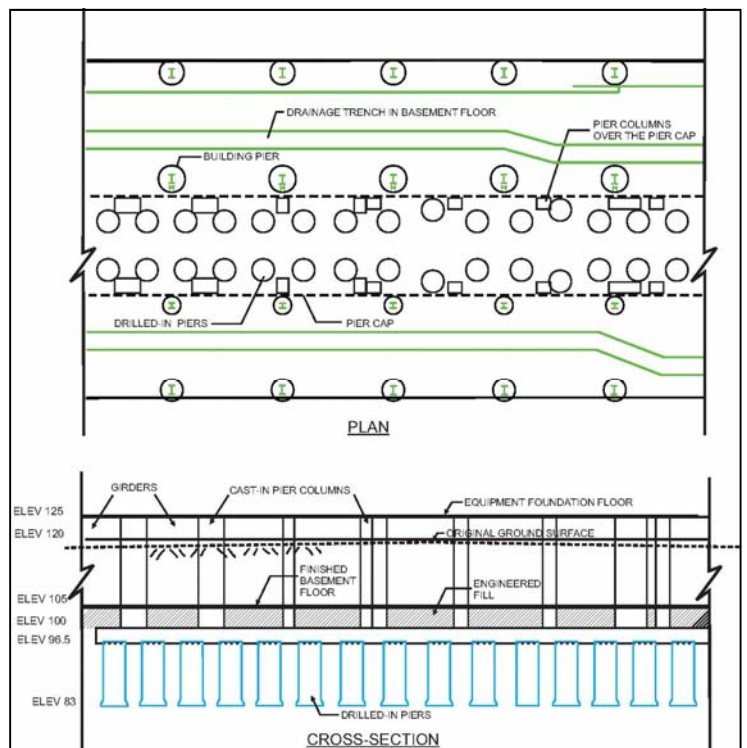
Due to the tight tolerance required for the production machinery, a massive foundation system consisting of concrete drilled piers was installed in the ground to minimize settlement. The foundation constructed to support the assemblage track consisted of 102, 5-6 ft. diameter, belled, reinforced concrete cassions installed about 25 ft. deep. The large diameter belled cassions were needed to insure that the compression of the pier itself and supporting ground from the manufacturing load would be minimized. The tops of the cassions were structurally connected by a 3.5 ft. thick, 25 ft. wide, and 500 ft. long reinforced concrete cap. A plan and cross-section showing this foundation system is shown in Figure 1.

FIGURE 1 PLAN AND CROSS-SECTION OF THE FOUNDATION FOR THE ASSEMBLAGE TRACK IN THE MANUFACTURING PLANT

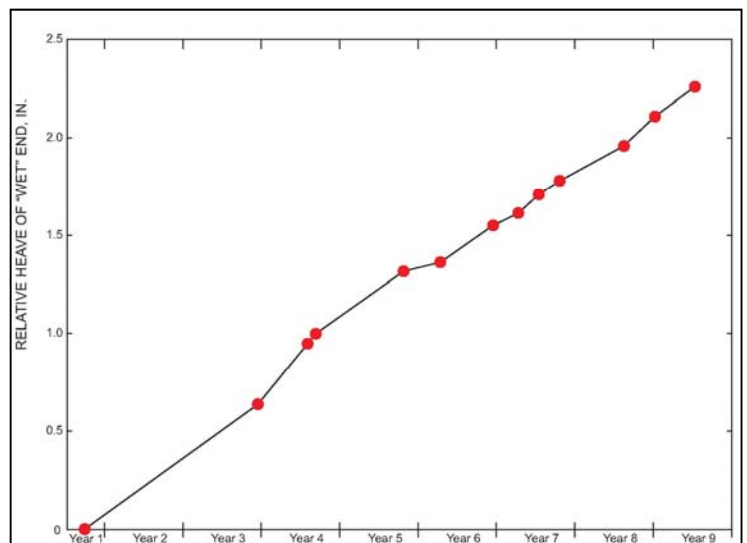
However, it was later discovered from level surveying that the concrete pier foundation was in fact moving upward, not settling. A plot of the differential upward movement along the assemblage track over about 8 years is shown in Figure 2. Figure 2 shows there has been a fairly constant rate of upward movement over the monitoring period of about 0.25 in./yr. The potential for ground swell from moisture absorption was also considered in the design but was underestimated. The ground swell potential was primarily based on testing of the more shallow, less dense, soil-like materials which had higher moisture contents.

FIGURE 2 PLOT OF THE UPWARD MOVEMENT OF THE MACHINE ASSEMBLAGE TRACK OVER TIME

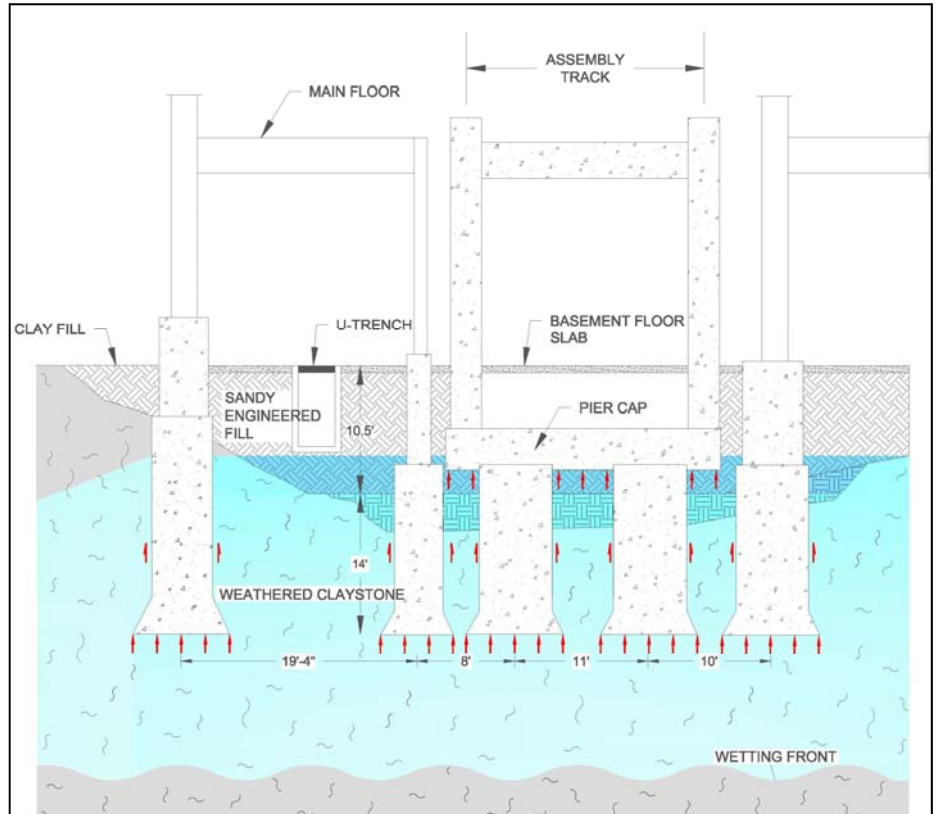
became more compact (or denser) and drier. These claystone conditions were non-optimum given that part of the manufacturing process resulted in disposing of the processing water onto the basement floor on one side of the assemblage track (the wet end). This processing water would flood the basement floor and seep into the subgrade. Consequently, the subsurface claystone materials were constantly exposed to processing water which became perched in the sandy engineered fill (see Figure 3).

FIGURE 3 ILLUSTRATION OF THE DOWNWARD ABSORPTION AND WETTING FRONT IN THE SUBSURFACE CLAYSTONE MATERIALS

This is also illustrated in Figure 3. As this water was being absorbed down to the wetting front, the claystone materials swelled upwards in spite of the significant download foundation loads. Based on in-ground measurements, upward movement was detected to depths of about 6-7 ft. below the pier bottoms at the wet end of the assemblage track (or a depth of about 31 ft.). Under these site conditions, combined with results of swelling tests performed at depth, downward movement of the wetting front (or greater depths of moisture penetration) would be expected. Historically, even deeper wetting fronts have been reported at sites with similar rock conditions. It should be noted that use of the term “active zone” would be a misnomer in this case as the surface was not subjected to evapotranspiration.

This project site was initially poorly investigated and analyzed. If swell tests were run on the lower foundation materials it should have at once become apparent that the swell potential and the depth of the wetting zone for the subsurface claystone materials were much greater. Because site conditions result in a “closed system” (i.e. no surface evapotranspiration), the depth of moisture penetration would be much greater than typically expected and thus deeper heaved conditions would exist. As a result, greater address of the heave potential was required. Misidentifying building foundation heave conditions can present difficult remediation options. They are better addressed before construction and thus worth a more expert design evaluation.
