## SCHOOL BOARD AVOIDS MINE STABILIZATION

MEA performed a subsidence engineering investigation of an existing vacated school property due to past mine subsidence. This school property is located in the East St. Louis Area. This one and two story school building was originally built in 1966 and was added on to in several phases up to 1987. In 2007 a significant portion of the school structure was subjected to sag subsidence. Movement and cracking were first observed in September 2007. About a month after subsidence was reported, the subsidence movements were monitored for about the next 12.5 years. During this period of time, about 0.63 ft of subsidence was measured at the southern end of the demolished section of the building. Given the rate of subsidence in the initial month was significantly more severe, the total subsidence experience at this southern building location was probably on the order of 2 ft based on our experience in the area.

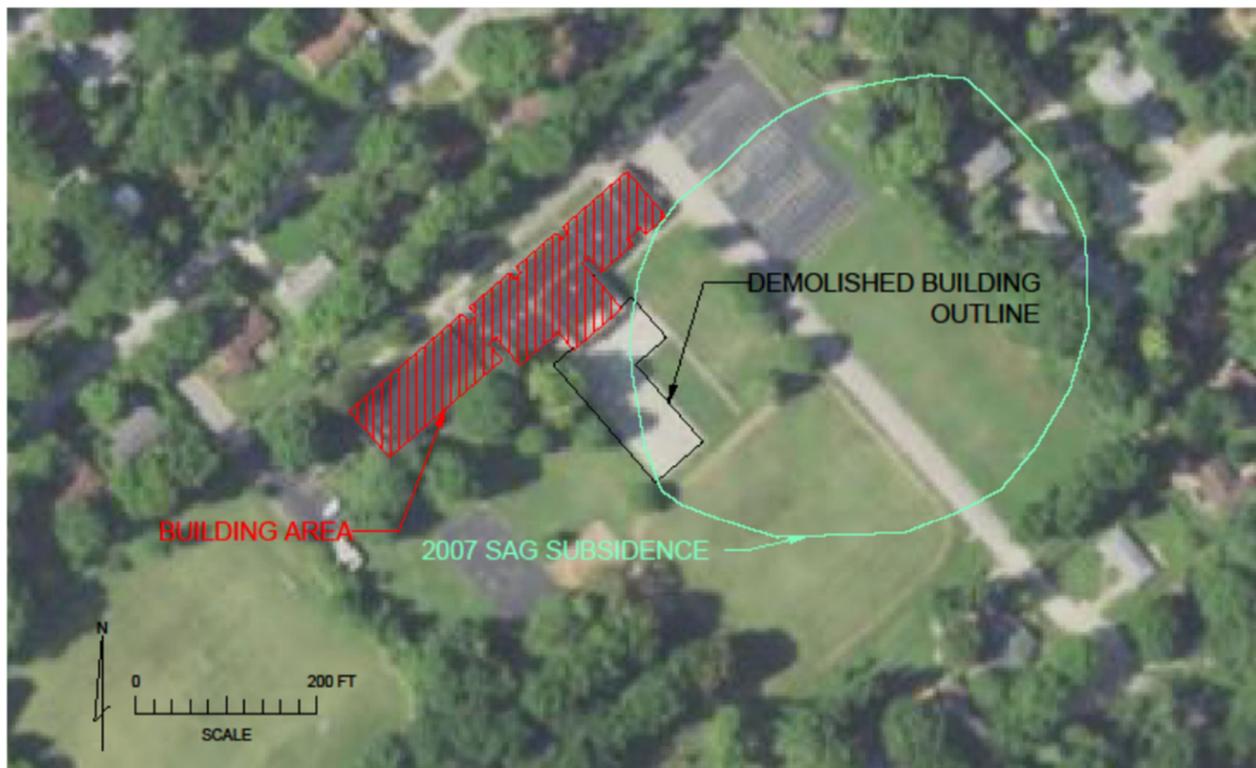
As a result of this subsidence, the southern wing of the school was demolished due to the severe subsidence damage. Figure 1 shows the structure and the location of the sag subsidence and the demolished section of the building. At the time of this investigation, the school building was still abandoned.

FIGURE 1 LOCATIONS OF SCHOOL AND THE 2007 SAG SUBSIDENCE EVENT AND DEMOLISHED SECTION OF THE STRUCTURE

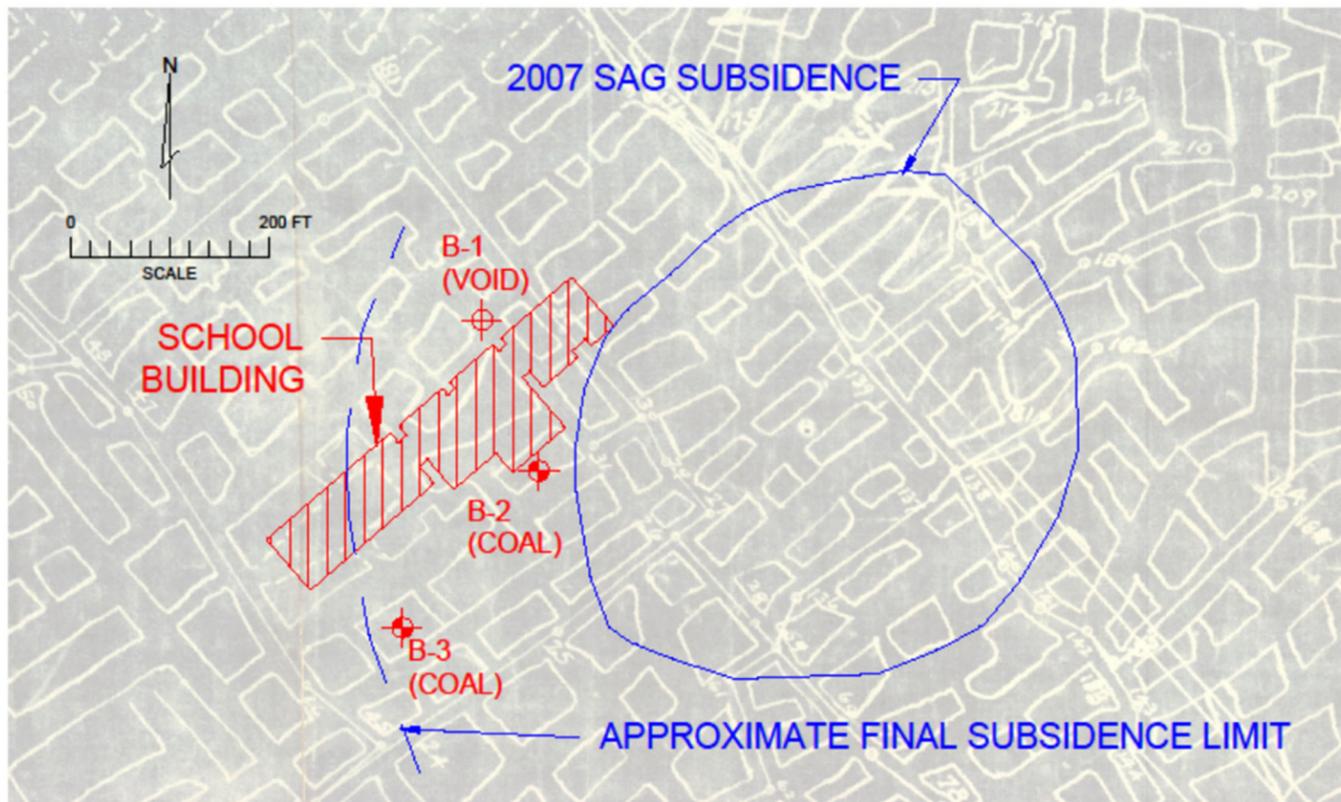
Figure 2 shows the existing school building area superimposed on to the mine map for below the site and the location of the sag subsidence. The room-and-pillar mine complex below the site operated between 1880 to 1946. The mine map indicates from about 50% to 68% of the coal was extracted from the mine. The coal which was mined is called the Herrin No. 6. Coal

FIGURE 2 PRESENT SCHOOL BUILDING OUTLINE WITH MINE MAP SUPERIMPOSED AND LOCATIONS OF SUBSIDENCE AND MINE BORINGS PERFORMED

Understanding the present state and projecting the future state of these abandoned workings was critical to assessing mine stability and thus the potential for future surface subsidence. In order to understand the existing mine stability conditions in the old workings beneath the site, three borings were drilled and sampled sufficiently into the mine floor. The three borings were drilled to depths of 135 to 143 feet where the mined-out coal was found from 105 to 112 feet deep. The location of these holes are shown in Figure 2.

From the rocks sampled from the roof and floor of the mine, laboratory testing was conducted in MEA's laboratory to determine the state of these rock which support the mine openings. With the use of advanced subsidence techniques, rock mechanics analyses were then performed to assess the stability on the mine structure. It was determined the stability of the mine roof and pillars as shown on the mine map should be stable in the long term. The mine investigation work also determined that the mine floor had significantly softened over time but was more likely than not to have sufficient long-term strength to support the bearing loads from the coal pillars. From these assessed mine stability conditions, the risk of surface subsidence, and the resulting damage potential were determined. Given the lower subsidence risk prediction assessed for the site, no mine stabilization measures were deemed necessary by the school board.
