FROZEN FILL CAUSES BUILDING DAMAGE

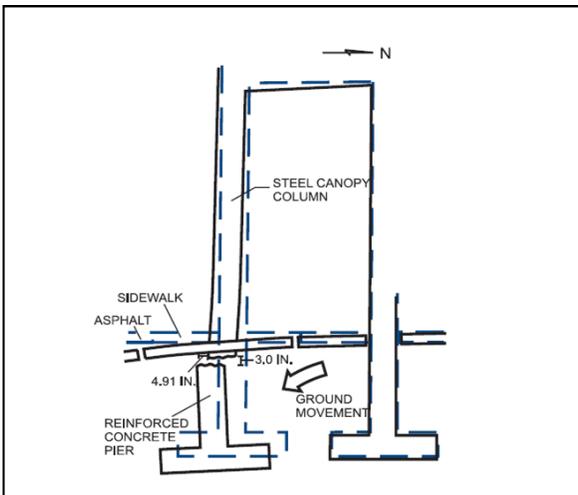
FIGURE 1 DEFORMATION PATTERNS AT THE FRONT OF THE STRUCTURE

Shortly after construction the ground beneath the front of a food store in Minnesota settled and moved laterally away from the building. This building behavior is shown in Figure 1. Also, significant movement was experienced in the parking lot in front of the store. The resulting damage mainly consisted of structural distortion of a canopy structure which supports second floor office facilities, significant cracking and separations in the masonry walls, racked store openings, as well as uneven settlement causing significant ponding and adverse grades in the parking lot.

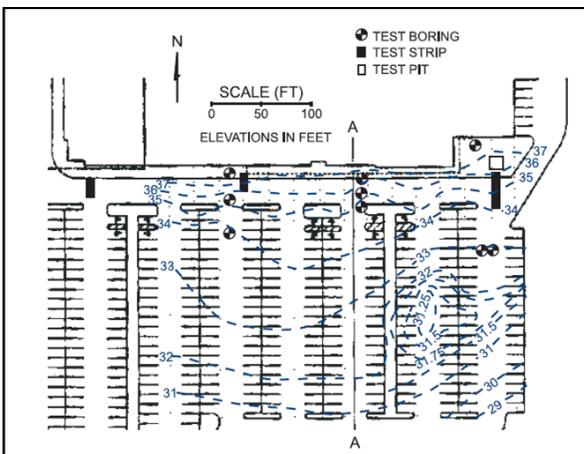
FIGURE 2 SURFACE TOPOGRAPHY OF PARKING LOT SOUTH OF THE BUILDING AND LOCATION OF TEST PITS/STRIP AND EXPLORATORY BORINGS

The maximum measured settlement was up to 3.5 ft. and was located in the parking lot. A topographic map prepared across the project site is shown in Figure 2. By analyzing design and post-settlement grades, the building experienced as much as 0.5 ft. of differential settlement. An important feature of the movement was the determination that basically a settlement trough had developed adjacent to the store. A section across the trough in the approximate area of maximum settlement is depicted in Figure 3. To determine the source(s) of the ground movement which resulted in the building damage, a total of 4 test pit/strips and 10 borings were drilled (see Figure 2).

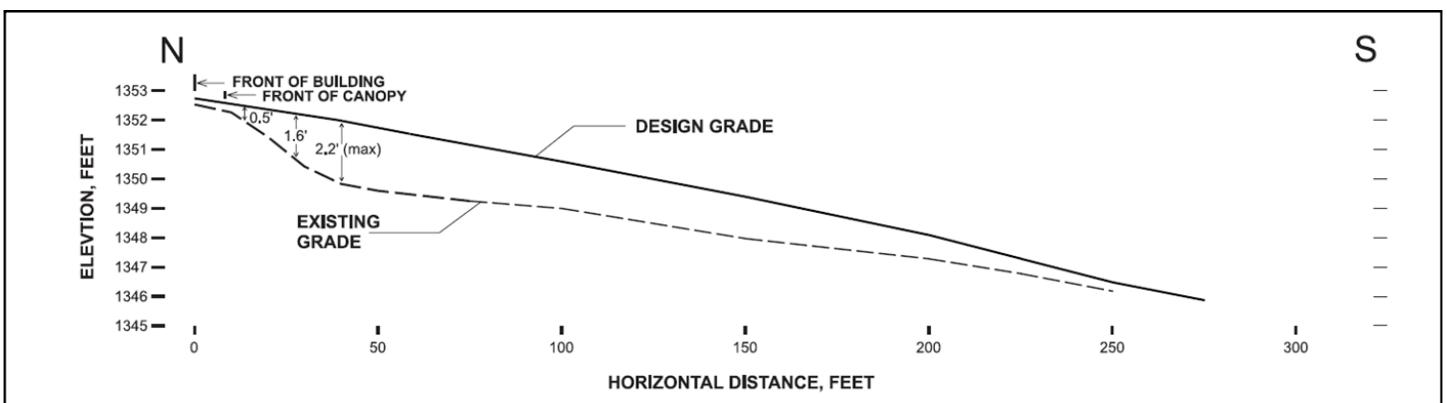
FIGURE 3 SECTION A-A SHOWING SETTLEMENT IN FRONT OF BUILDING AND THROUGH PARKING LOT

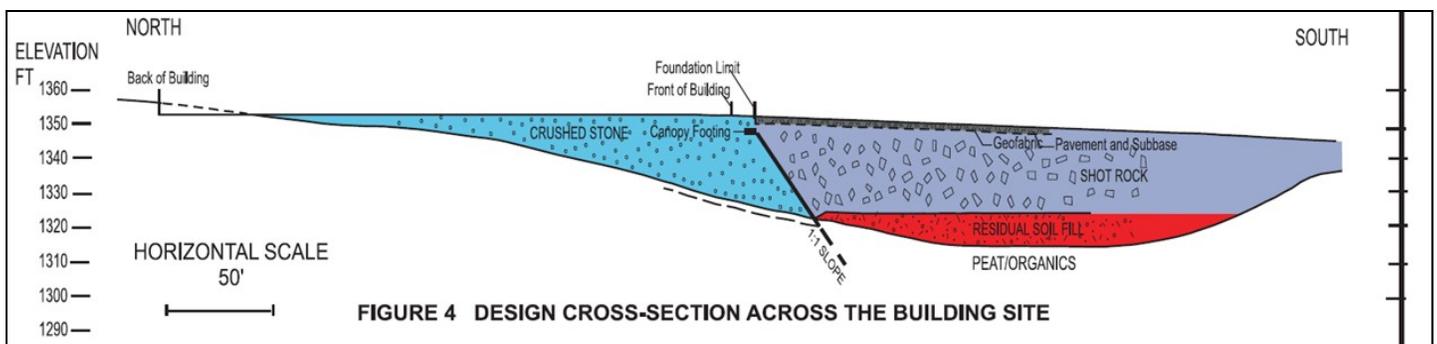
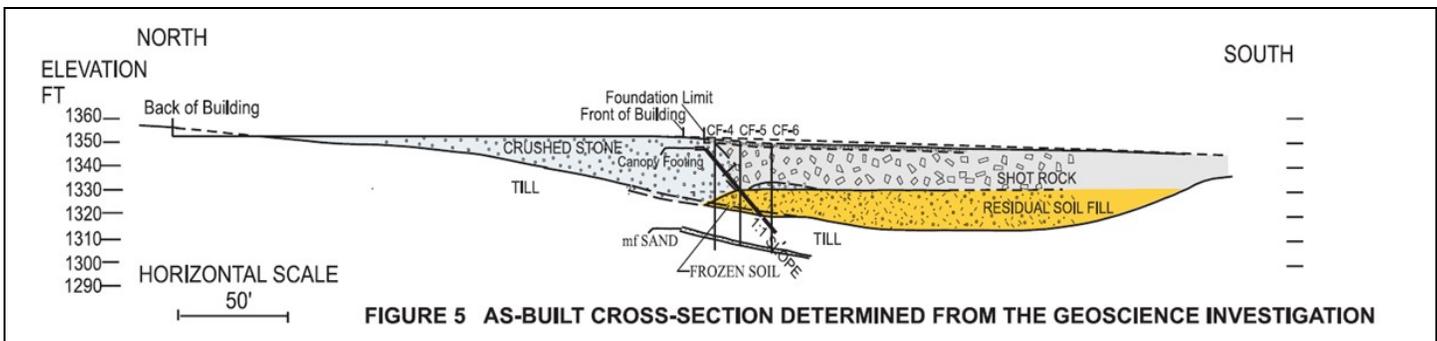
was installed to about 1 ft. below top of pavement. The shot rock was covered with geofabric, subbase stone, and then asphalt (see Figure 4).

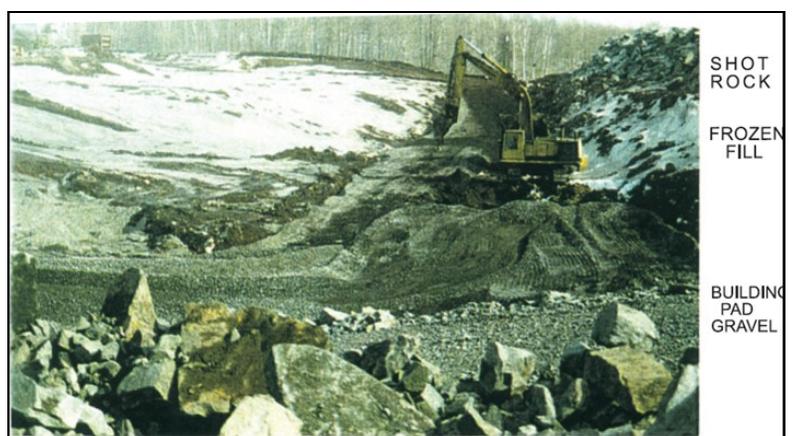
It was initially thought that the presence of peat to the south was the likely cause of ground movement affecting the building. While it appeared to be mainly the cause for settlement to the south in the parking lot, the exploratory work uncovered the main cause for the resulting damage to the store was thawing of frozen residual soil fill within the influence zone (and building pad) of the structure. The location of this material is shown in the cross-section in Figure 5. Based on our forensic studies this frozen material was left within the building pad and froze when the north construction slope of this fill was exposed to winter conditions because the building pad gravel had not been placed over it in time. This can be seen in the photograph looking along this construction slope in Figure 6. The photograph was taken by a local geotechnical inspection engineer.

FIGURE 6 GRAVEL BEING INSTALLED IN BUILDING PAD AND AGAINST FROZEN FILL SLOPE
