## INVESTIGATION OF A ROADWAY FAILURE

A town in Missouri located on the banks of the Mississippi River demanded the construction of an earthen levee to protect itself from the floodwaters of the river. This required the construction of an asphalt bypass road for an existing state highway, as the proposed levee construction cuts across the highway into the adjacent limestone bluff.

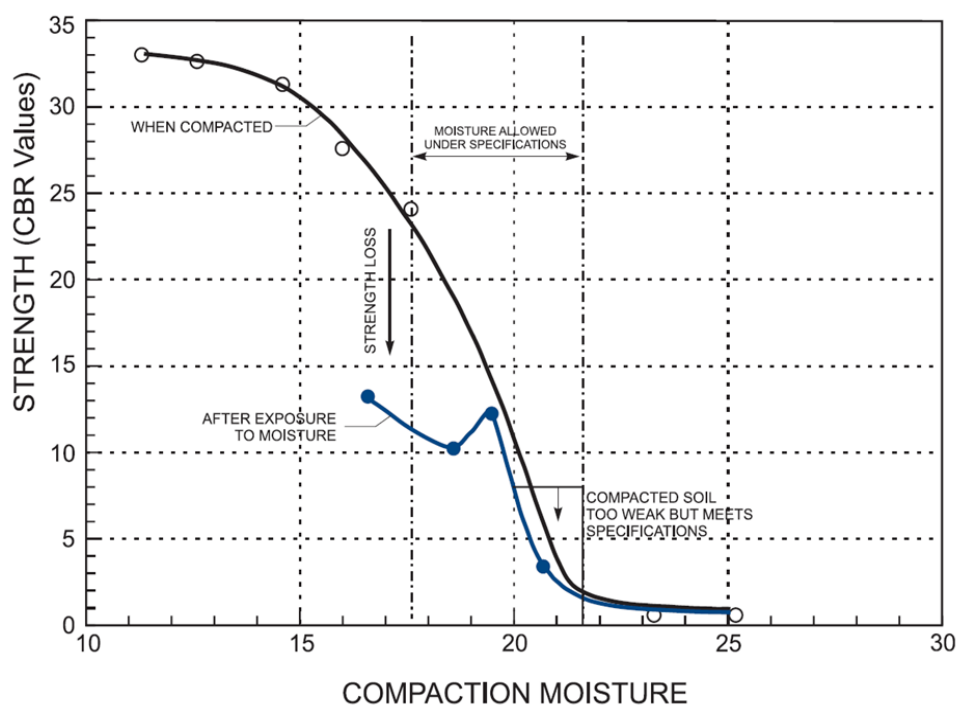
It was discovered from the laboratory testing that there was a dramatic decrease in soil strength when the fill or subgrade soil was compacted at wetter allowable moisture contents or when the soil compacted to specifications became exposed to moisture (see Figure 1). Therefore, the decline in the performance of the bypass road is linked to the moisture-induced softening of previously compacted embankment subgrade soils. It was found that the exposure to moisture was exacerbated by the upward movement of groundwater given the geologic setting. The results of laboratory testing explained how the fill and subgrade prepared to the plans and specifications resulted in the road failure realized in the field. Although the compacted roadway foundation was prepared under the engineer's approval it was too unstable

FIGURE 1 SOIL COMPACTED TO SPECIFICATIONS BECOMES TOO WEAK AT ALLOWABLE MOISTURE CONTENTS OR WHEN EXPOSED TO MOISTURE

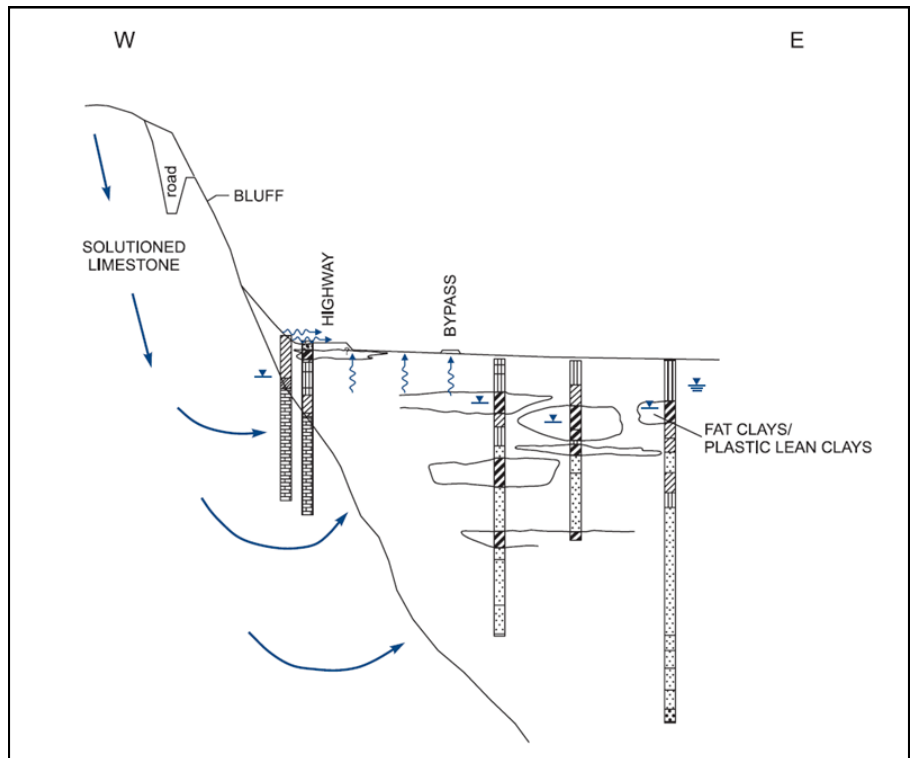
During construction a number of observations were made of upward migration of groundwater, surface springs, and artesian conditions. However, the pre-construction groundwater levels at the site were considerably lower. An analysis of the hydrogeologic conditions helped in unraveling the story behind this moisture softening of the compacted subgrade and fill. The bluff which is adjacent to the site is made of solutioned limestone and acted as a groundwater recharge area (see Figure 2). During heavy rains, the groundwater levels rose in the bluffs which in turn caused a rise in the hydraulic head in the sand layers lying underneath the silts/

FIGURE 2 HYDROGEOLOGIC PROFILE OF THE SITE

silty fine sands in the foundation and embankment. The plastic lean clays and fat clays below the foundation subgrade appear discontinuous and did not provide an impermeable barrier for the upward movement of the groundwater. Also the silty embankment and foundation soils are conducive to significant capillary rise and are extremely vulnerable to pumping action which brings the freewater to surface in response to traffic loads.
