## LANDSLIDE DURING LAND DEVELOPMENT

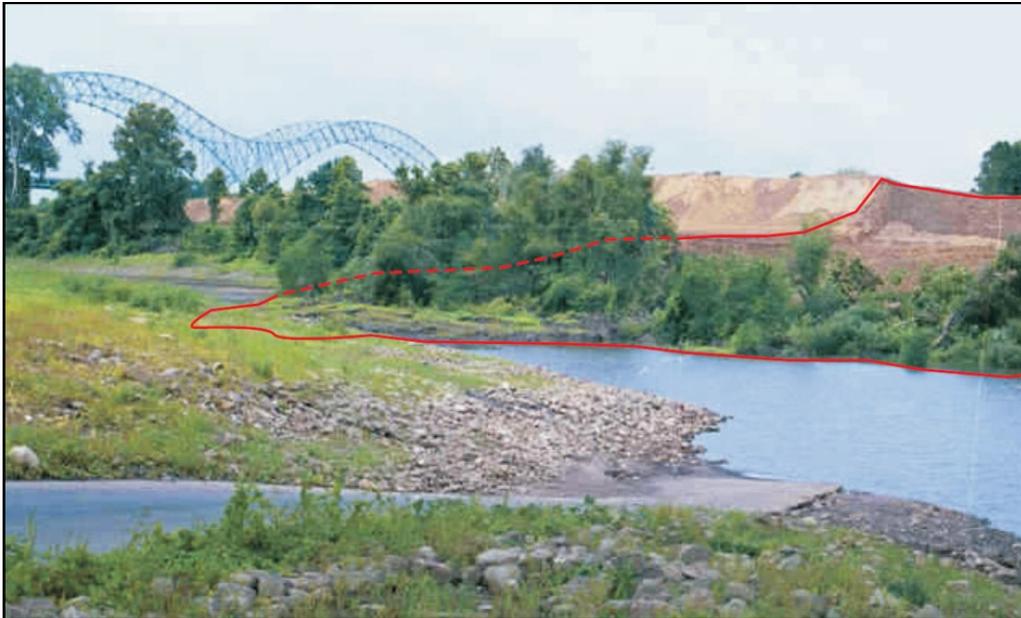
FIGURE 1 LANDSLIDE INTO A WATER CHANNEL DURING THE PLACEMENT OF FILL

An investigation of a landslide was undertaken by MEA to determine the cause of the failure (see Figure 1). The failure occurred during the placement of fill above soft clay soils. The site required up to about 20 ft. of fill to bring it above flood elevation. Most of the fill was required along an earth-sloped water channel.

As the site was being filled, borrow soil was being stockpiled at a rate of soil import that significantly exceeded that of fill placement. The balance of imported soil was stored farthest from the channel. With as much as 10 ft. of fill installed and a large resulting stockpile, failure occurred overnight without warning.

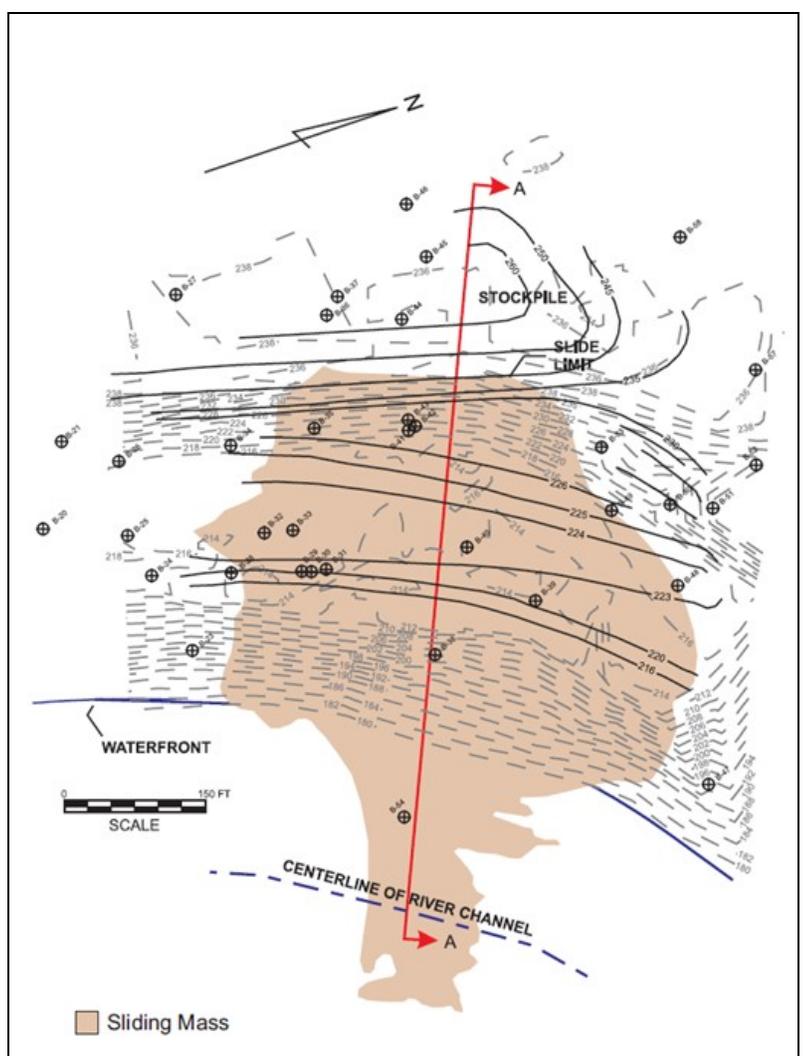
The pre-existing and estimated topography at the time of failure is shown in Figure 2. Figure 2 also depicts the outline of the failed soil mass which accounted for 3.4 acres

FIGURE 2 PRE-EXISTING AND ESTIMATED AT-FAILURE TOPOGRAPHY AS WELL AS AN OUTLINE OF THE SLIDE

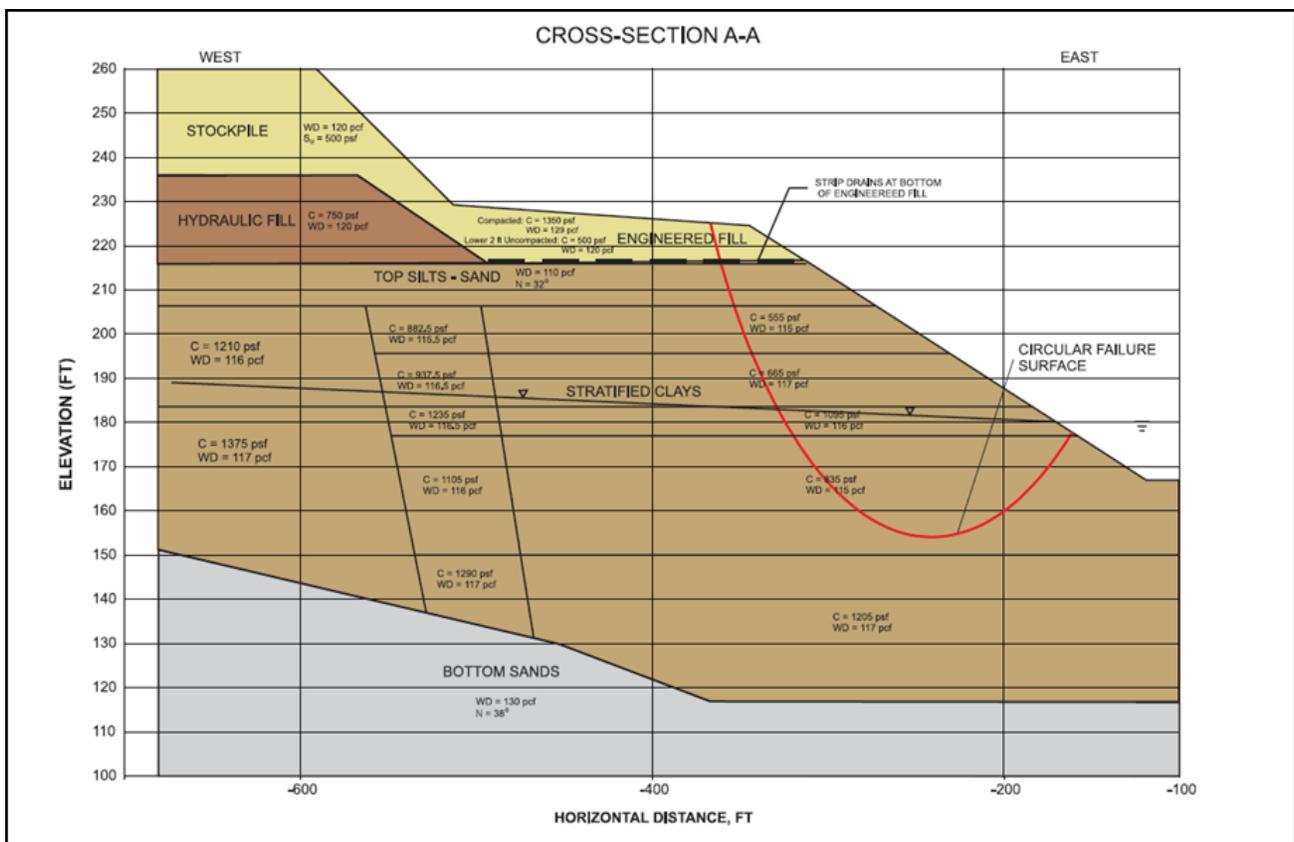
FIGURE 3 BASIC SOIL PROFILE CONDITIONS WITH THE CRITICAL FAILURE

above water level. As can be seen in Figure 2, the sliding mass extended into the stockpile area. The landslide was investigated from a number of soil borings and laboratory test data. The basic soil profile used in the evaluation of the failure is shown in Figure 3. It is interesting to note that after about 45 days of fill placement, which is the time of failure, no noticeable increase in soil strength could be discerned as a result of the wick drains. Based on the groundwater and soil conditions at failure, the critical failure surface was obtained and is shown in Figure 3.

As can be seen in Figure 3, the sliding failure initiated at the channel bank and extended to a depth of 70 ft. This bank failure resulted in an inland progressive failure encompassing a limited section of the stockpile. Based on stability analyses, one massive failure was found to be much less likely.

In summary, a significant landslide was investigated. The landslide occurred during the soil fill operations and displaced 3.4 acres towards and into a water channel. Analysis of the failure determined that the sliding initiated near the channel bank and progressed further into the site. No noticeable improvement in soil strength was gained from the installed wick drains.
