HYDROLOGIC IMPACTS ON AN UNDERGROUND ABANDONED COAL MINE

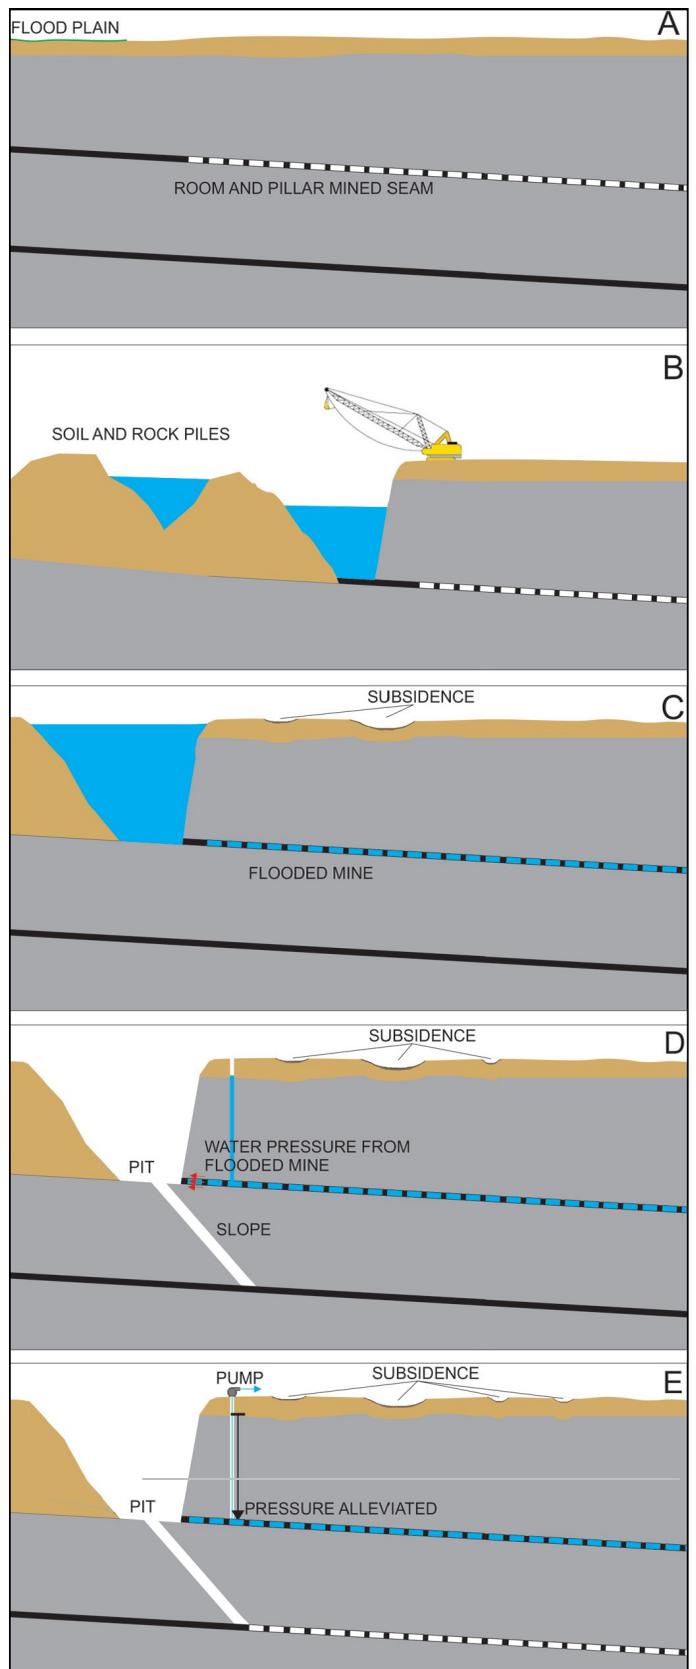
FIGURE 1 SNAPSHOTS OF MINING AND HYDROLOGICAL CONDITIONS OVER TIME

At shallower depths to the south, (due to the dip of the coal to the north), the coal seam was being stripped out in the area. This stripping operation was ongoing while the underground mining was taking place. See Figure 1B. The stripped area was in the lowlands, therefore significant amounts of runoff drained into the mined pit. This could be clearly observed on the historic photos of the area.

As a result of the dewatering, the water level was dropped as much as about 140 ft. over extended periods of time, but would vary depending upon the pumping effort. In other words, in addition to putting the full weight of the overburden back on the mine structure that had been subjected to long term moisture deterioration, the dewatering resulted in oscillating water levels causing cyclic slaking and roof cave conditions (see Figure 2). In effect, this roof deterioration would result in heightened pillars with reduced capacity. Given the now softened floors, reduced pillar capacity, and significant increase in overburden load from dewatering, a substantial increase in surface subsidence was observed. See Figure 1E.

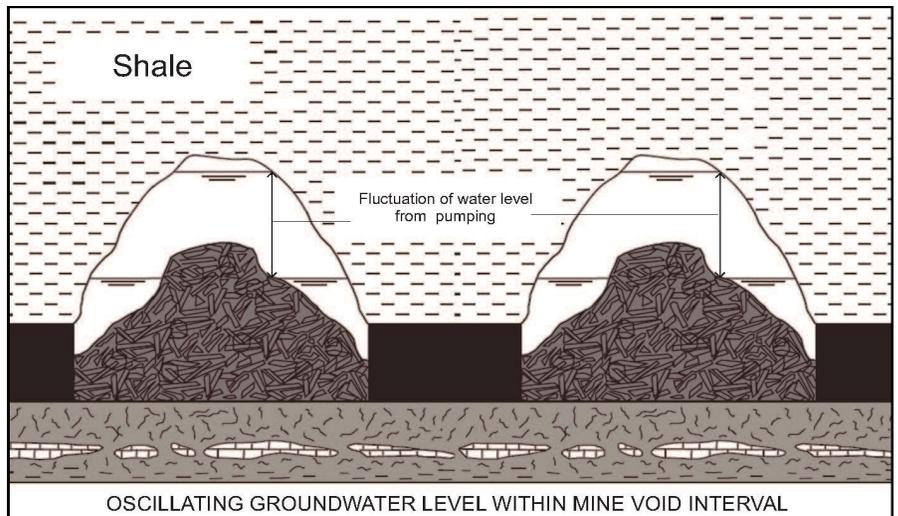
FIGURE 2 ROOF FAILURE ABOVE ROOM
