FROZEN FILL CAUSES BUILDING DAMAGE

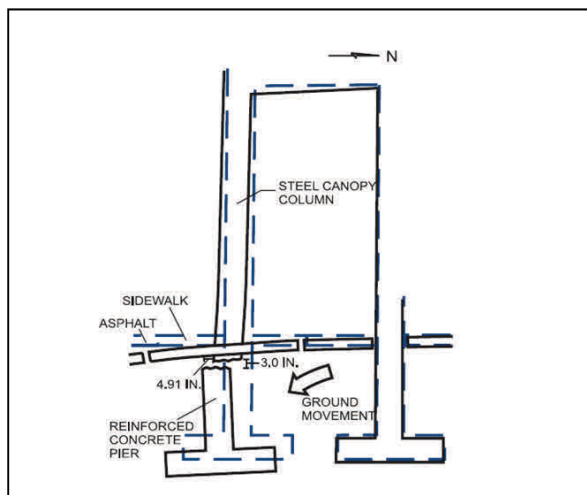
FIGURE 1 DEFORMATION PATTERNS AT THE FRONT OF THE STRUCTURE

Shortly after construction the ground beneath the front of a food store in Minnesota settled and moved laterally away from the building. This building behavior is shown in Figure 1. Also, significant movement was experienced in the parking lot in front of the store. The resulting damage mainly consisted of structural distortion of a canopy structure which supports second floor office facilities, significant cracking and separations in the masonry walls, racked store openings, as well as uneven settlement causing significant ponding and adverse grades in the parking lot.

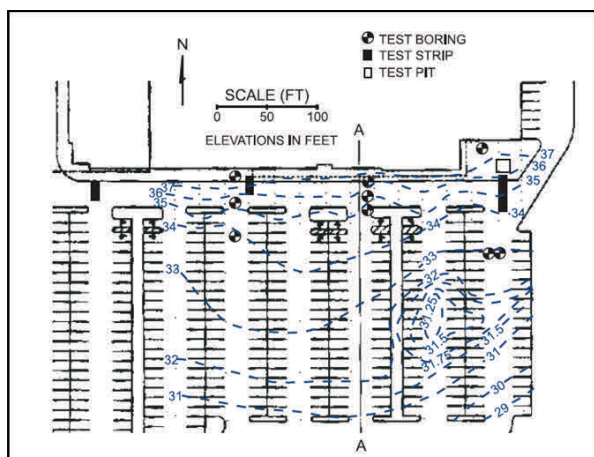
FIGURE 2 SURFACE TOPOGRAPHY OF PARKING LOT SOUTH OF THE BUILDING AND LOCATION OF TEST PITS/STRIP AND EXPLORATORY BORINGS

The maximum measured settlement was up to 3.5 ft. and was located in the parking lot. A topographic map prepared across the project site is shown in Figure 2. By analyzing design and post-settlement grades, the building experienced as much as 0.5 ft. of differential settlement. An important feature of the movement was the determination that basically a settlement trough had developed adjacent to the store. A section across the trough in the approximate area of maximum settlement is depicted in Figure 3. To determine the source(s) of the ground movement which resulted in the building damage, a total of 4 test pit/strips and 10 borings were drilled (see Figure 2).

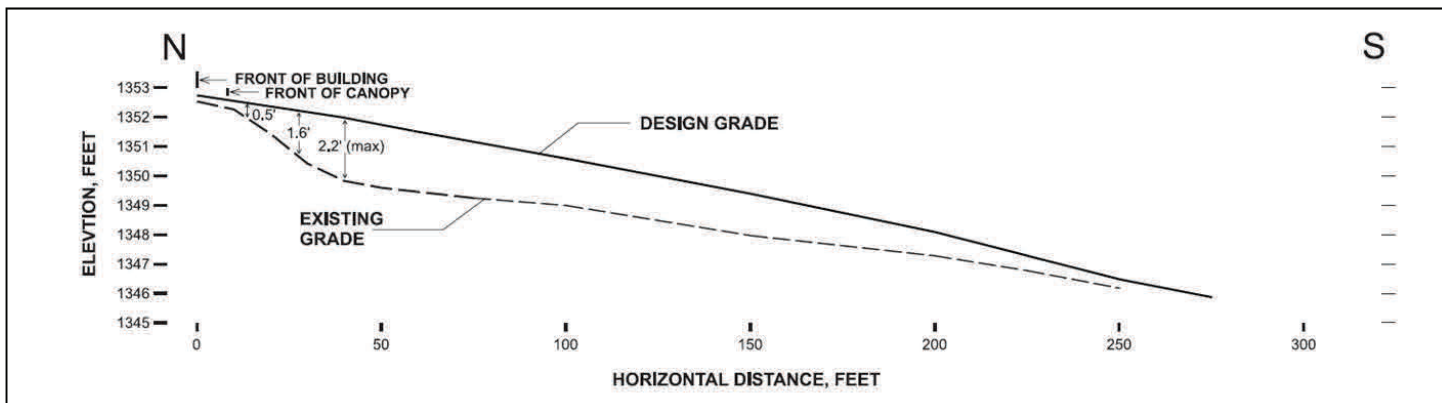
FIGURE 3 SECTION A-A SHOWING SETTLEMENT IN FRONT OF BUILDING AND THROUGH PARKING LOT

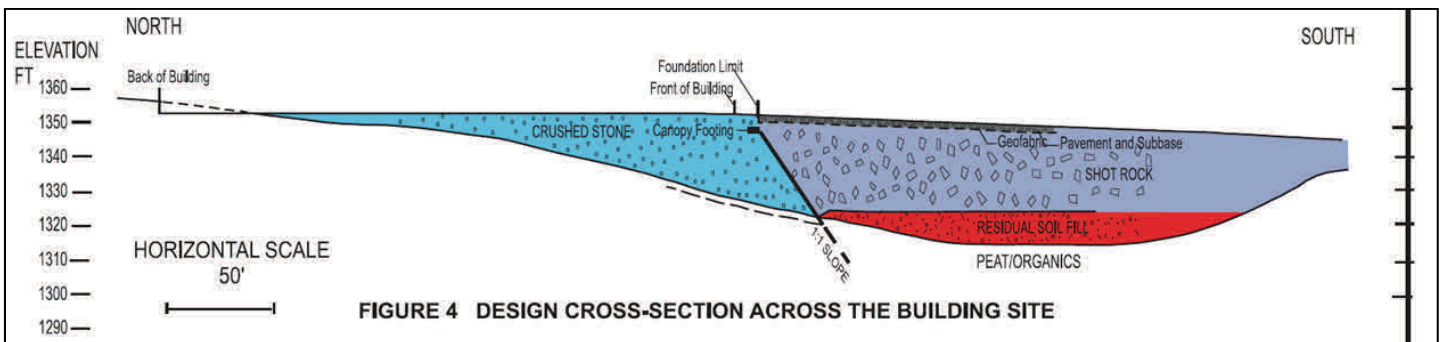
FIGURE 4 DESIGN CROSS-SECTION ACROSS THE BUILDING SITE

On top of the residual soil fill shot (blast) rock (mainly boulder and cobble sized from the rock cut) was installed to about 1 ft. below top of pavement. The shot rock was covered with geofabric, subbase stone, and then asphalt (see Figure 4).

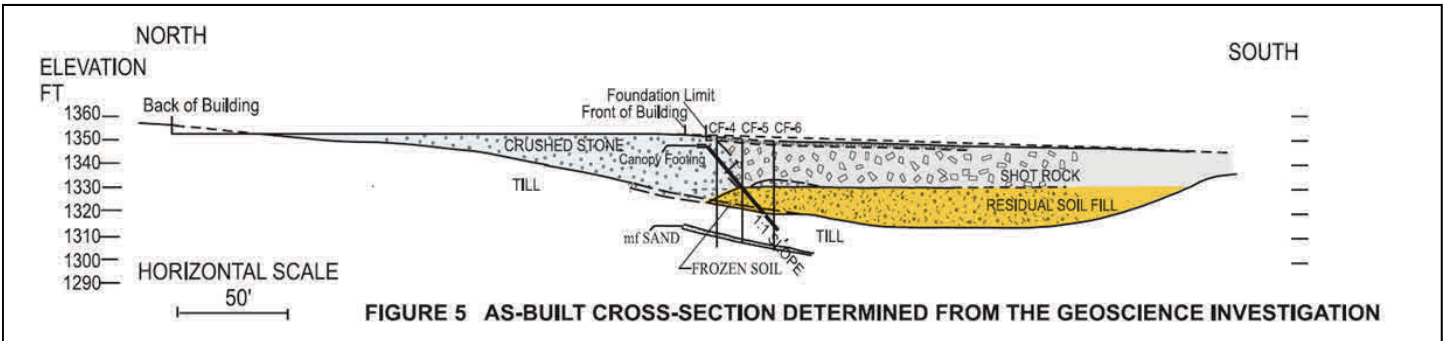
FIGURE 5 AS-BUILT CROSS-SECTION DETERMINED FROM THE GEOSCIENCE INVESTIGATION

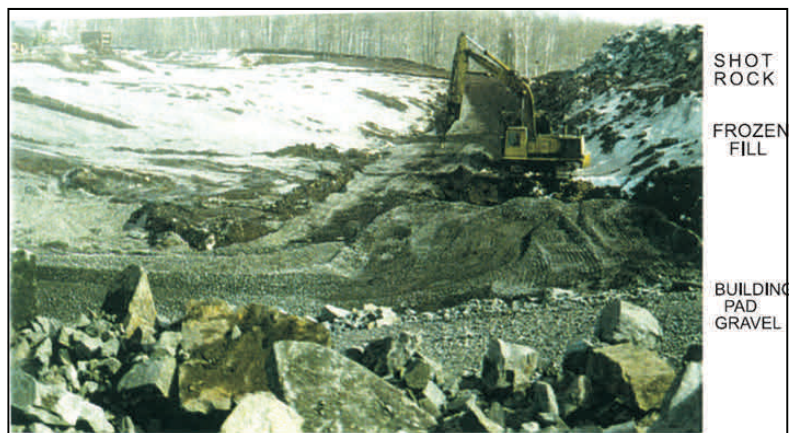
It was initially thought that the presence of peat to the south was the likely cause of ground movement affecting the building. While it appeared to be mainly the cause for settlement to the south in the parking lot, the exploratory work uncovered the main cause for the resulting damage to the store was thawing of frozen residual soil fill within the influence zone (and building pad) of the structure. The location of this material is shown in the cross-section in Figure 5. Based on our forensic studies this frozen material was left within the building pad and froze when the north construction slope of this fill was exposed to winter conditions because the building pad gravel had not been placed over it in time. This can be seen in the photograph looking along this construction slope in Figure 6. The photograph was taken by a local geotechnical inspection engineer.

FIGURE 6 GRAVEL BEING INSTALLED IN BUILDING PAD AND AGAINST FROZEN FILL SLOPE
