INVESTIGATION OF A ROADWAY FAILURE

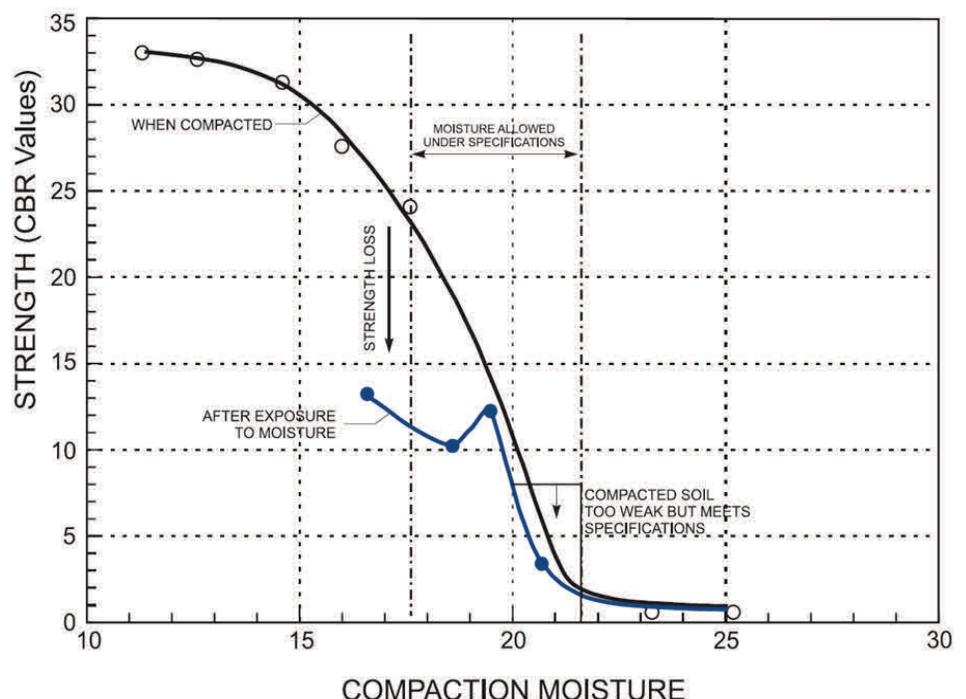
It was discovered from the laboratory testing that there was a dramatic decrease in soil strength when the fill or subgrade soil was compacted at wetter allowable moisture contents or when the soil compacted to specifications became exposed to moisture (see Figure 1). Therefore, the decline in the performance of the bypass road is linked to the moisture-induced softening of previously compacted embankment subgrade soils. It was found that the exposure to moisture was exacerbated by the upward movement of groundwater given the geologic setting. The results of laboratory testing explained how the fill and subgrade prepared to the plans and specifications resulted in the

FIGURE 1 SOIL COMPACTED TO SPECIFICATIONS BECOMES TOO WEAK AT ALLOWABLE MOISTURE CONTENTS OR WHEN EXPOSED TO MOISTURE

road failure realized in the field. Although the compacted roadway foundation was prepared under the engineer's approval it was too unstable for the installation of the asphalt pavement when exposed to moisture.

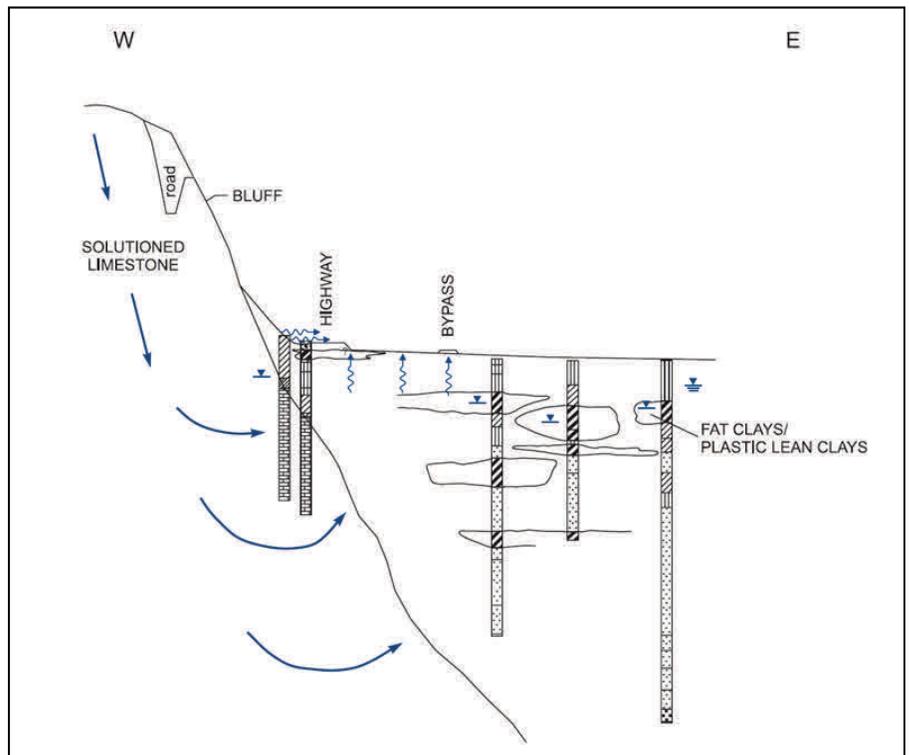
During construction a number of observations were made of upward migration of groundwater, surface springs, and artesian conditions. However, the pre-construction groundwater levels at the site were considerably lower. An analysis of the hydrogeologic conditions helped in unraveling the story behind this moisture softening of the compacted subgrade and fill. The bluff which is adjacent to the site is made of solutioned limestone and acted as a groundwater recharge area (see Figure 2).

During heavy rains, the groundwater levels rose in the bluffs which in turn caused a rise in the hydraulic head in the sand layers lying underneath the silts/silty fine sands in the foundation and embankment. The plastic lean clays and fat clays below the foundation subgrade appear discontinuous and did not provide an impermeable barrier for the upward movement of the groundwater. Also the silty embankment and foundation soils are conducive to significant capillary rise and are extremely vulnerable to pumping action which brings the freewater to surface in response to traffic loads.

FIGURE 2 HYDROGEOLOGIC PROFILE OF THE SITE
