FOUNDATION RECOMMENDATIONS RESULT IN UNNECESSARY LARGE COST

This update concerns a case where a more well thought out geotechnical investigation which would have cost a little more could have saved millions of dollars and a significant amount of lost time. This project involves an assessment of the swell potential of weathered to fresh rock, the foundation system chosen, and the repair of mushroomed piers (see Figure 1). Mushroomed concrete piers are the result of pouring against the naturally formed widening of the drill hole made to install the pier.

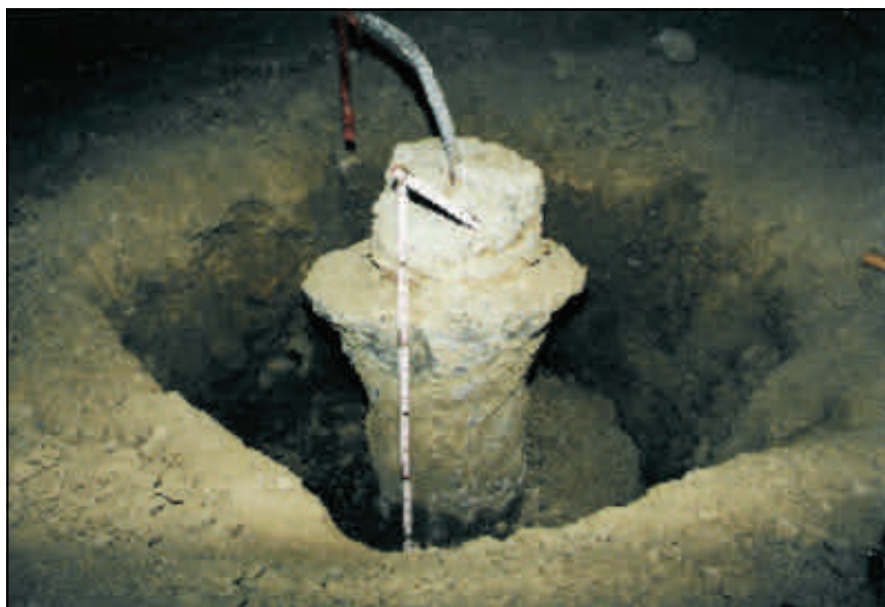
FIGURE 1 TYPICAL PICTURE SHOWING THE MUSHROOMING OF THE PIER TOP

either method of drilling would render the basic intent to avoid mushrooming at the tops of the piers futile as drilling in hard rock using either method caused the drill bit to wander. The action of the drill bit and gravity movement of soil and weathered rock into the hole resulted in instability at the upper portion of the drill holes and S-shaped piers. Better choice and planning of equipment would have prevented this. The S-shaped piers typically develop in the hard rock areas, where the bit would tend to wander during drilling through alternate hard and weathered horizons. Some of the piers ended up with mushroomed tops, which could be detrimental in expansive soils as shown below, but this was not the case for this site.

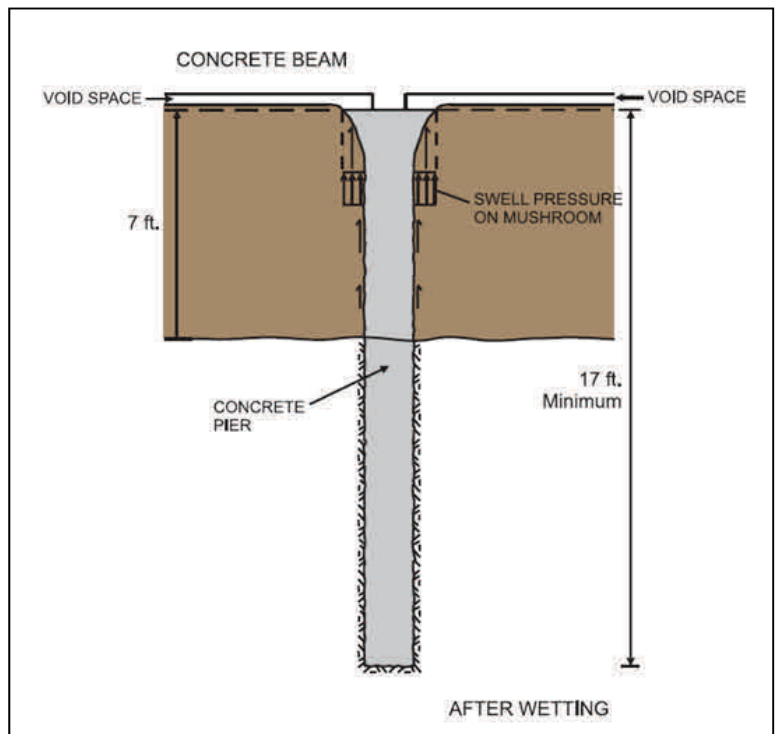
FIGURE 2 MUSHROOM STRESS ANALYSIS
