LANDSLIDE DURING LAND DEVELOPMENT

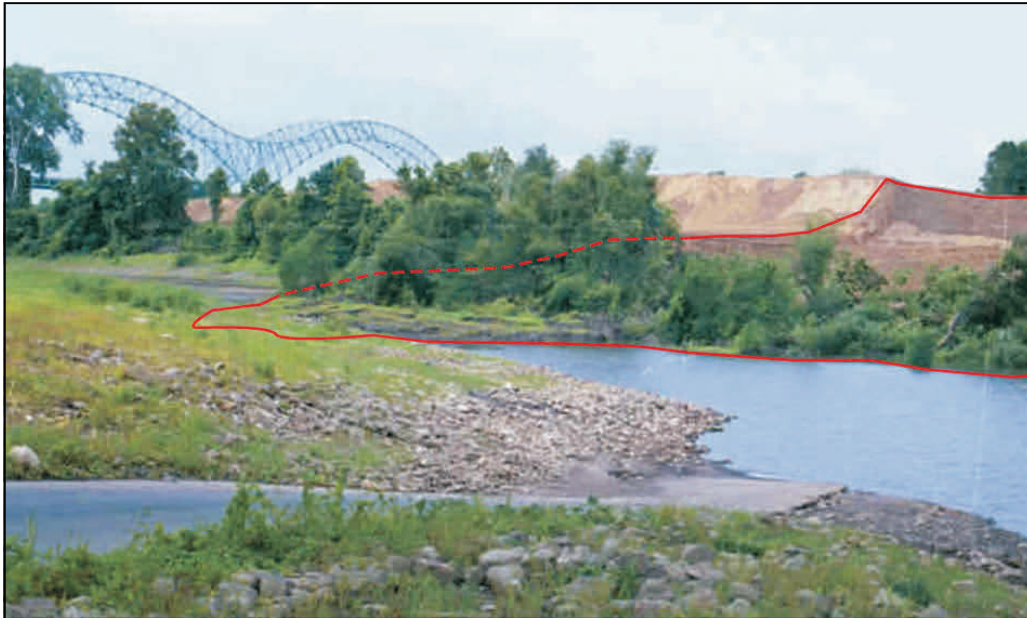
FIGURE 1 LANDSLIDE INTO A WATER CHANNEL DURING THE PLACEMENT OF FILL

An investigation of a landslide was undertaken by MEA to determine the cause of the failure (see Figure 1). The failure occurred during the placement of fill above soft clay soils. The site required up to about 20 ft. of fill to bring it above flood elevation. Most of the fill was required along an earth-sloped water channel.

As the site was being filled, borrow soil was being stockpiled at a rate of soil import that significantly exceeded that of fill placement. The balance of imported soil was stored farthest from the channel. With as much as 10 ft. of fill installed and a large resulting stockpile, failure occurred overnight without warning.

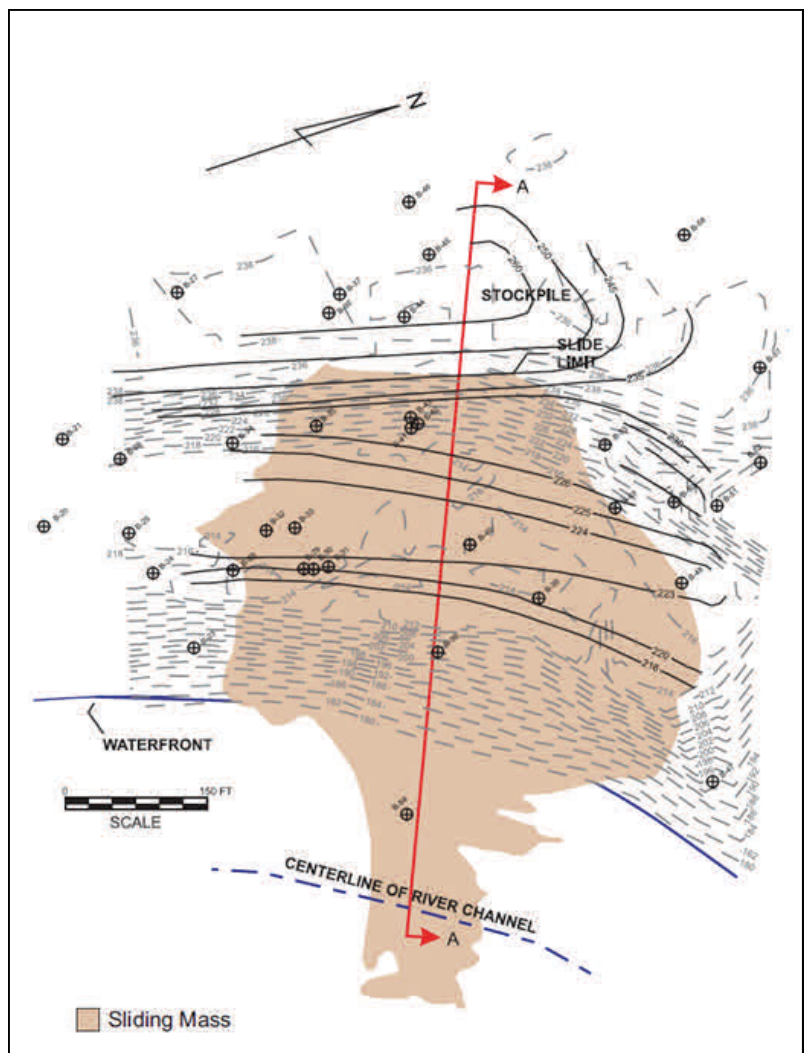
FIGURE 2 PRE-EXISTING AND ESTIMATED AT-FAILURE TOPOGRAPHY AS WELL AS AN OUTLINE OF THE SLIDE

Figure 2 also depicts the outline of the failed soil mass which accounted for 3.4 acres above water level. As can be seen in Figure 2, the sliding mass extended into the stockpile area.

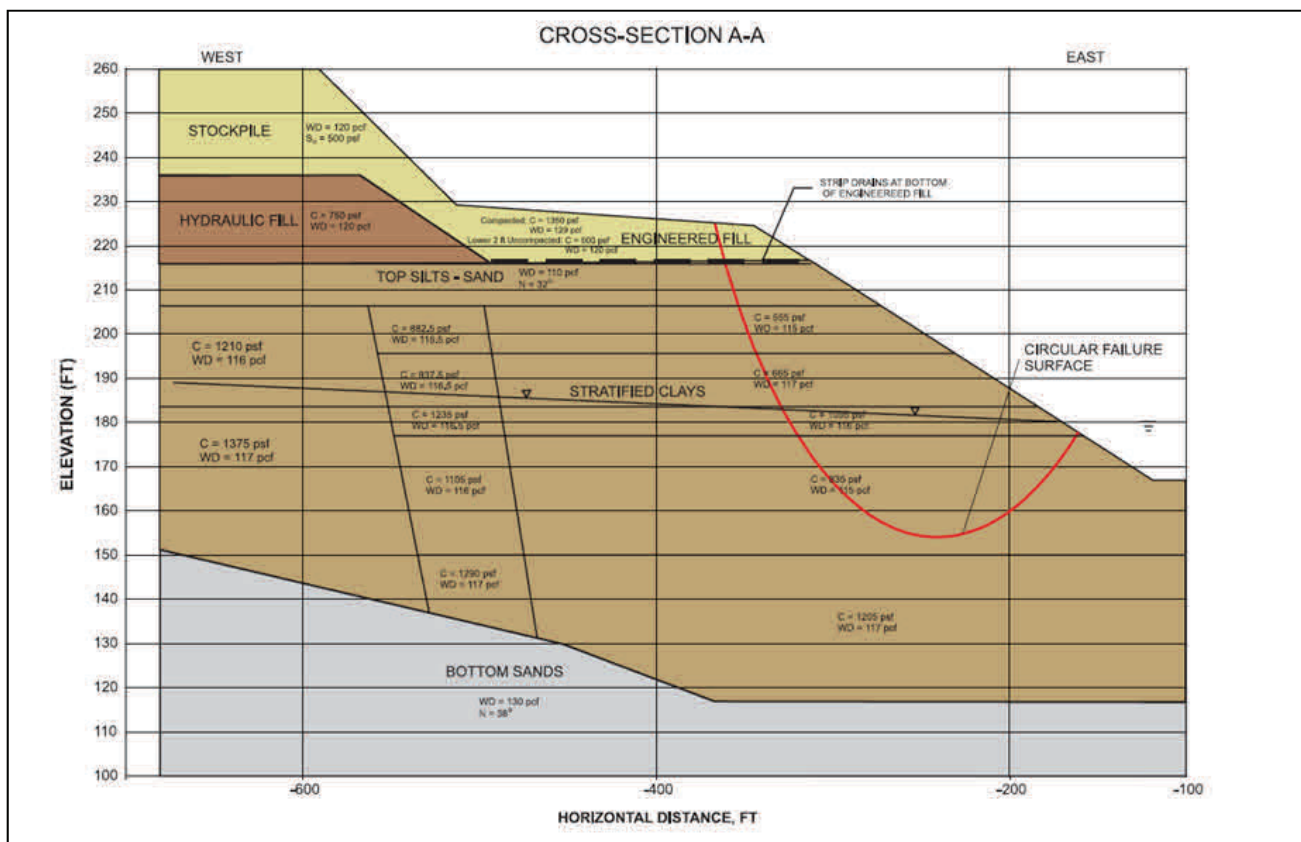
FIGURE 3 BASIC SOIL PROFILE CONDITIONS WITH THE CRITICAL FAILURE

The landslide was investigated from a number of soil borings and laboratory test data. The basic soil profile used in the evaluation of the failure is shown in Figure 3. It is interesting to note that after about 45 days of fill placement, which is the time of failure, no noticeable increase in soil strength could be discerned as a result of the wick drains. Based on the groundwater and soil conditions at failure, the critical failure surface was obtained and is shown in Figure 3.

As can be seen in Figure 3, the sliding failure initiated at the channel bank and extended to a depth of 70 ft. This bank failure resulted in an inland progressive failure encompassing a limited section of the stockpile. Based on stability analyses, one massive failure was found to be much less likely.
