INVESTIGATION AND REPAIR OF A FAILED OLYMPIC POOL

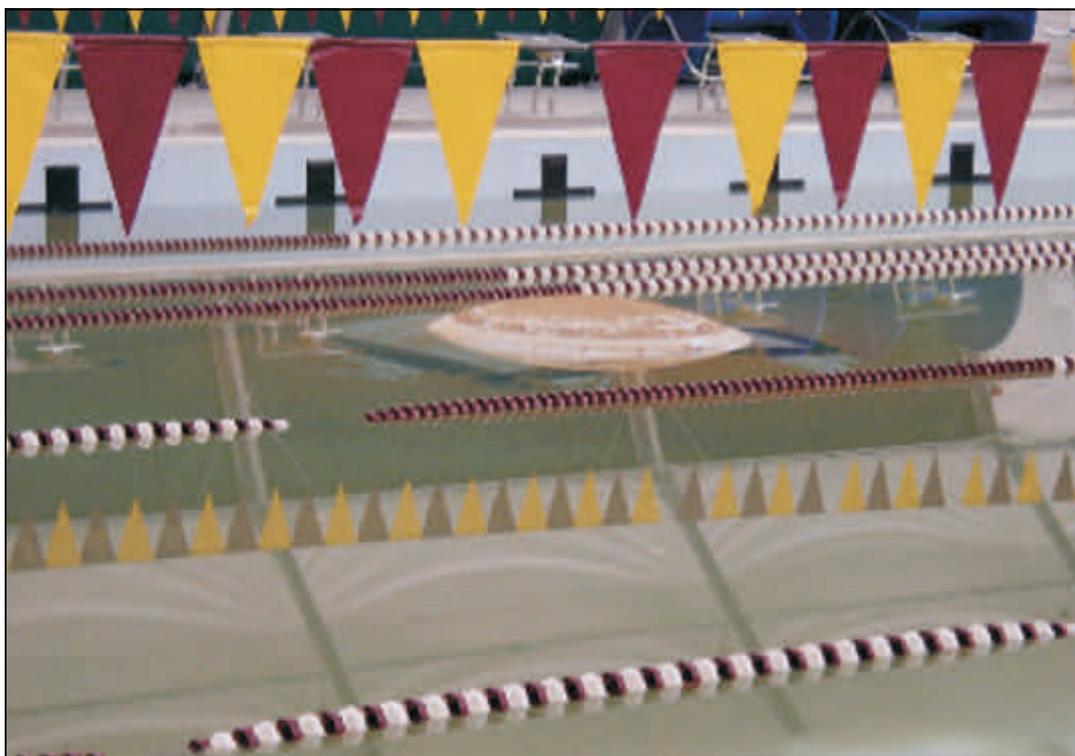
FIGURE 1 VERY LARGE BUBBLE IN THE FLOOR LINER WHICH GREW OUT OF THE WATER DURING THE OPERATION OF THE POOL

From the beginning of the operation of the Olympic Pool in Tennessee there were signs of trouble. The water in the pool would not clear up, the pool liner had bubbles which appeared to grow over time, and the pool floor needed constant vacuuming. Initial thoughts by the contractor who constructed the pool was that filtration plumbing, which was installed below the pool floor, contained a significant amount of construction debris which was making its way into the pool. As the pool continued to operate, the blisters in the liner grew, which was speculated to be the result of a high groundwater table. Eventually one of these bubbles became so large that it rose above the water surface. To deflate this now very significant liner bubble, it was punctured spewing soil and water (see Figure 1).

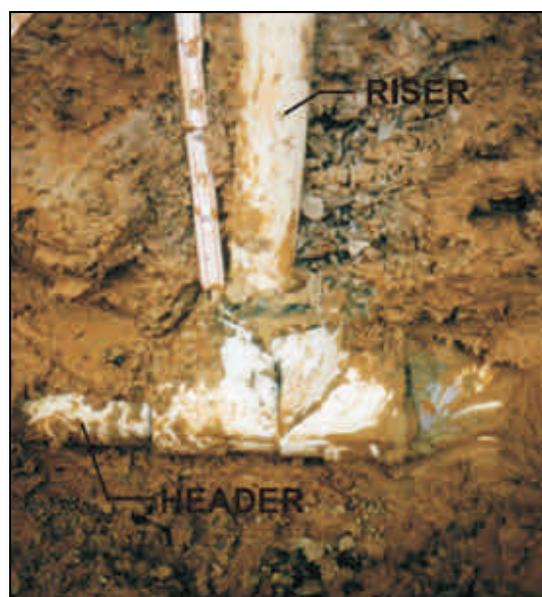
From a borehole camera inspection it was discovered that there was a significant fracturing of the sub-floor plumbing. The fracturing was concentrated at the connector of the rise pipe and header (see Figure 2). Also from manometer survey and photographic information it was established that the pool floor and wall had settled. Normally, such pool settlement would not affect the

FIGURE 2 TYPICAL FRACTURING FOUND AT THE RISER/HEADER CONNECTION
