MEA MARINO ENGINEERING ASSOCIATES, INC. • Issue 28

AIRPORT PAVEMENT SUBBASE AND SUBGRADE PREPARATION DIFFICULTIES

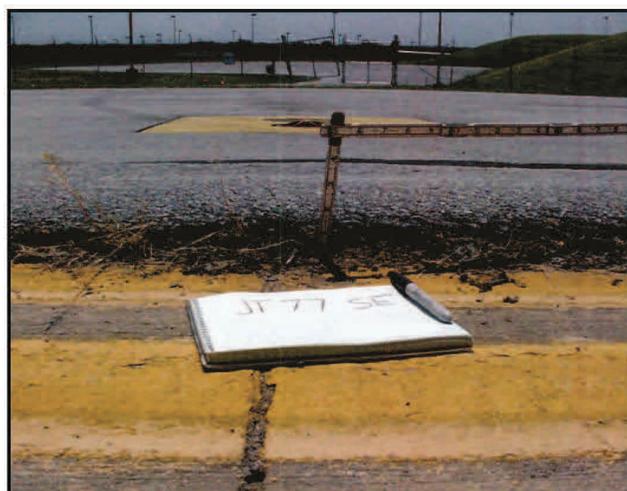
Problems began during pavement construction when the prepared subgrade became wet from precipitation. This resulted in egregious softening and swelling, which destabilized the overlying subbase. The potential for swelling and softening can be seen in constructed pavement with the swelling heave differential of about 1.3 in. between the concrete and asphalt pavement (see Figure 1).

FIGURE 1: DIFFERENTIAL HEAVE OF 1.3 IN. FROM SUBGRADE SWELLING BETWEEN THE TAXIWAY

Oftentimes, construction subbase/subgrade issues are not sufficiently addressed in the plans and specifications. Foresight into pavement preparation constructability issues during design can significantly mitigate disputes, claims, delays and the final cost, especially with respect to large projects such as the one mentioned above.

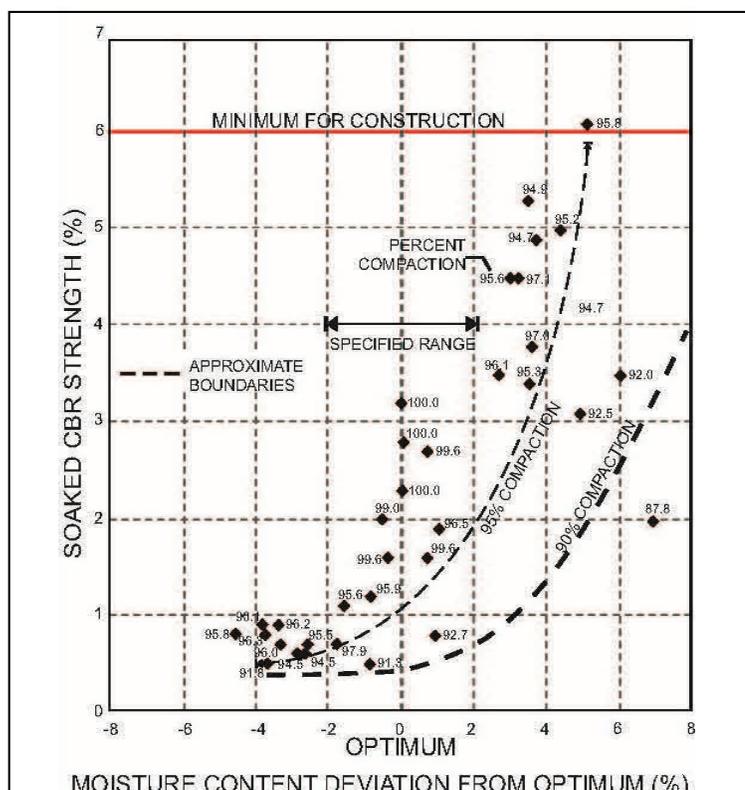
FIGURE 2: MOISTURE CONTENT RELATIVE TO OPTIMUM PLOTTED AGAINST THE SOAKED CBR VALUE FOR ALL COMPACTED SAMPLES

To investigate whether the subgrade specifications would be problematic during construction, a series of strength tests (i.e. CBR tests) were run on compacted site clay subgrade samples. The results, which are shown in Figure 2, were consistent with the difficulties encountered in the field. When the clay soil subgrade was exposed to moisture it became extremely unstable when prepared to within the specified moisture and compaction range and actually showed better performance at greater moistures.

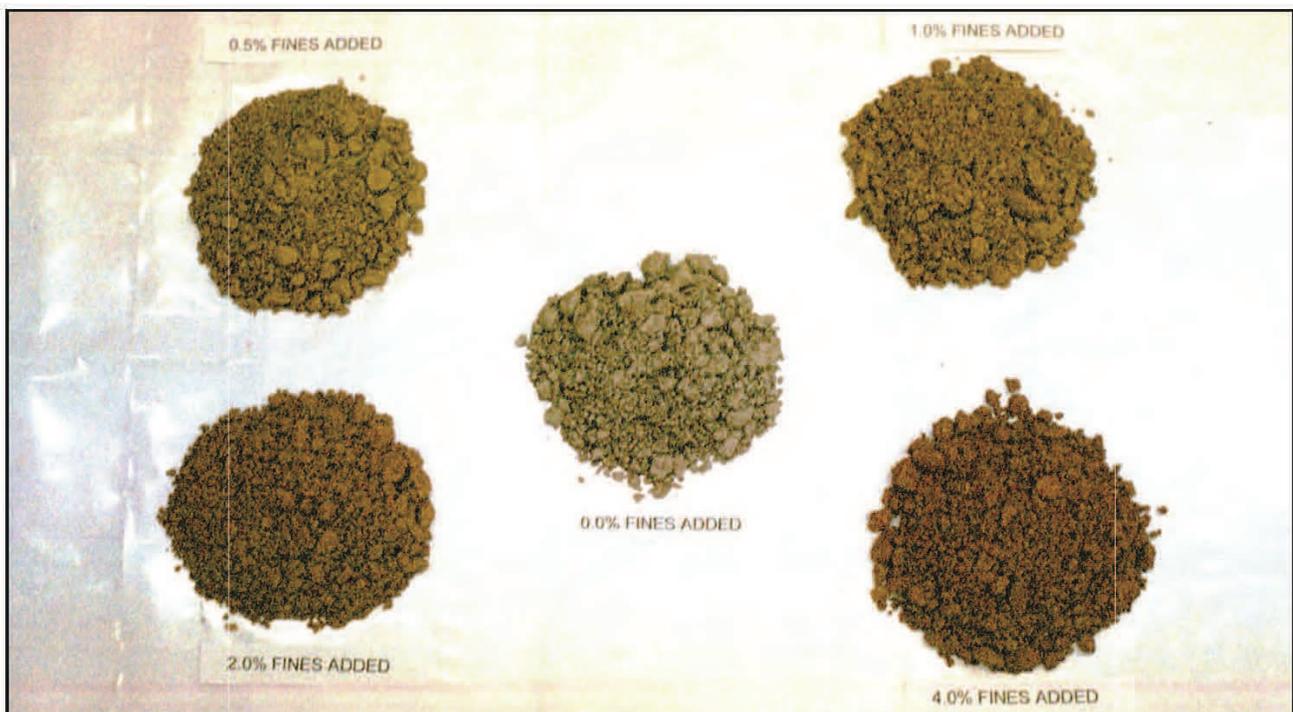
difficult to install the subbase stone to the specified conditions. The project engineer, however, identified the wrong target. He contended that the subbase was discolored by the contractor during installation of the subbase and consequently contaminated with the red clay subgrade. From laboratory tests it was found that discoloration was not, in fact, a good measure of contamination. Mixtures of the subbase stone and the red subgrade soil showed that even with the addition of only 0.5% of the subgrade soil, discoloration was achieved (see Figure 3). The subbase stone used by the contractor typically had 7-9% fines and 20% was allowed in the specifications. Consequently, the discolored subbase stone could fall well within the range of the fines allowed and therefore was not a good measure of significant contamination and rejection of the subbase material.

FIGURE 3: PHOTOGRAPH SHOWS DISCOLORATION TEST RESULTS: SUBGRADE FINES ADDED TO THE SPECIFIED BASE ROCK USED ON PROJECT AT PERCENTAGES BY TOTAL DRY WEIGHT OF: 0.5% (UPPER LEFT); 1.0% (UPPER RIGHT); 2.0% (LOWER LEFT); AND 4.0% (LOWER RIGHT). CONTROL SAMPLE (0% FINES ADDED) IS IN THE MIDDLE.
