## RISK BASED ANALYSIS RESULTS IN EFFICIENT MINE STABILIZATION

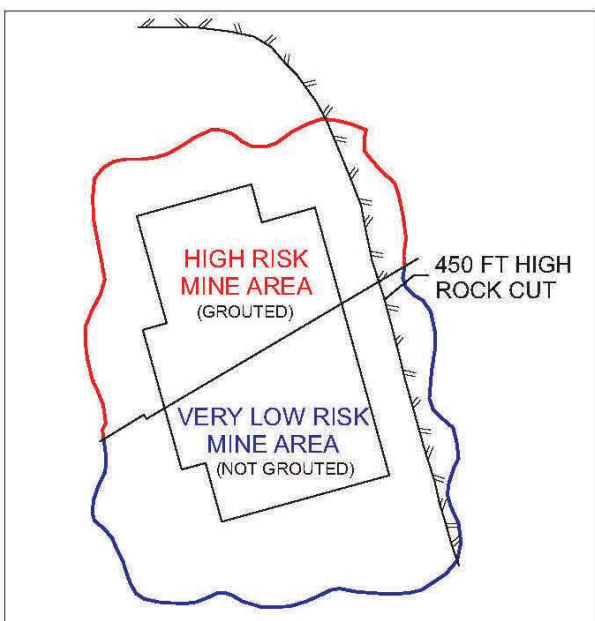
FIGURE 1: SITE LAYOUT WITH ASSESSED MINE COLLAPSE RISK AREAS. STABILIZED ONLY HIGH RISK AREA IN LIEU OF ENTIRE MINE UNDER BUILDING

Based on rock testing and MEA's stability calculations, it was found that the coal mine had limited stability under the northern half of the building which meant there was a high risk of subsidence in the future. However, an acceptable amount of risk existed over the southern portion of the underlying old works (see Figure 1). Therefore, the noted settlement of the building was consistent with the risk analysis performed across the building.

Given the assessed range of risk under the building, the owner chose to only grout stabilize the northern half and saved about

\$3 million. This was in lieu of stabilizing the entire mine beneath the structure, which would be conventionally done.

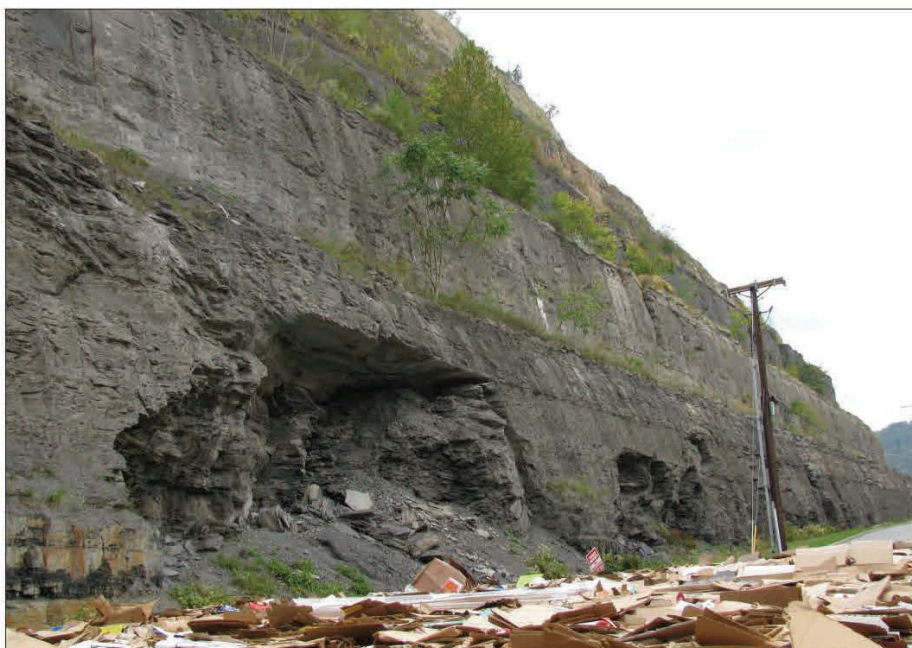
These climatic effects could be seen in the mine roof as it collapsed over time (see Figure 2). To mitigate these deteriorating mine conditions, the open and exposed voids were filled with grout, lift by lift. Where mine openings contained significant collapsed roof materials, the rubble was consolidated by pressure grouting with up to 75 ft. long injection holes drilled into these areas (see Figure 3).

FIGURE 2: MINE OPENINGS IN 400 FT. HIGH ROCK CUT. MINE ROOF CAVED UPWARD OVER TIME.

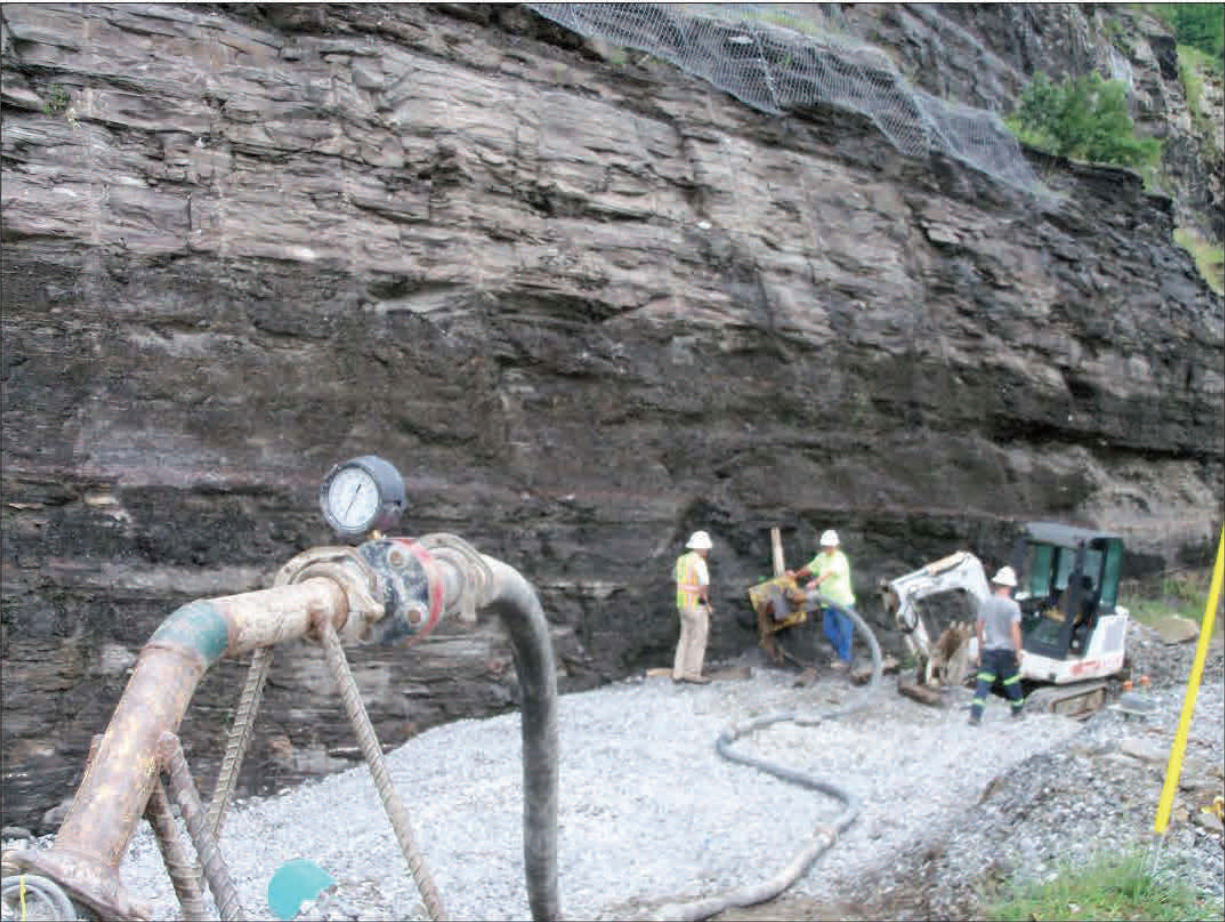
FIGURE 3: GROUT INJECTION WITH PRESSURE INTO THE MINE OPENING FILLED WITH CAVE MATERIAL ALONG THE ROCK CUT.
