## DEVELOPER AVOIDS SUBSTANTIAL RISK OF SUBSIDENCE DAMAGE

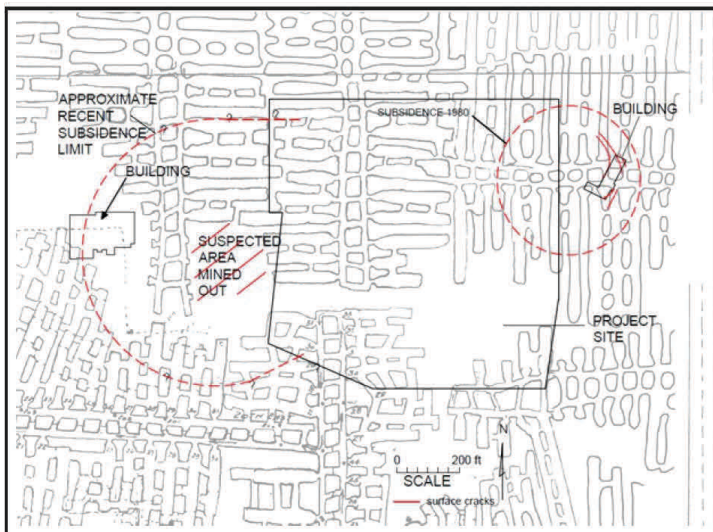
FIGURE 2: HISTORICAL MINE MAP SHOWING ROOMS AND PILLARS WITH LOCATIONS OF SITE AND SURFACE SUBSIDENCE

Also based on our in-house files, it was known that about a quarter of a century ago there was a subsidence event which formed on the east side of the property. Because of this subsidence, a structure was damaged and had to be abandoned and razed (see Figure 2). As a result of the assessed risk, the developer decided to abandon the site due to the related potential liabilities it presented.

Four years after our investigation, a fairly significant subsidence event resulted in substantial damage to another structure just west of the site (see Figure 2). Although no data is available on the former store site, it is likely that this subsidence extended into it. This would have resulted in substantial damage if the store had been built, unless the mine had been stabilized.

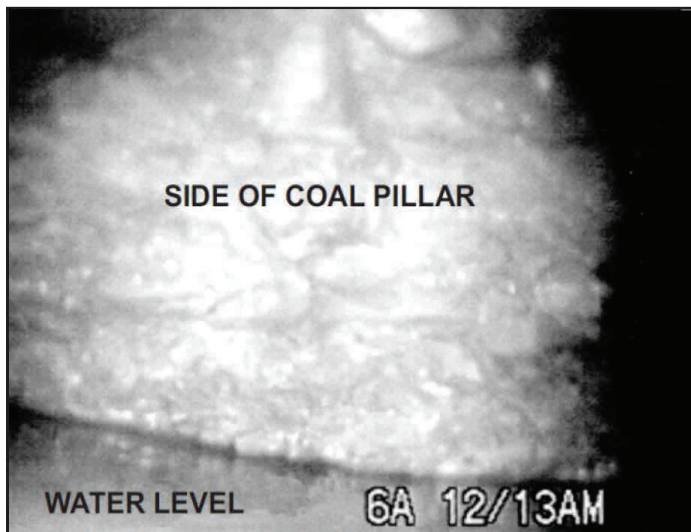
Also, existing conditions of mine voids were inspected with the use of a borehole camera. One of the features which could be seen with the camera was pooled groundwater present in the old works (Figure 3).

From all the information collected, including the subsidence activity in the area and advanced engineering analyses of the stability of these old works it was determined that there was a high risk of future subsidence, and that it was possible that very severe damage could result. What was determined was that the coal pillars did not have firm bearing and would eventually sink into the water softened mine floor.

FIGURE 3: BOREHOLE CAMERA SHOT IN ABANDONED MINE AT A DEPTH OF 211 FT. SHOWING POOLED WATER AGAINST COAL PILLAR
