INVESTIGATION OF EXCESSIVE FILL SHRINKAGE FROM EMBANKMENT CONSTRUCTION

MARINO ENGINEERING ASSOCIATES, INC.

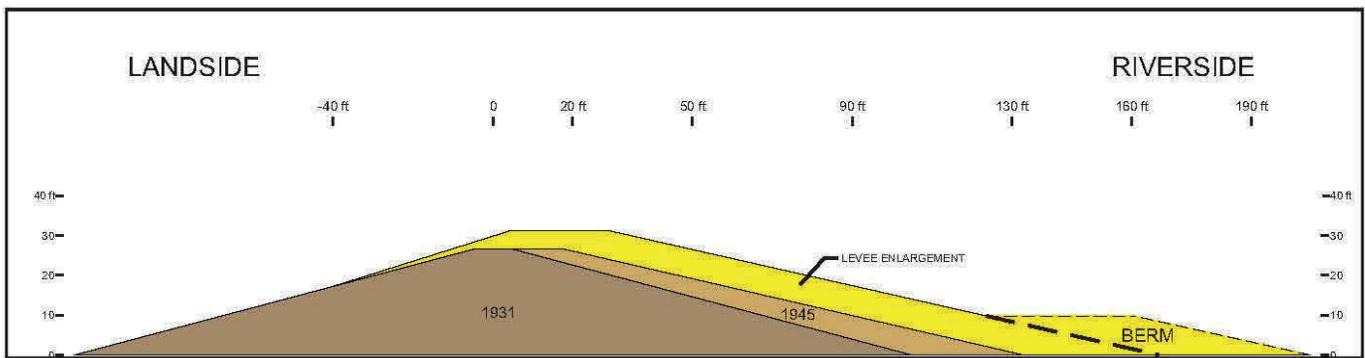
FIGURE 1: TYPICAL EXISTING AND PROPOSED ENLARGEMENT SECTIONS OF 7.75 MILE PROJECT LEVEE

This project involved a 40,940 ft. (7.75 miles) long enlargement of an existing levee located along the east side of the Mississippi River. The enlargement included increasing both width and height of the levee. A cross section of the levee enlargement is shown in Figure 1. Figure 1 also depicts the historical construction of this levee, which was originally placed in 1931 and added to in 1945.

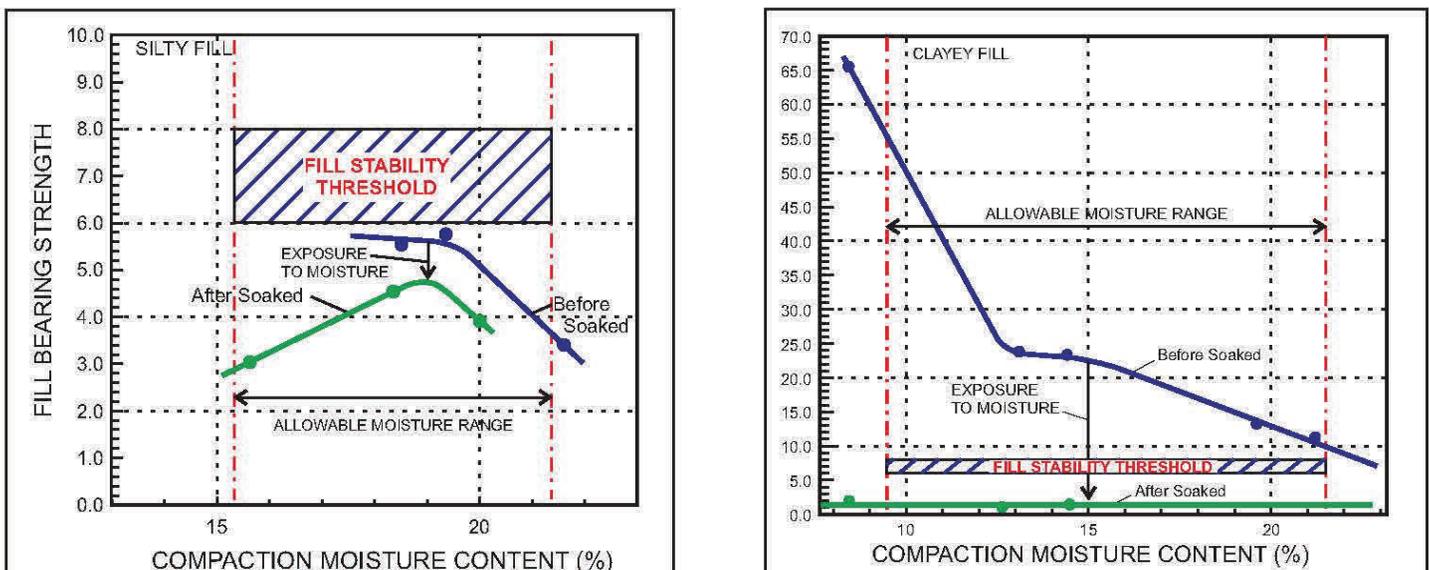
FIGURE 2: FILL STRENGTH WHEN COMPACTED UNDER CONDITIONS ALLOWED IN THE SPECIFICATIONS

More interesting, however, was the cause for the unexpected and significant foundation settlement and the greater than expected shrinkage from compaction. The culprit was found to be the instability of the placed borrow material, even though it was compacted to specifications. Lab tests showed that when compacted to within specification, the various borrow-to-fill soils would be too weak to support the necessary construction

traffic (see Figure 2). This fill instability resulted in the need to extend the wet fill lifts along the entire project reach in order to minimize disturbance from processing, which significantly delayed completion of levee sections.

In addition to extending fill lifts along the project levee, the borrow material had to be dried to levels less than what was allowed, and compacted to greater densities in order to create at least some stability. About 5% of the fill compaction shrinkage occurred due to the densification of the borrow requiring a higher percent compaction than was specified.

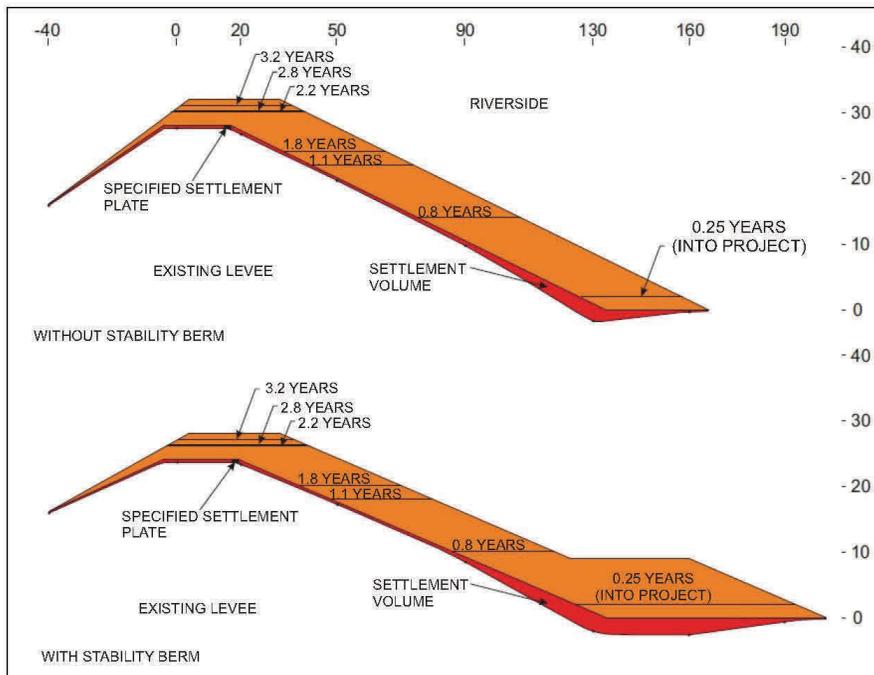
FIGURE 3: CALCULATED TOTAL SETTLEMENT DUE TO THE LEVEE ENLARGEMENT

Although thick compressible clayey deposits would be expected along the project reach in this river laid geologic environment, the considerable time that was needed before a levee section could be completed allowed for these clay soils to be compressed and the levee to settle. This resulted in much greater borrow volume to complete a section of the enlargement.

Measuring the volume of fill required to compensate for the settlement which occurred during embankment placement can be problematic with the use of one settlement plate. Yet, in the specifications, the instructions to quantify added embankment volume from underlying settlement were based on measuring one settlement plate in the riverside crown of the old embankment. At this location the underlying foundation soils were much stiffer from long term compression under the weight of the old levee. Therefore, measurements from this one specified plate location severely underestimated the fill volume loss from foundation settlement under the riverside toe and beyond (see Figure 3). In other words, the distribution of settlement, especially when significant time dependent movement is present, is not directly proportional to the height of the fill placed as the specified settlement plate method assumed.

- In design, consider the constructability of the compaction requirements.
- To assess settlement loss, perform accurate pre-fill cross-sectional surveys in addition to the closeout sections required for release of the embankment section.
- To minimize foundation settlement, finish embankment sections as soon as possible. Do not extend lower lifts over longer reaches resulting in sustained loads on the subsoils which tend to be much more compressible.
