## HYDROLOGIC IMPACTS ON AN UNDERGROUND ABANDONED COAL MINE

This UPDATE article discusses a project investigation of the effects that mine flooding and subsequent dewatering have on surface subsidence. Due to the non-durable rock conditions associated with mine structure, these hydrologic impacts were found to cause a significant number of mine collapses and subsequent subsidence events.

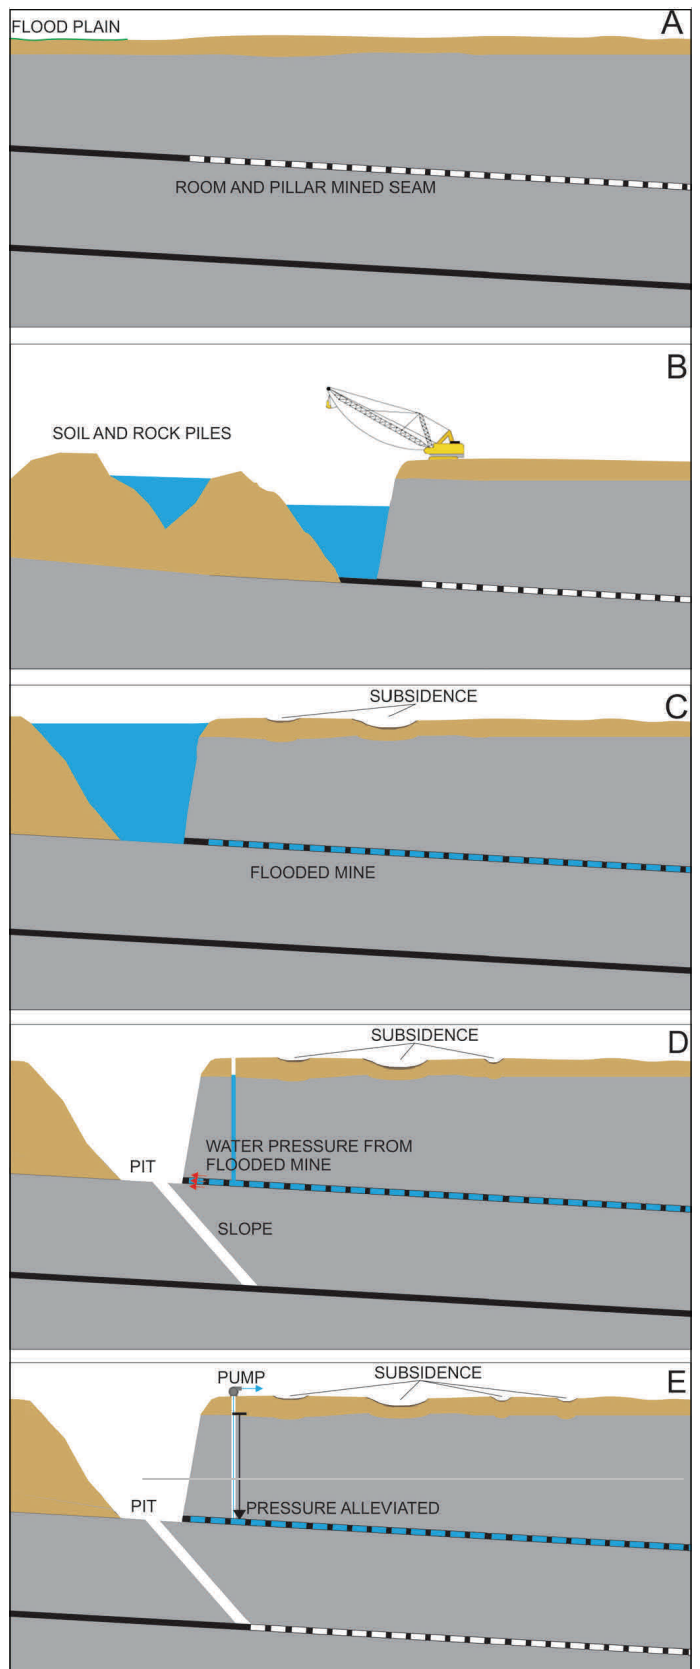
At shallower depths to the south, (due to the dip of the coal to the north), the coal seam was being stripped out in the area. This stripping operation was ongoing while the underground mining was taking place. See Figure 1B. The stripped area was in the lowlands, therefore significant amounts of runoff drained into the mined pit. This could be clearly observed on the historic photos of the area.

FIGURE 1 SNAPSHOTS OF MINING AND HYDROLOGICAL CONDITIONS OVER TIME

As a result of the dewatering, the water level was dropped as much as about 140 ft. over extended periods of time, but would vary depending upon the pumping effort. In other words, in addition to putting the full weight of the overburden back on the mine structure that had been subjected to long term moisture deterioration, the dewatering resulted in oscillating water levels causing cyclic slaking and roof cave conditions (see Figure 2). In effect, this roof deterioration would result in heightened pillars with reduced capacity. Given the now softened floors, reduced pillar capacity, and significant increase in overburden load from dewatering, a substantial increase in surface subsidence was observed. See Figure 1E.

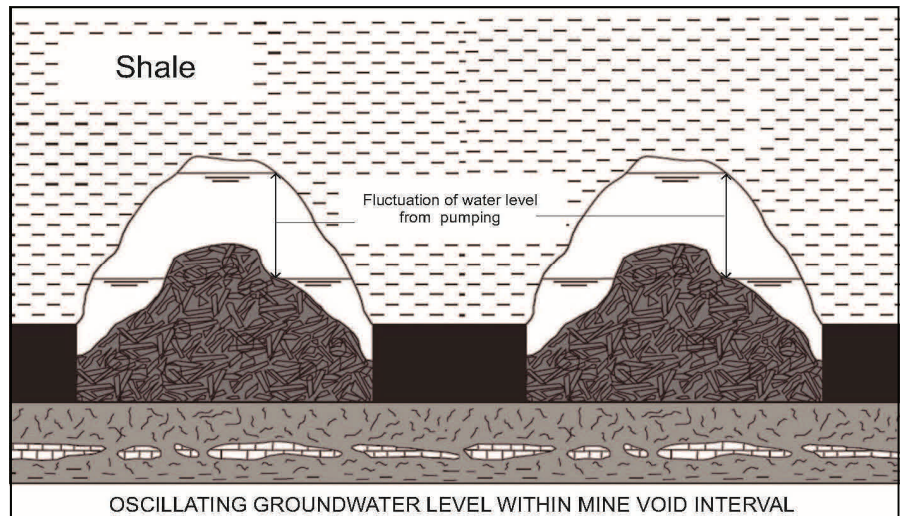
FIGURE 2 ROOF FAILURE ABOVE ROOM
