FROZEN FILL CAUSES BUILDING DAMAGE

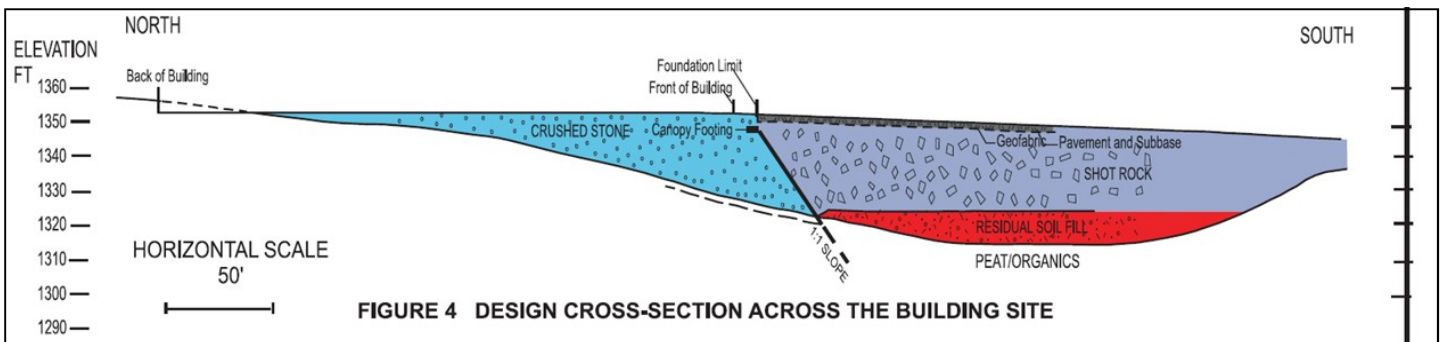
FIGURE 4 DESIGN CROSS-SECTION ACROSS THE BUILDING SITE

was installed to about 1 ft. below top of pavement. The shot rock was covered with geofabric, subbase stone, and then asphalt (see Figure 4).

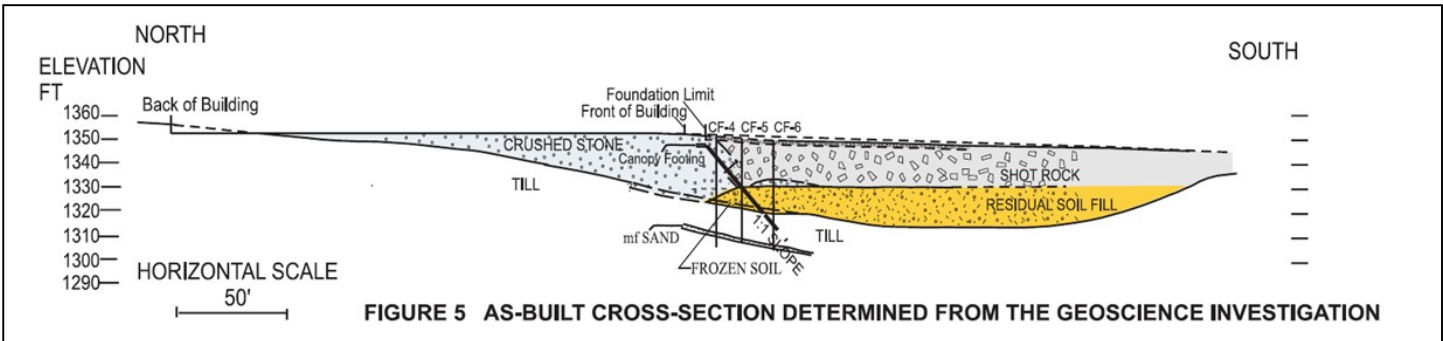
FIGURE 5 AS-BUILT CROSS-SECTION DETERMINED FROM THE GEOSCIENCE INVESTIGATION

It was initially thought that the presence of peat to the south was the likely cause of ground movement affecting the building. While it appeared to be mainly the cause for settlement to the south in the parking lot, the exploratory work uncovered the main cause for the resulting damage to the store was thawing of frozen residual soil fill within the influence zone (and building pad) of the structure. The location of this material is shown in the cross-section in Figure 5. Based on our forensic studies this frozen material was left within the building pad and froze when the north construction slope of this fill was exposed to winter conditions because the building pad gravel had not been placed over it in time. This can be seen in the photograph looking along this construction slope in Figure 6. The photograph was taken by a local geotechnical inspection engineer.
