FROZEN FILL CAUSES BUILDING DAMAGE

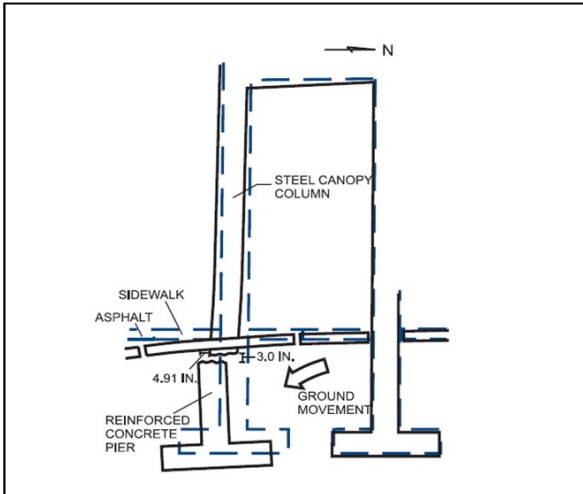
FIGURE 1 DEFORMATION PATTERNS AT THE FRONT OF THE STRUCTURE

Shortly after construction the ground beneath the front of a food store in Minnesota settled and moved laterally away from the building. This building behavior is shown in Figure 1. Also, significant movement was experienced in the parking lot in front of the store. The resulting damage mainly consisted of structural distortion of a canopy structure which supports second floor office facilities, significant cracking and separations in the masonry walls, racked store openings, as well as uneven settlement causing significant ponding and adverse grades in the parking lot.

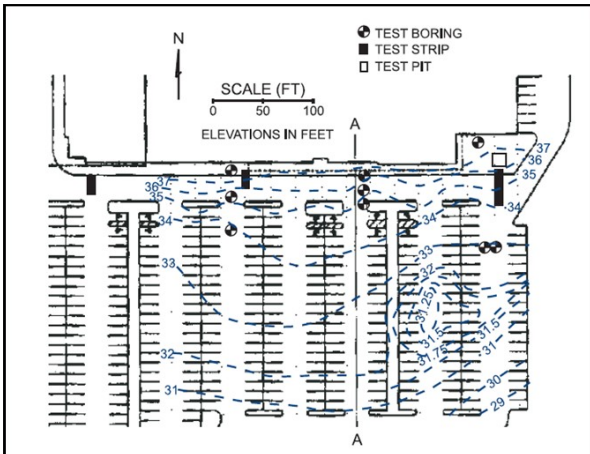
FIGURE 2 SURFACE TOPOGRAPHY OF PARKING LOT SOUTH OF THE BUILDING AND LOCATION OF TEST PITS/STRIP AND EXPLORATORY BORINGS

The maximum measured settlement was up to 3.5 ft. and was located in the parking lot. A topographic map prepared across the project site is shown in Figure 2. By analyzing design and post-settlement grades, the building experienced as much as 0.5 ft. of differential settlement. An important feature of the movement was the determination that basically a settlement trough had developed adjacent to the store. A section across the trough in the approximate area of maximum settlement is depicted in Figure 3. To determine the source(s) of the ground movement which resulted in the building damage, a total of 4 test pit/strips and 10 borings were drilled (see Figure 2).

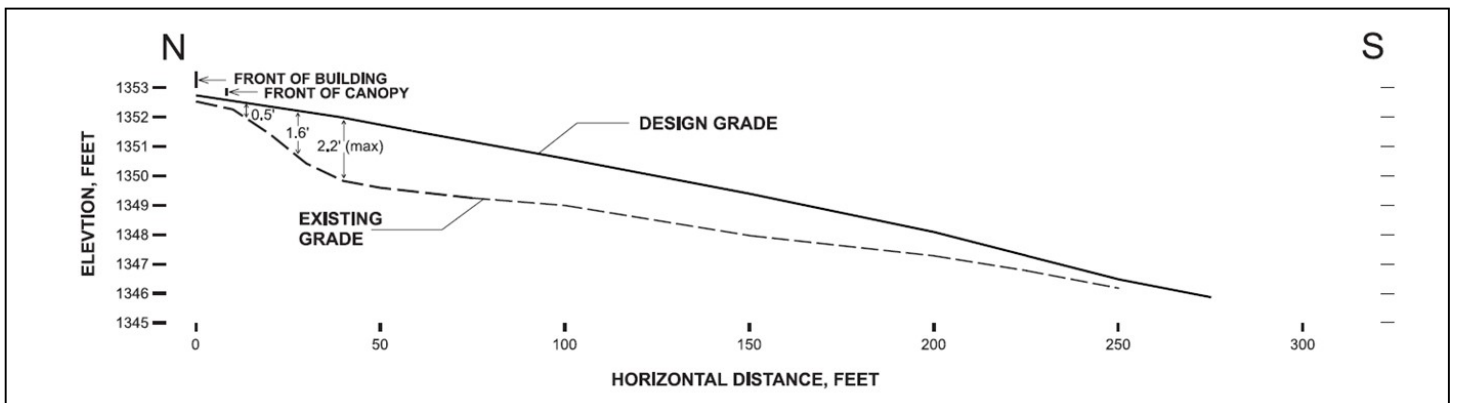
FIGURE 3 SECTION A-A SHOWING SETTLEMENT IN FRONT OF BUILDING AND THROUGH PARKING LOT

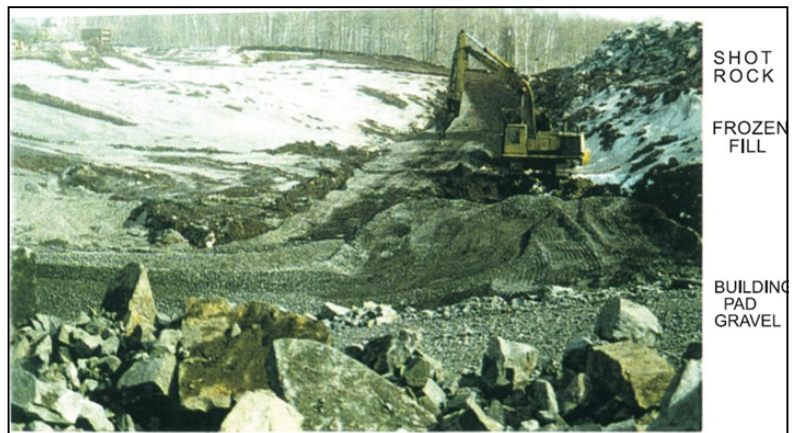
It was initially thought that the presence of peat to the south was the likely cause of ground movement affecting the building. While it appeared to be mainly the cause for settlement to the south in the parking lot, the exploratory work uncovered the main cause for the resulting damage to the store was thawing of frozen residual soil fill within the influence zone (and building pad) of the structure. The location of this material is shown in the cross-section in Figure 5. Based on our forensic studies this frozen material was left within the building pad and froze when the north construction slope of this fill was exposed to winter conditions because the building pad gravel had not been placed over it in time. This can be seen in the photograph looking along this construction slope in Figure 6. The photograph was taken by a local geotechnical inspection engineer.

FIGURE 6 GRAVEL BEING INSTALLED IN BUILDING PAD AND AGAINST FROZEN FILL SLOPE
