INVESTIGATION OF A ROADWAY FAILURE

A town in Missouri located on the banks of the Mississippi River demanded the construction of an earthen levee to protect itself from the floodwaters of the river. This required the construction of an asphalt bypass road for an existing state highway, as the proposed levee construction cuts across the highway into the adjacent limestone bluff.

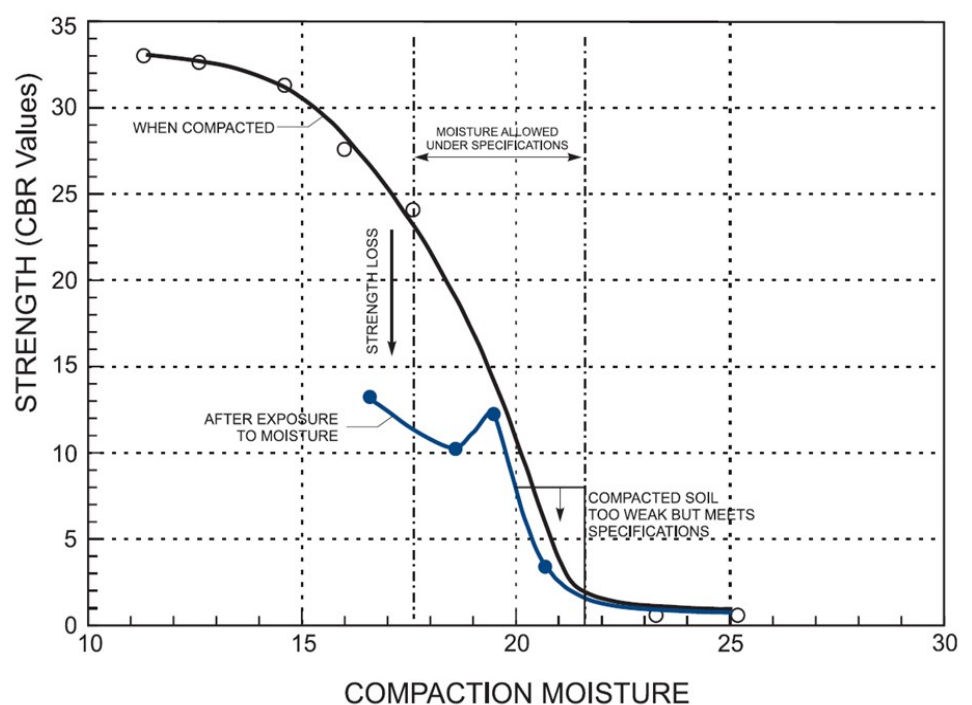
It was discovered from the laboratory testing that there was a dramatic decrease in soil strength when the fill or subgrade soil was compacted at wetter allowable moisture contents or when the soil compacted to specifications became exposed to moisture (see Figure 1). Therefore, the decline in the performance of the bypass road is linked to the moisture-induced softening of previously compacted embankment subgrade soils. It was found that the exposure to moisture was exacerbated by the upward movement of groundwater given the geologic setting. The results of laboratory testing explained how the fill and subgrade prepared to the plans and specifications resulted in the road failure realized in the field. Although the compacted roadway foundation was prepared under the engineer's approval it was too unstable

FIGURE 1 SOIL COMPACTED TO SPECIFICATIONS BECOMES TOO WEAK AT ALLOWABLE MOISTURE CONTENTS OR WHEN EXPOSED TO MOISTURE
