INVESTIGATION OF A ROADWAY FAILURE

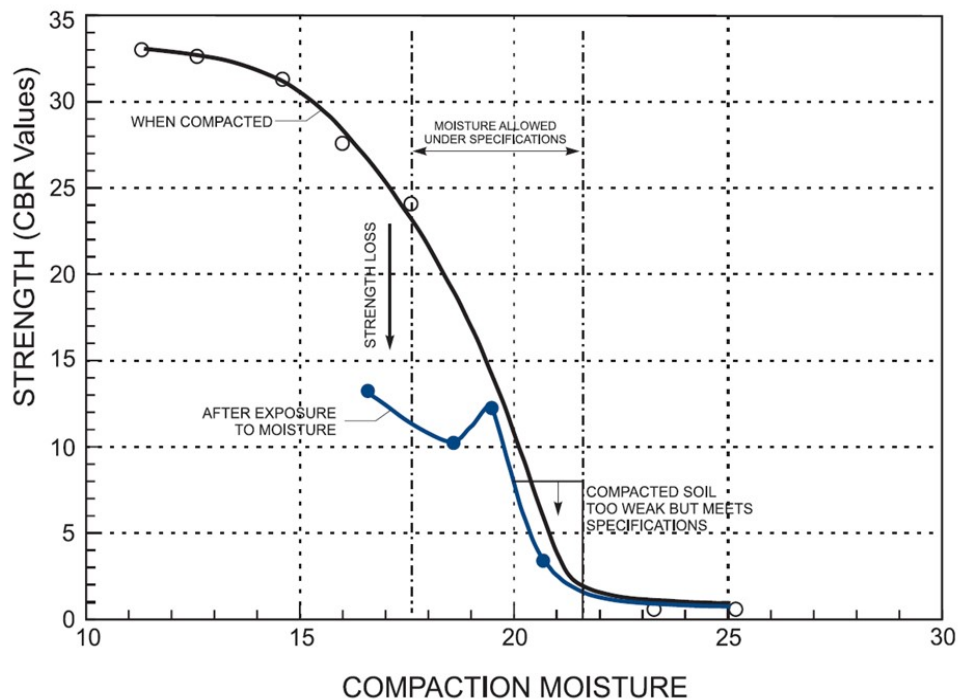
It was discovered from the laboratory testing that there was a dramatic decrease in soil strength when the fill or subgrade soil was compacted at wetter allowable moisture contents or when the soil compacted to specifications became exposed to moisture (see Figure 1). Therefore, the decline in the performance of the bypass road is linked to the moisture-induced softening of previously compacted embankment subgrade soils. It was found that the exposure to moisture was exacerbated by the upward movement of groundwater given the geologic setting. The results of laboratory testing explained how the fill and subgrade prepared to the plans and specifications resulted in the road failure realized in the field. Although the compacted roadway foundation was prepared under the engineer's approval it was too unstable

FIGURE 1 SOIL COMPACTED TO SPECIFICATIONS BECOMES TOO WEAK AT ALLOWABLE MOISTURE CONTENTS OR WHEN EXPOSED TO MOISTURE

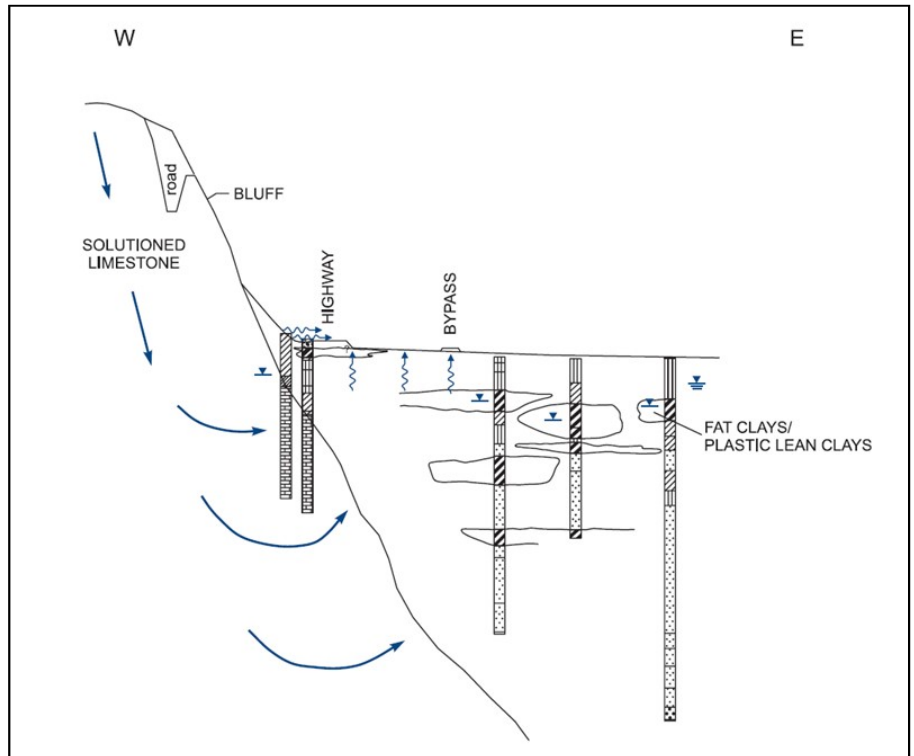
During construction a number of observations were made of upward migration of groundwater, surface springs, and artesian conditions. However, the pre-construction groundwater levels at the site were considerably lower. An analysis of the hydrogeologic conditions helped in unraveling the story behind this moisture softening of the compacted subgrade and fill. The bluff which is adjacent to the site is made of solutioned limestone and acted as a groundwater recharge area (see Figure 2). During heavy rains, the groundwater levels rose in the bluffs which in turn caused a rise in the hydraulic head in the sand layers lying underneath the silts/

FIGURE 2 HYDROGEOLOGIC PROFILE OF THE SITE

silty fine sands in the foundation and embankment. The plastic lean clays and fat clays below the foundation subgrade appear discontinuous and did not provide an impermeable barrier for the upward movement of the groundwater. Also the silty embankment and foundation soils are conducive to significant capillary rise and are extremely vulnerable to pumping action which brings the freewater to surface in response to traffic loads.
