FOUNDATION RECOMMENDATIONS RESULT IN UNNECESSARY LARGE COST

This update concerns a case where a more well thought out geotechnical investigation which would have cost a little more could have saved millions of dollars and a significant amount of lost time. This project involves an assessment of the swell potential of weathered to fresh rock, the foundation system chosen, and the repair of mushroomed piers (see Figure 1). Mushroomed concrete piers are the result of pouring against the naturally formed widening of the drill hole made to install the pier.

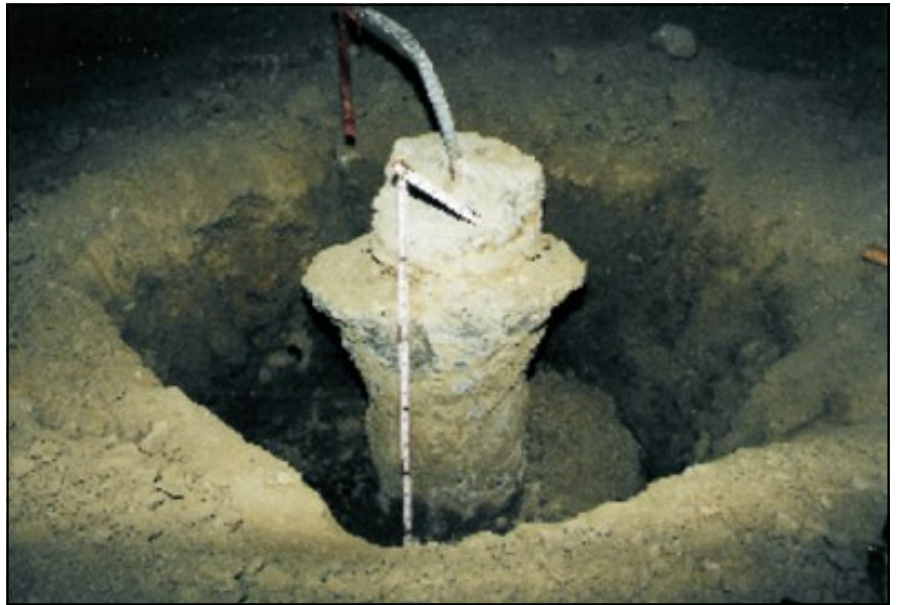
The contract for this project involved the construction of 7 structures and a total of 705 drilled piers. After a preliminary geotechnical investigation of several sites, this location was chosen for construction. Through analyzing laboratory tests of the soil and rock samples, the geotechnical engineer recommended pier foundations to be used at this site. The design and guidelines for execution were presented with clearly assigned responsibilities of each party within the project. Everything seemed to be in order until the work started. The grading of the surface and drilling for pier installation was found to be more difficult than expected. This caused delays and deviations from the specifications. It was not until after completion and payment for the work that the owner, the structural engineer, and the construction manager insisted the drilled pier installations were defective and had to be corrected.

FIGURE 1 TYPICAL PICTURE SHOWING THE MUSHROOMING OF THE PIER TOP

At some locations, the contractor encountered harder than expected rock, and the use of a bucket or helical auger resulted in construction delays and significant changes in the original pier specifications. The use of either method of drilling would render the basic intent to avoid mushrooming at the tops of the piers futile as drilling in hard rock using either method caused the drill bit to wander. The action of the drill bit and gravity

movement of soil and weathered rock into the hole resulted in instability at the upper portion of the drill holes and S-shaped piers. Better choice and planning of equipment would have prevented this. The S-shaped piers typically develop in the hard rock areas, where the bit would tend to wander during drilling through alternate hard and weathered horizons. Some of the piers ended up with mushroomed tops, which could be detrimental in expansive soils as shown below, but this was not the case for this site.

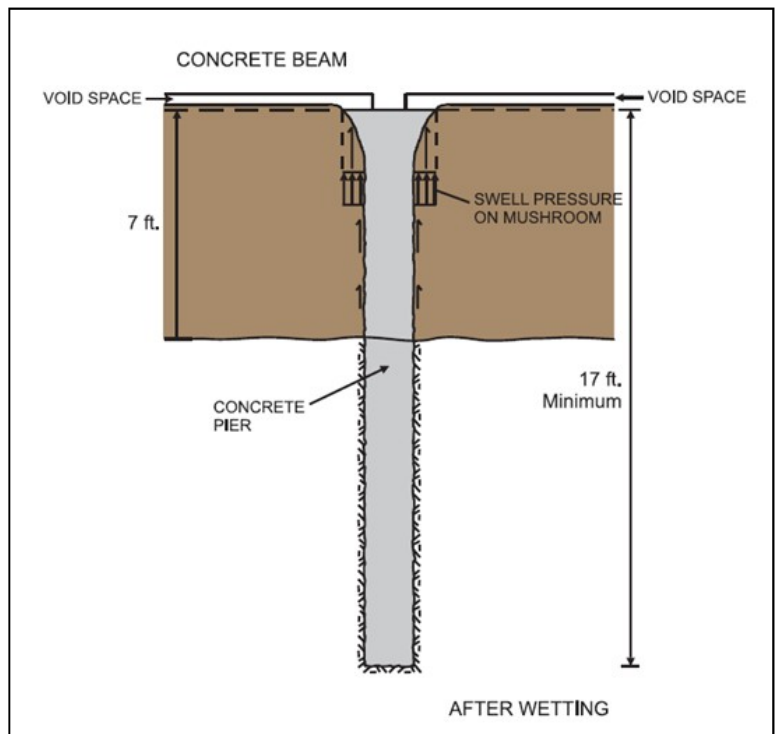
FIGURE 2 MUSHROOM STRESS ANALYSIS

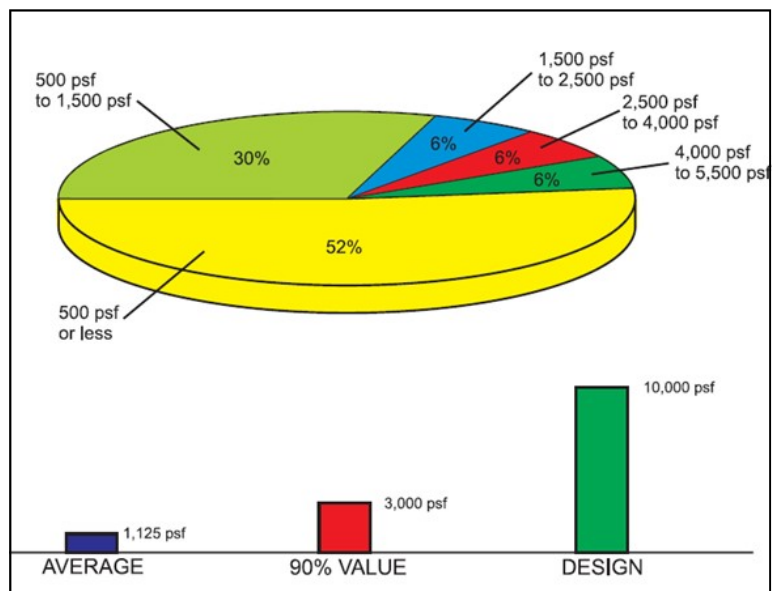
MEA made field visits to do geotechnical reconnaissance. Literature survey and laboratory tests conducted on the samples revealed that the actual rocks at the site are limestone and micrite of the Niobara Formation, contrary to the geotechnical engineers' classification as Pierre Shale Formation. The latter formation is notoriously known in Colorado by its swell or heave potential. Based on this fault classification and a few anomalous swell tests, the geotechnical engineer considered the ground to be highly expansive and rather than using regular spread foundations, an expensive drilled pier-structural floor system was chosen for all the structures. This foundation system caused the cost to increase significantly. Later on the structural engineer raised concern over the execution of the piers as some of these piers were mushroomed near the top (the diameter was bigger at the top). This can cause significant stresses in the piers upon swelling of the ground as shown in Figure 2. There was no provision in the contract to use cylindrical carton "Sondex" near the top section of the pier to prevent mushrooming. To relieve this concern the owner decided to chip off the mushrooms of a significant number of piers. This costly action was based on an unfounded fear of high swelling pressure induced by the shale. The fact that the typical weathered rock foundation was not this shale and exhibited lower swell pressures resulted in overestimating the design forces and caused the owner to choose the wrong foundation type and later on to carry out costly and unnecessary remediation actions. Figure 3 below shows the range of swell pressure as determined in the lab on many weathered rock samples collected at different locations at the site. The figure shows that 90% of the samples showed a swell pressure of 3000 psf or less. This is 30% of the design swell pressure value of 10,000 psf.

FIGURE 3 DISTRIBUTION OF SWELL PRESSURE RESULTS FOR WEATHERED ROCK
