## LANDSLIDE DURING LAND DEVELOPMENT

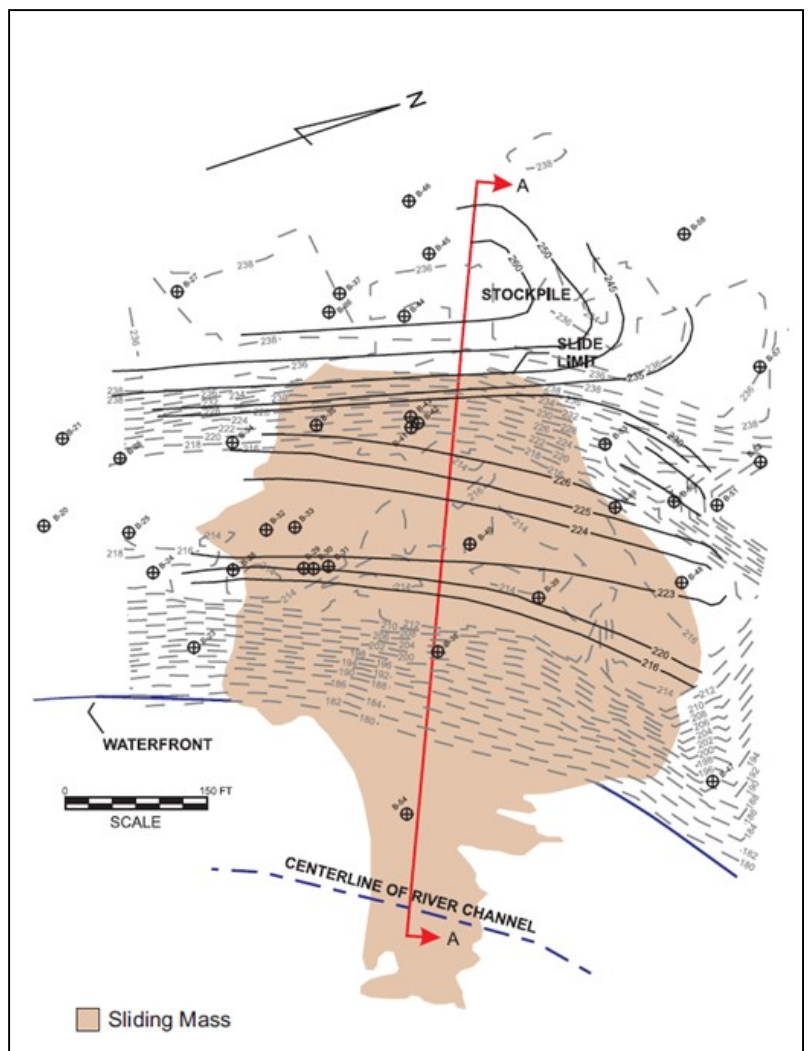
The pre-existing and estimated topography at the time of failure is shown in Figure 2. Figure 2 also depicts the outline of the failed soil mass which accounted for 3.4 acres

FIGURE 2 PRE-EXISTING AND ESTIMATED AT-FAILURE TOPOGRAPHY AS WELL AS AN OUTLINE OF THE SLIDE
