MEA MARINO ENGINEERING ASSOCIATES, INC. • Issue 17

LANDSLIDE DURING LAND DEVELOPMENT

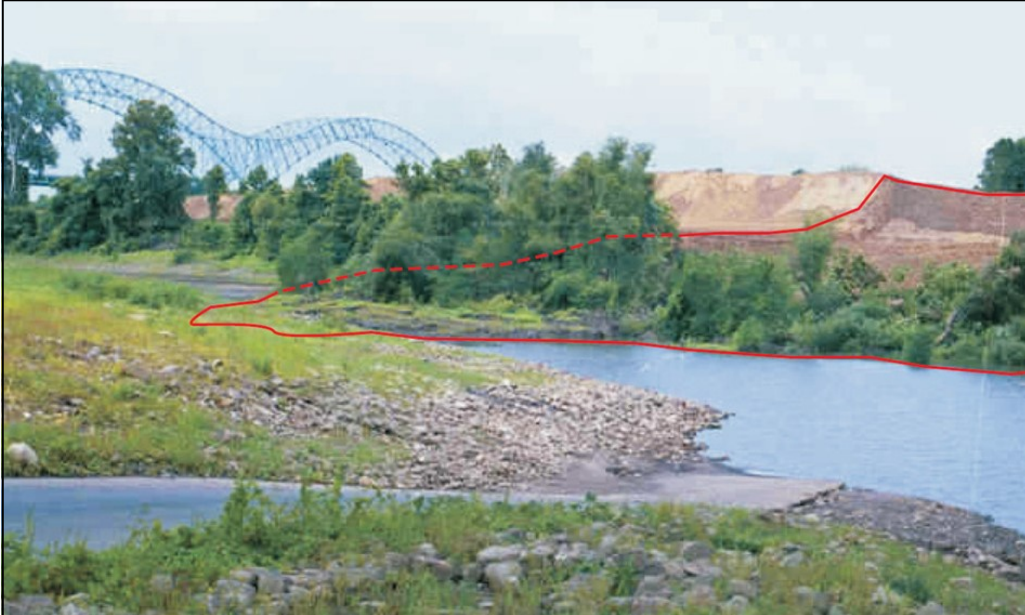
FIGURE 1 LANDSLIDE INTO A WATER CHANNEL DURING THE PLACEMENT OF FILL

An investigation of a landslide was undertaken by MEA to determine the cause of the failure (see Figure 1). The failure occurred during the placement of fill above soft clay soils. The site required up to about 20 ft. of fill to bring it above flood elevation. Most of the fill was required along an earth-sloped water channel.

As the site was being filled, borrow soil was being stockpiled at a rate of soil import that significantly exceeded that of fill placement. The balance of imported soil was stored farthest from the channel. With as much as 10 ft. of fill installed and a large resulting stockpile, failure occurred overnight without warning.

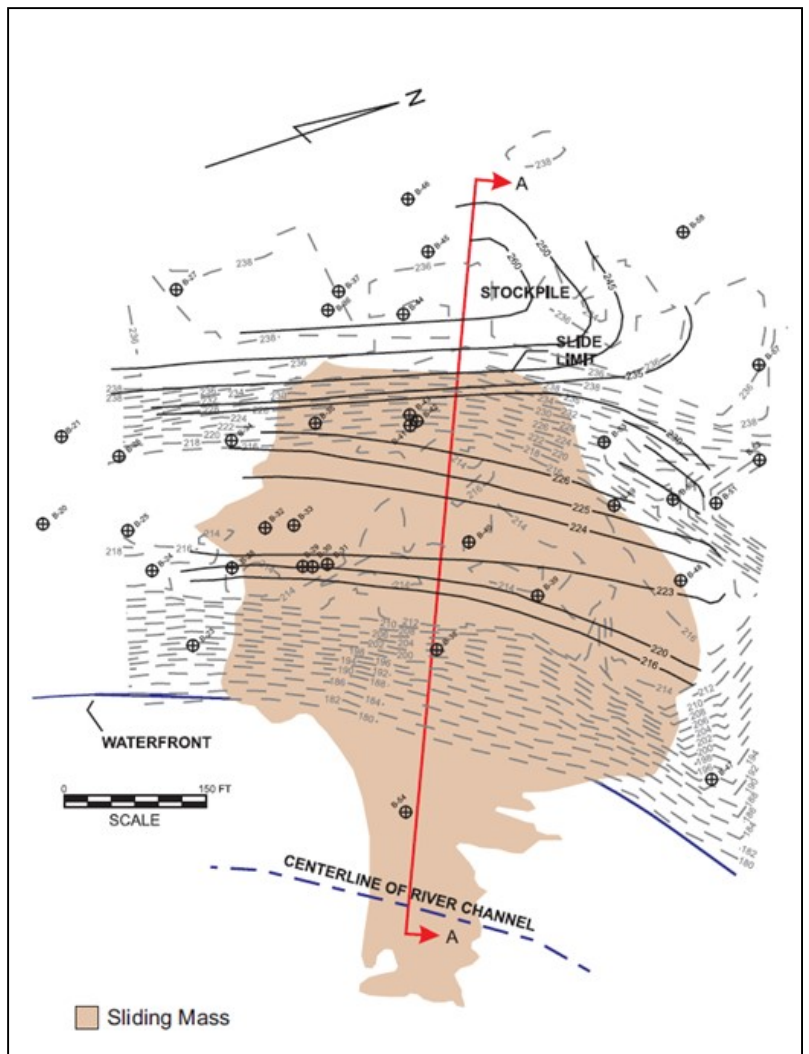
The pre-existing and estimated topography at the time of failure is shown in Figure 2. Figure 2 also depicts the outline of the failed soil mass which accounted for 3.4 acres

FIGURE 2 PRE-EXISTING AND ESTIMATED AT-FAILURE TOPOGRAPHY AS WELL AS AN OUTLINE OF THE SLIDE

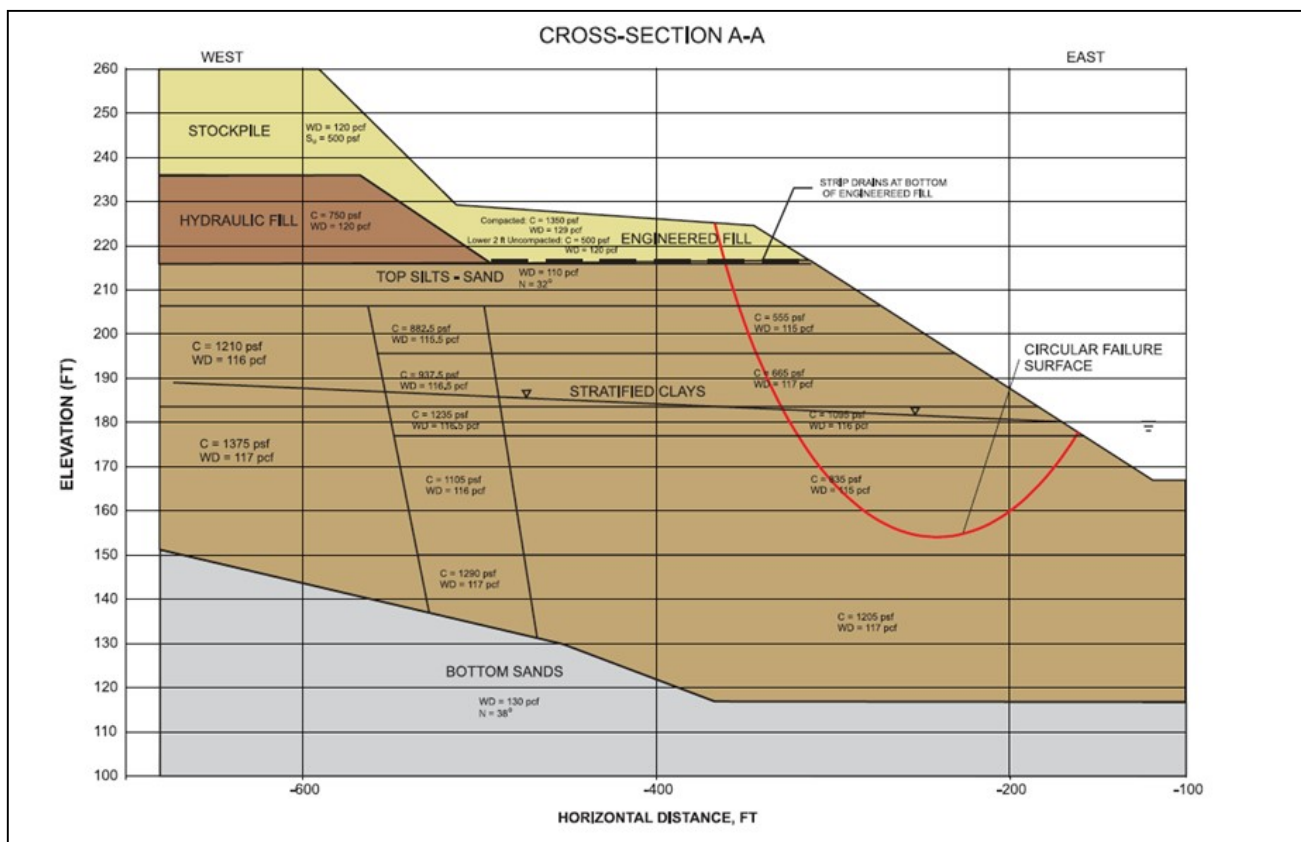
FIGURE 3 BASIC SOIL PROFILE CONDITIONS WITH THE CRITICAL FAILURE

above water level. As can be seen in Figure 2, the sliding mass extended into the stockpile area. The landslide was investigated from a number of soil borings and laboratory test data. The basic soil profile used in the evaluation of the failure is shown in Figure 3. It is interesting to note that after about 45 days of fill placement, which is the time of failure, no noticeable increase in soil strength could be discerned as a result of the wick drains. Based on the groundwater and soil conditions at failure, the critical failure surface was obtained and is shown in Figure 3.

As can be seen in Figure 3, the sliding failure initiated at the channel bank and extended to a depth of 70 ft. This bank failure resulted in an inland progressive failure encompassing a limited section of the stockpile. Based on stability analyses, one massive failure was found to be much less likely.
