## INVESTIGATION AND REPAIR OF A FAILED OLYMPIC POOL

With all the confusion and various theories on what caused this just constructed Olympic pool to fail, MEA was selected to perform an independent forensic investigation.

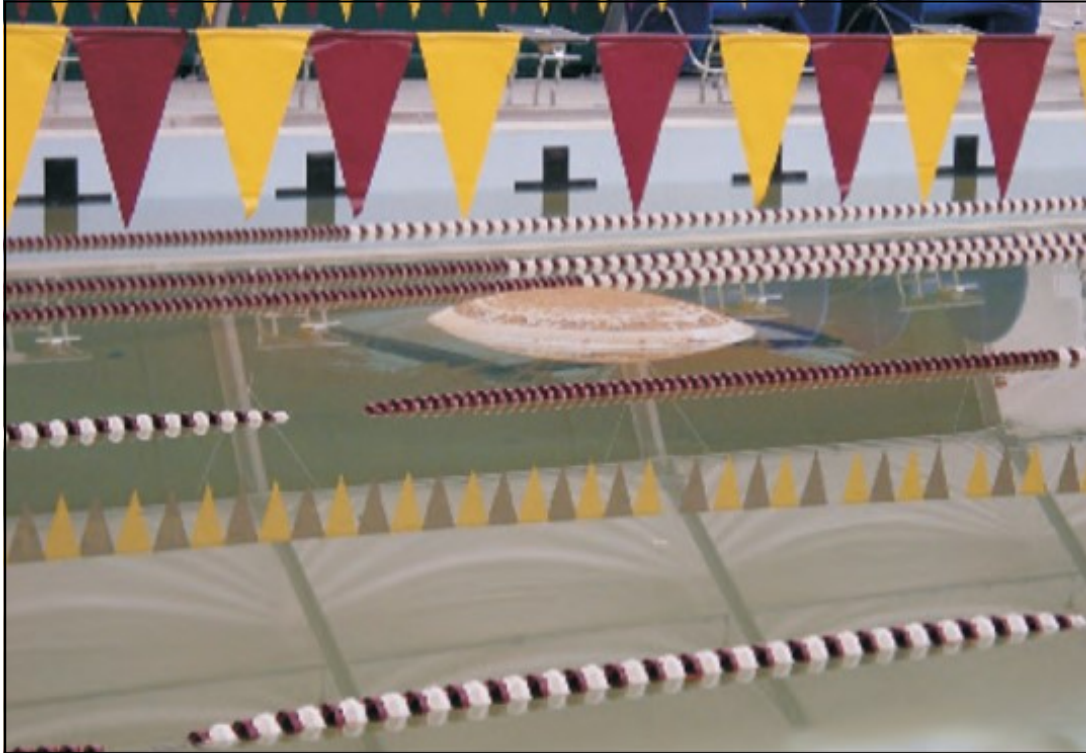
FIGURE 1 VERY LARGE BUBBLE IN THE FLOOR LINER WHICH GREW OUT OF THE WATER DURING THE OPERATION OF THE POOL

From the beginning of the operation of the Olympic Pool in Tennessee there were signs of trouble. The water in the pool would not clear up, the pool liner had bubbles which appeared to grow over time, and the pool floor needed constant vacuuming. Initial thoughts by the contractor who constructed the pool was that filtration plumbing, which was installed below the pool floor, contained a significant amount of construction debris which was making its way into the pool. As the pool continued to operate, the blisters in the liner grew, which was speculated to be the result of a high groundwater table. Eventually one of these bubbles became so large that it rose above the water surface. To deflate this now very significant liner bubble, it was punctured spewing soil and water (see Figure 1).

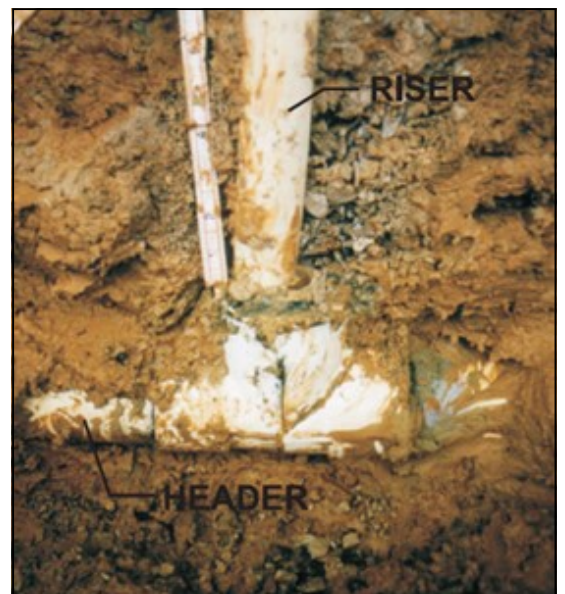
From a borehole camera inspection it was discovered that there was a significant fracturing of the sub-floor plumbing. The fracturing was concentrated at the connector of the rise pipe and header (see Figure 2). Also from manometer survey and photographic information it was established that the pool floor and wall had settled. Normally, such pool settlement would not affect the operation of the pool but the pool floor plumbing was particularly sensitive to compressibility of the fill as the

FIGURE 2 TYPICAL FRACTURING FOUND AT THE RISER/HEADER CONNECTION

Although some had recommended removal and replacement of the entire pool structure, MEA determined the foundation for in-place pool walls could be repaired by pressure grouting under MEA monitoring. This resulted in a savings of several hundred thousand dollars for the owner. The floor subsoil was removed and replaced, as well as the slab and associated plumbing.

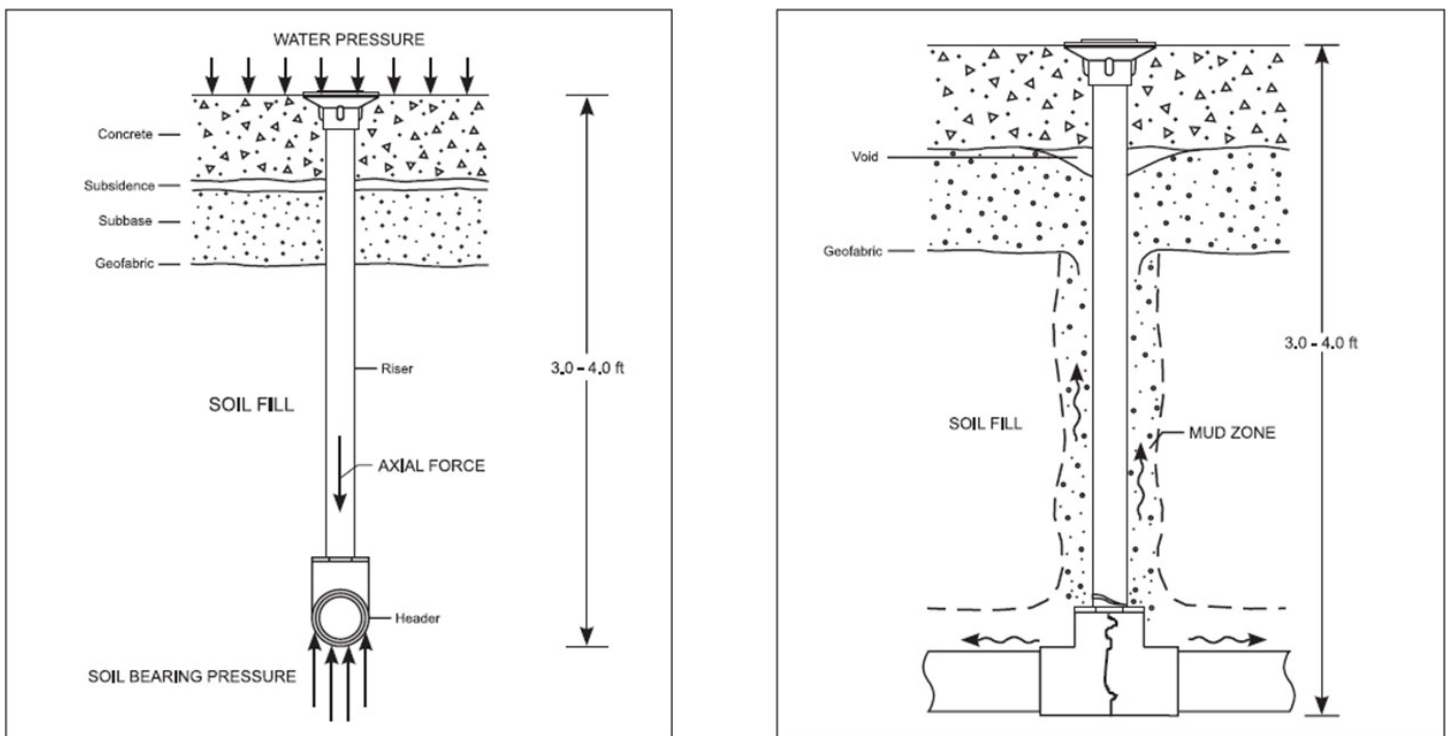
FIGURE 3 LOADING CONDITIONS ON THE WATER FILTRATION RISER/HEADER SYSTEM AND RESULTING DAMAGE

PVC floor plumbing system consisted of about a 3 ft. riser pipe connected to a header pipe (see Figure 3). The system in effect acted as a concrete slab supported by load columns (PVC risers) which were in turn supported by footings (PVC header tees). After drilling and sampling the sub-soils and performing tests in their laboratory, MEA determined that the fill installed beneath the pool floor and wall was improperly placed and caused the pipe failures. Based on this testing and analysis it was further determined that this pipe system would not have failed if the soil fill was compacted to specifications. MEA laboratory tests demonstrated under these placement conditions that the soil was not sufficiently compressible.
