AIRPORT PAVEMENT SUBBASE AND SUBGRADE PREPARATION DIFFICULTIES

An MEA investigation where airport pavement difficulties in Oklahoma were encountered, exemplifies the above and is discussed herein. The project involved the construction of a taxiway and connecting staging area. The taxiway and staging area required 12.5 in. and 7 in. of reinforced concrete. Along the 50 ft. shoulders, 2 in. of hot asphalt concrete was specified. Beneath all pavement areas a 6 in. subbase at 100% compaction or more was required. All soil subgrade and fill required greater than 95% compaction. All subbase stone and subgrade compaction was to be performed within 2% of the optimum water content.

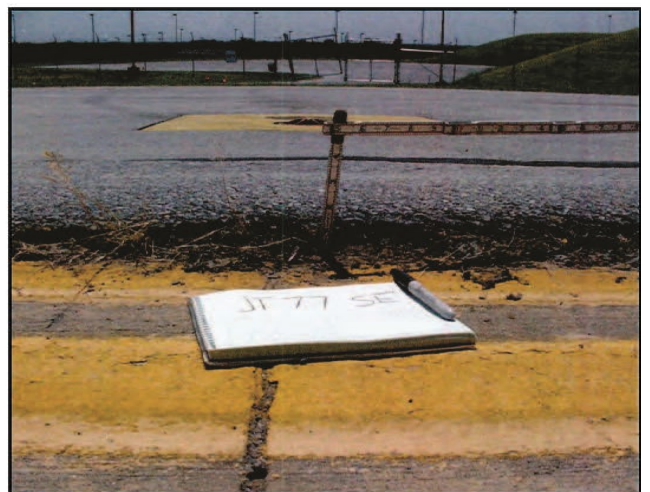
Problems began during pavement construction when the prepared subgrade became wet from precipitation. This resulted in egregious softening and swelling, which destabilized the overlying subbase. The potential for swelling and softening can be seen in constructed pavement with the swelling heave differential of about 1.3 in. between the concrete and asphalt pavement (see Figure 1).

FIGURE 1: DIFFERENTIAL HEAVE OF 1.3 IN. FROM SUBGRADE SWELLING BETWEEN THE TAXIWAY

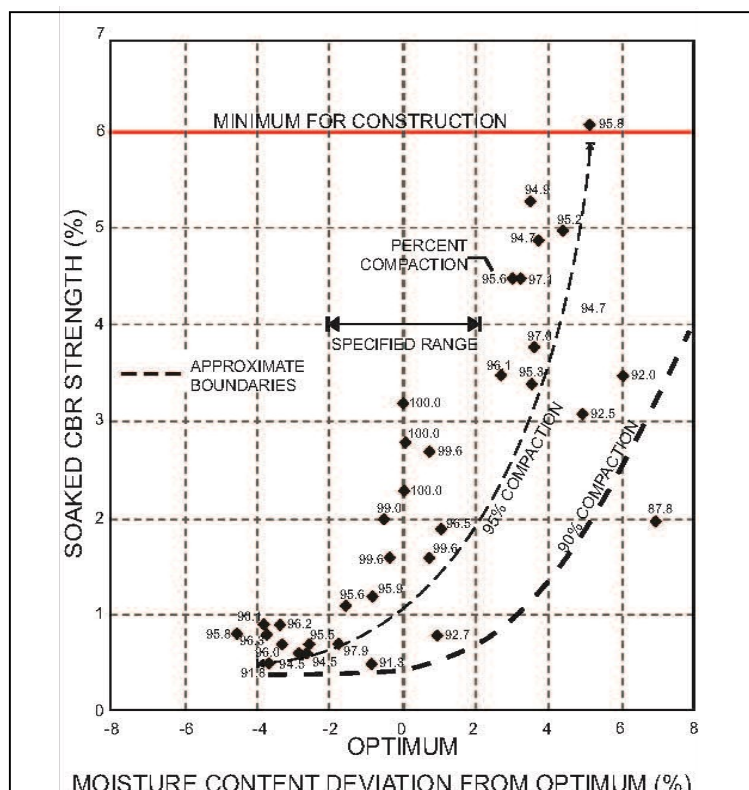
FIGURE 2: MOISTURE CONTENT RELATIVE TO OPTIMUM PLOTTED AGAINST THE SOAKED CBR VALUE FOR ALL COMPACTED SAMPLES

To investigate whether the subgrade specifications would be problematic during construction, a series of strength tests (i.e. CBR tests) were run on compacted site clay subgrade samples. The results, which are shown in Figure 2, were consistent with the difficulties encountered in the field. When the clay soil subgrade was exposed to moisture it became extremely unstable when prepared to within the specified moisture and compaction range and actually showed better performance at greater moistures.
