MEA MARINO ENGINEERING ASSOCIATES, INC. • Issue 28

## AIRPORT PAVEMENT SUBBASE AND SUBGRADE PREPARATION DIFFICULTIES

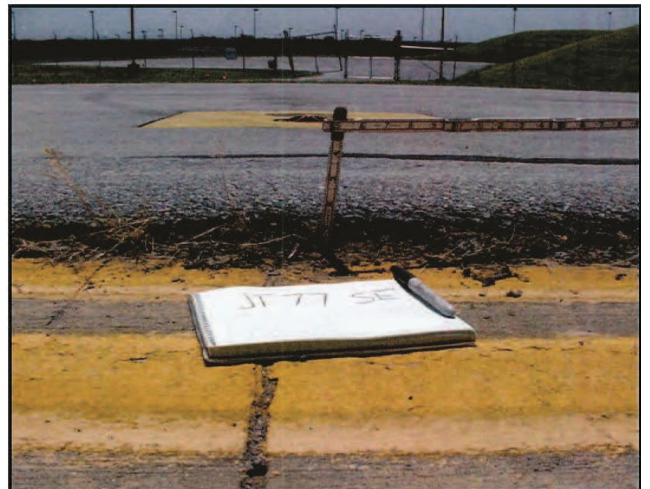
Problems began during pavement construction when the prepared subgrade became wet from precipitation. This resulted in egregious softening and swelling, which destabilized the overlying subbase. The potential for swelling and softening can be seen in constructed pavement with the swelling heave differential of about 1.3 in. between the concrete and asphalt pavement (see Figure 1).

FIGURE 1: DIFFERENTIAL HEAVE OF 1.3 IN. FROM SUBGRADE SWELLING BETWEEN THE TAXIWAY

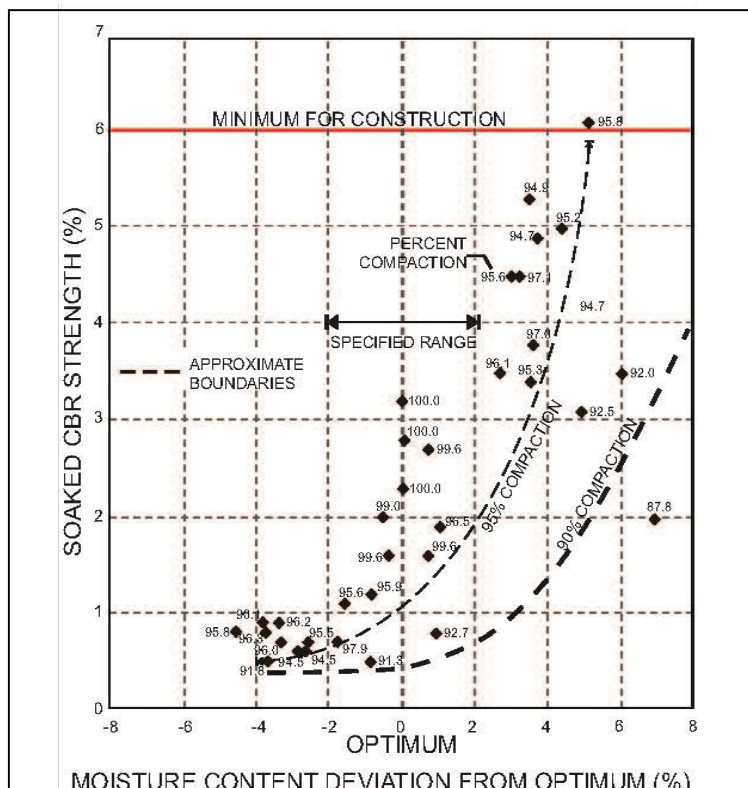
FIGURE 2: MOISTURE CONTENT RELATIVE TO OPTIMUM PLOTTED AGAINST THE SOAKED CBR VALUE FOR ALL COMPACTED SAMPLES

To investigate whether the subgrade specifications would be problematic during construction, a series of strength tests (i.e. CBR tests) were run on compacted site clay subgrade samples. The results, which are shown in Figure 2, were consistent with the difficulties encountered in the field. When the clay soil subgrade was exposed to moisture it became extremely unstable when prepared to within the specified moisture and compaction range and actually showed better performance at greater moistures.

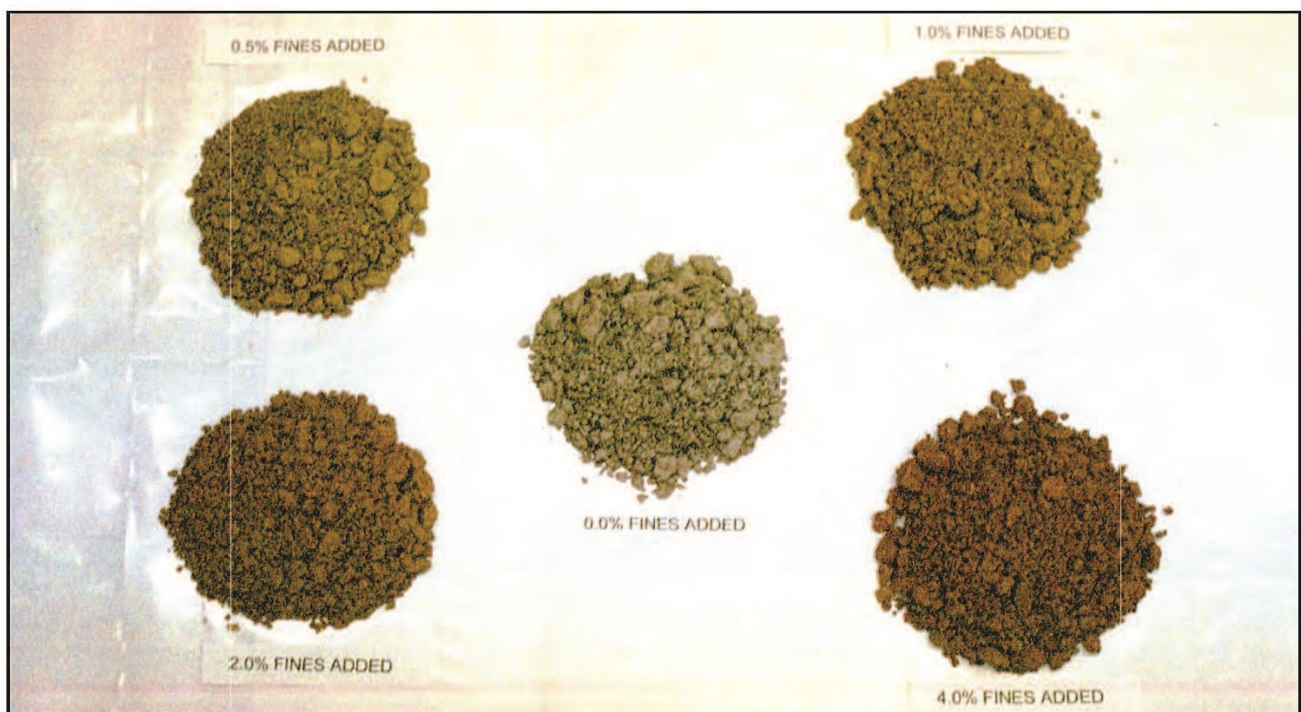
however, identified the wrong target. He contended that the subbase was discolored by the contractor during installation of the subbase and consequently contaminated with the red clay subgrade. From laboratory tests it was found that discoloration was not, in fact, a good measure of contamination. Mixtures of the subbase stone and the red subgrade soil showed that even with the addition of only 0.5% of the subgrade soil, discoloration was achieved (see Figure 3). The subbase stone used by the contractor typically had 7-9% fines and 20% was allowed in the specifications. Consequently, the discolored subbase stone could fall well within the range of the fines allowed and therefore was not a good measure of significant contamination and rejection of the subbase material.

FIGURE 3: PHOTOGRAPH SHOWS DISCOLORATION TEST RESULTS: SUBGRADE FINES ADDED TO THE SPECIFIED BASE ROCK USED ON PROJECT AT PERCENTAGES BY TOTAL DRY WEIGHT OF: 0.5% (UPPER LEFT); 1.0% (UPPER RIGHT); 2.0% (LOWER LEFT); AND 4.0% (LOWER RIGHT). CONTROL SAMPLE (0% FINES ADDED) IS IN THE MIDDLE.
