RISK BASED ANALYSIS RESULTS IN EFFICIENT MINE STABILIZATION

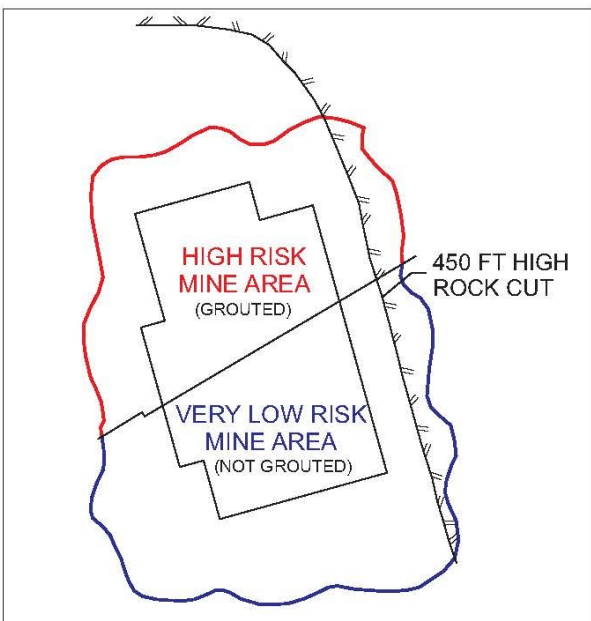
FIGURE 1: SITE LAYOUT WITH ASSESSED MINE COLLAPSE RISK AREAS. STABILIZED ONLY HIGH RISK AREA IN LIEU OF ENTIRE MINE UNDER BUILDING

In addition to the existing rock cut concerns, MEA discovered during its investigations that evidence existed that subsidence had already occurred at the existing commercial building. According to a survey done around the building, about 4 in. of subsidence had occurred, resulting in localized ponding on its flat roof. Under further investigation, it was found that the building rested on another abandoned coal mine which operated from the 1940s to the late 1960s. Based on information collected from drilling into these old coal workings, the mine was found to be open, dry and about 160 ft. deep.

Based on rock testing and MEA’s stability calculations, it was found that the coal mine had limited stability under the northern half of the building which meant there was a high risk of subsidence in the future. However, an acceptable amount of risk existed over the southern portion of the underlying old works (see Figure 1). Therefore, the noted settlement of the building was consistent with the risk analysis performed across the building.

Given the assessed range of risk under the building, the owner chose to only grout stabilize the northern half and saved about \$3 million. This was in lieu of stabilizing the entire mine beneath the structure, which would be conventionally done.

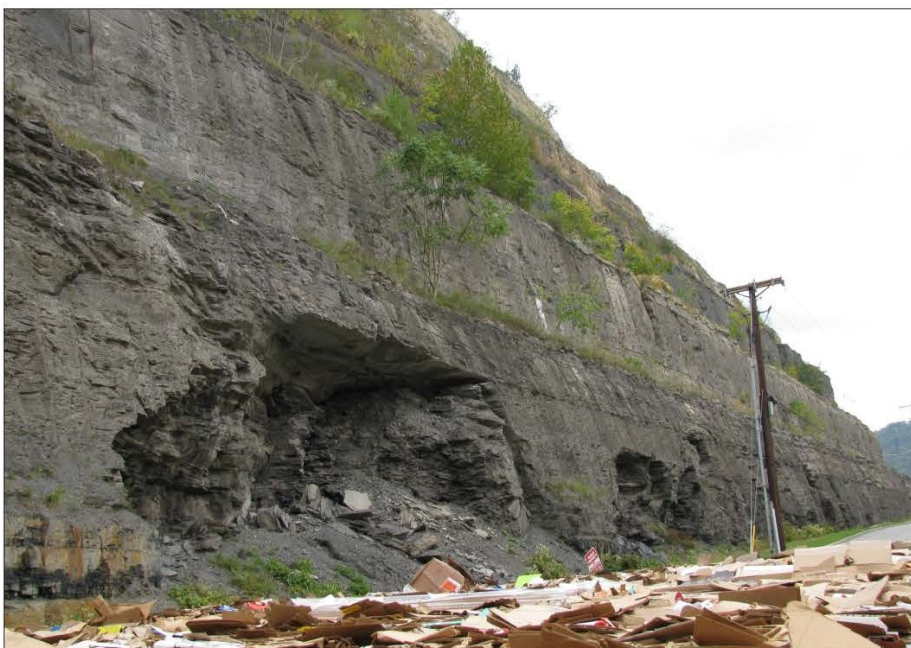
These climatic effects could be seen in the mine roof as it collapsed over time (see Figure 2). To mitigate these deteriorating mine conditions, the open and exposed voids were filled with grout, lift by lift. Where mine openings contained significant collapsed roof materials, the rubble was consolidated by pressure grouting with up to 75 ft. long injection holes drilled into these areas (see Figure 3).

FIGURE 2: MINE OPENINGS IN 400 FT. HIGH ROCK CUT. MINE ROOF CAVED UPWARD OVER TIME.

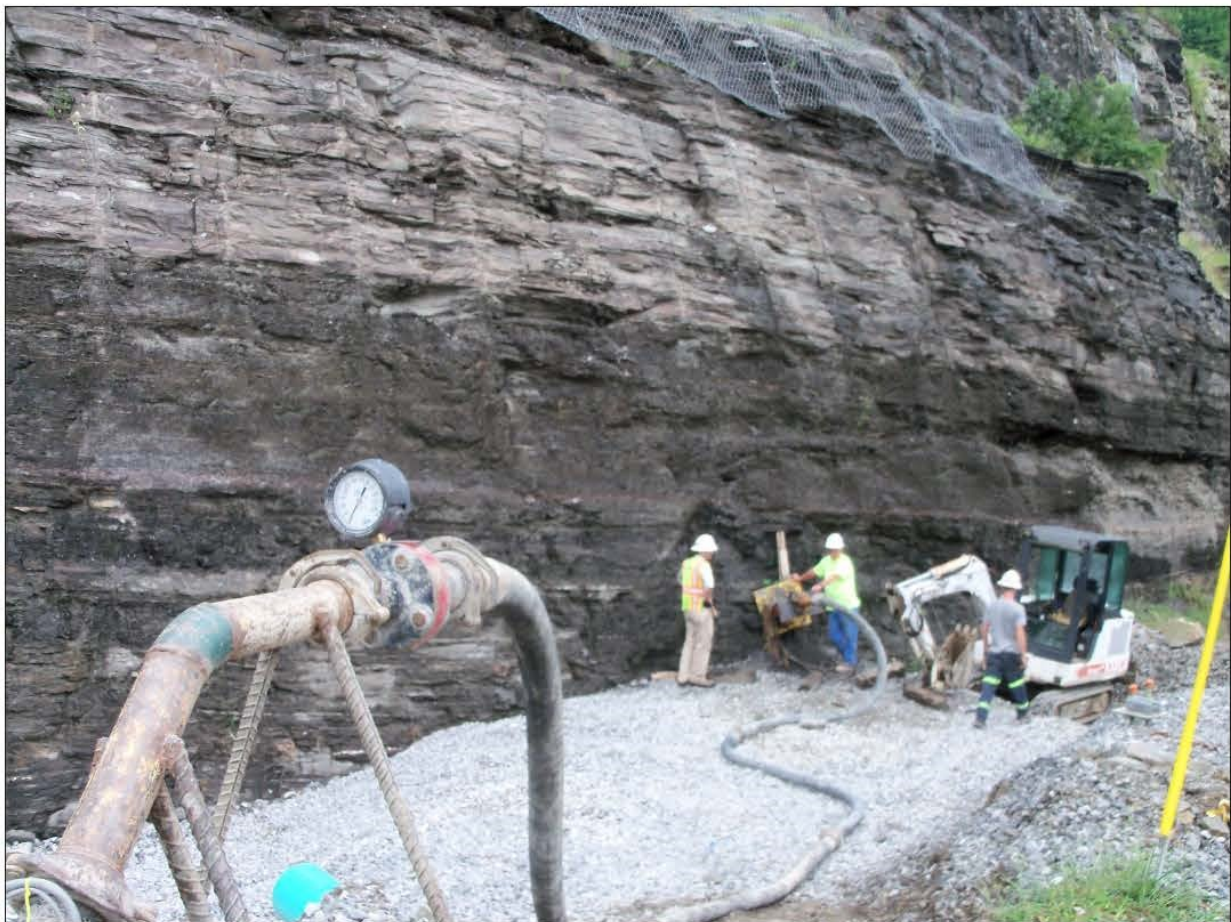
FIGURE 3: GROUT INJECTION WITH PRESSURE INTO THE MINE OPENING FILLED WITH CAVE MATERIAL ALONG THE ROCK CUT.
