INVESTIGATION OF EXCESSIVE FILL SHRINKAGE FROM EMBANKMENT CONSTRUCTION

MARINO ENGINEERING ASSOCIATES, INC.

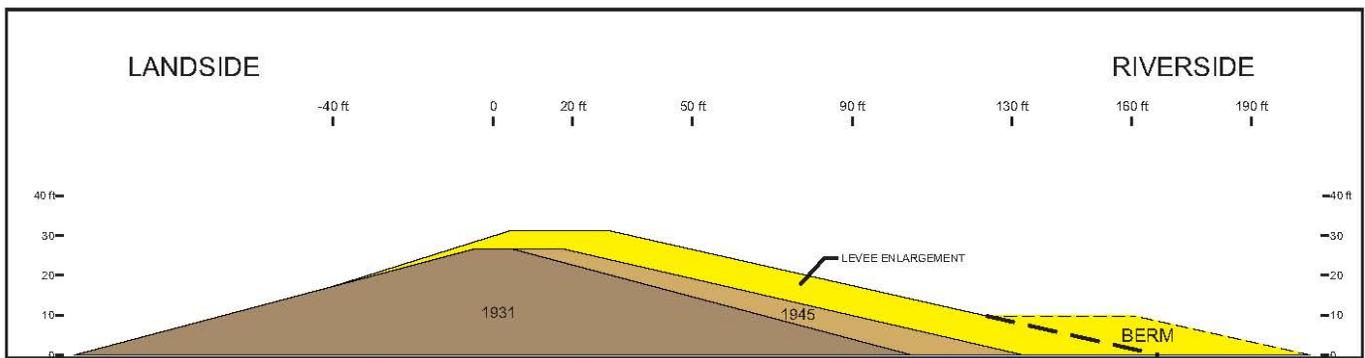
This project involved a 40,940 ft. (7.75 miles) long enlargement of an existing levee located along the east side of the Mississippi River. The enlargement included increasing both width and height of the levee. A cross section of the levee enlargement is shown in Figure 1. Figure 1 also depicts the historical construction of this levee, which was originally placed in 1931 and added to in 1945.

FIGURE 1: TYPICAL EXISTING AND PROPOSED ENLARGEMENT SECTIONS OF 7.75 MILE PROJECT LEVEE

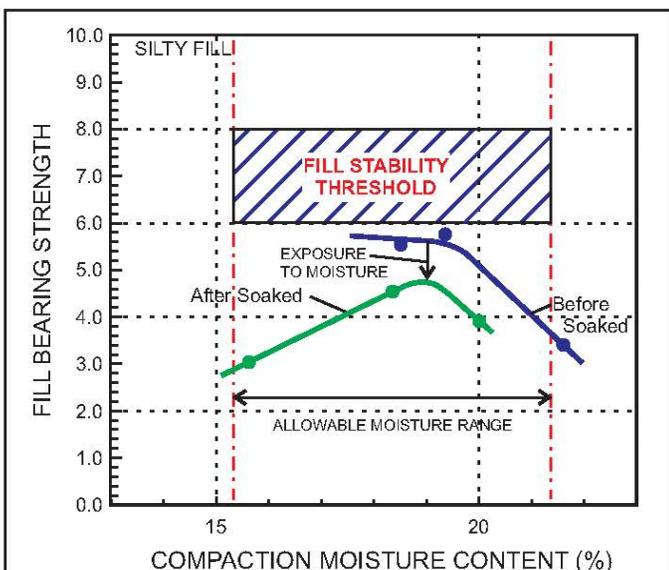
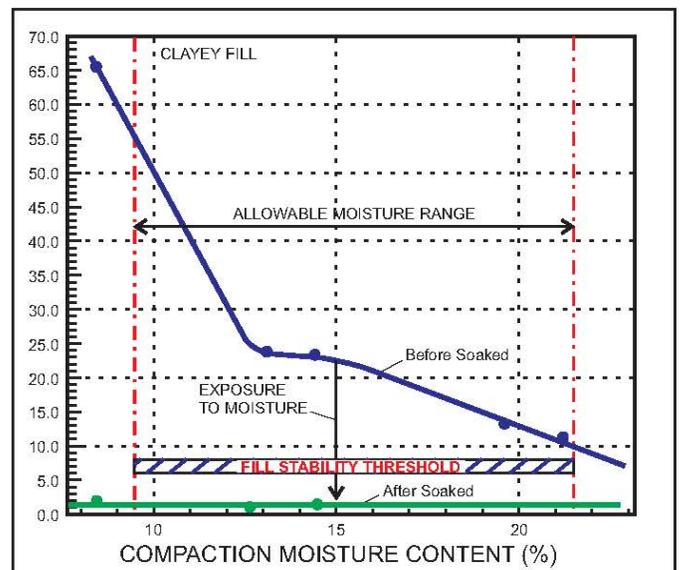
More interesting, however, was the cause for the unexpected and significant foundation settlement and the greater than expected shrinkage from compaction. The culprit was found to be the instability of the placed borrow material, even though it was compacted to specifications. Lab tests showed that when compacted to within specification, the various borrow-to-fill soils would be too weak to support the necessary construction traffic (see Figure 2). This fill instability resulted in the need to extend the wet fill lifts along the entire project

FIGURE 2: FILL STRENGTH WHEN COMPACTED UNDER CONDITIONS ALLOWED IN THE SPECIFICATIONS

In addition to extending fill lifts along the project levee, the borrow material had to be dried to levels less than what was allowed, and compacted to greater densities in order to create at least some stability. About 5% of the fill compaction shrinkage occurred due to the densification of the borrow requiring a higher percent compaction than was specified.

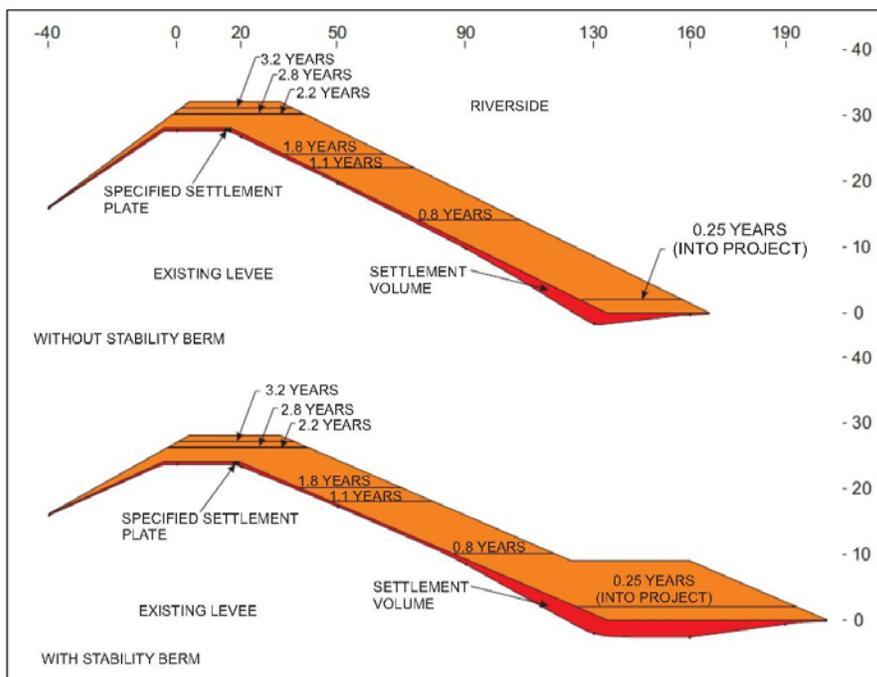
Although thick compressible clayey deposits would be expected along the project reach in this river laid geologic environment, the considerable time that was needed before a levee section could be completed allowed for these clay soils to be compressed and the levee to settle. This resulted in much greater borrow volume to complete a section of the enlargement. Measuring the volume of fill required to compensate for the settlement which occurred during embankment placement can be problematic with the use of one settlement plate. Yet, in the specifications, the instructions to quantify added embankment volume from underlying settlement were based on measuring one settlement plate in the riverside crown of the old embankment. At this location the underlying foundation soils were much stiffer from long term compression under the weight of the old levee. Therefore, measurements from this one specified plate location severely underestimated the fill volume loss from foundation settlement under the riverside toe and beyond (see Figure 3). In other words, the distribution of settlement, especially when significant time dependent movement is present, is not directly proportional to the height of the fill placed as the specified settlement plate method assumed.

FIGURE 3: CALCULATED TOTAL SETTLEMENT DUE TO THE LEVEE ENLARGEMENT

- In design, consider the constructability of the compaction requirements.
- To assess settlement loss, perform accurate pre-fill cross-sectional surveys in addition to the closeout sections required for release of the embankment section.
- To minimize foundation settlement, finish embankment sections as soon as possible. Do not extend lower lifts over longer reaches resulting in sustained loads on the subsoils which tend to be much more compressible.
