500 FT. ASSEMBLY PLATFORM ON CONCRETE PIERS HEAVES

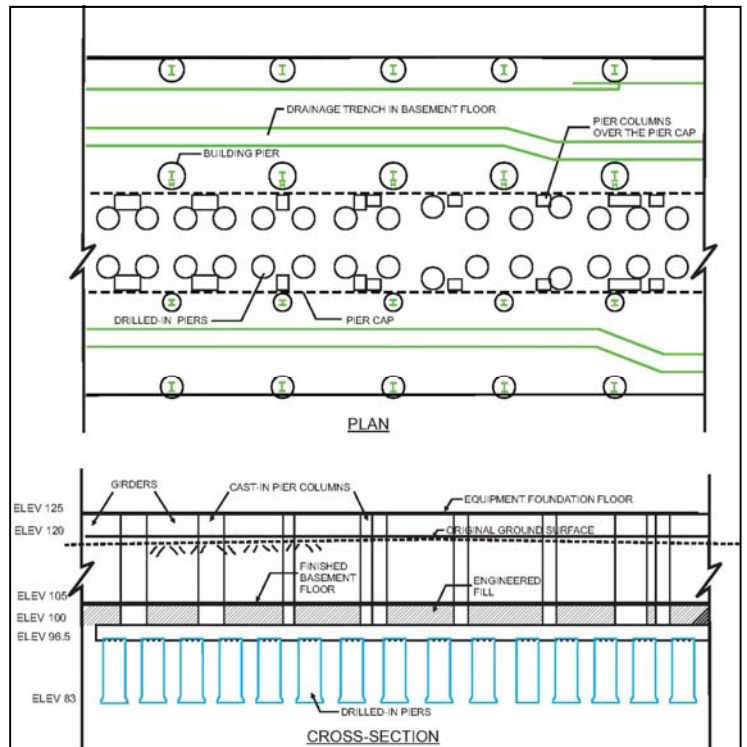
FIGURE 1 PLAN AND CROSS-SECTION OF THE FOUNDATION FOR THE ASSEMBLAGE TRACK IN THE MANUFACTURING PLANT

Due to the tight tolerance required for the production machinery, a massive foundation system consisting of concrete drilled piers was installed in the ground to minimize settlement. The foundation constructed to support the assemblage track consisted of 102, 5-6 ft. diameter, belled, reinforced concrete cassions installed about 25 ft. deep. The large diameter belled cassions were needed to insure that the compression of the pier itself and supporting ground from the manufacturing load would be minimized. The tops of the cassions were structurally connected by a 3.5 ft. thick, 25 ft. wide, and 500 ft. long reinforced concrete cap. A plan and cross-section showing this foundation system is shown in Figure 1.

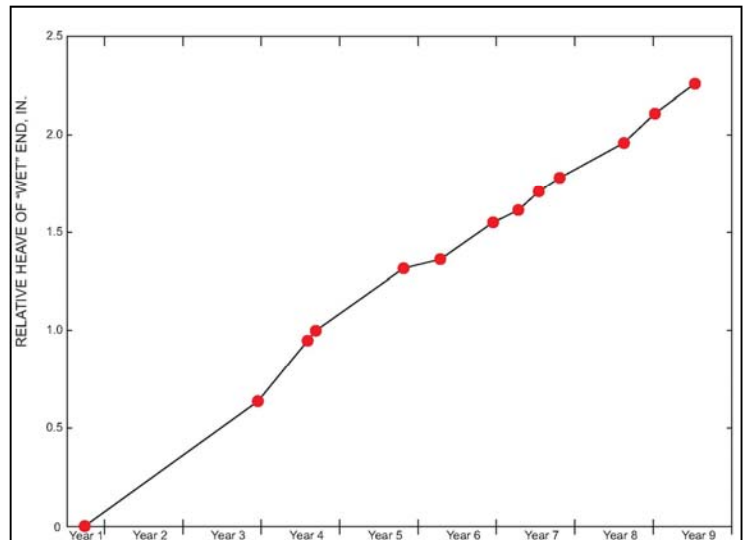
FIGURE 2 PLOT OF THE UPWARD MOVEMENT OF THE MACHINE ASSEMBLAGE TRACK OVER TIME

However, it was later discovered from level surveying that the concrete pier foundation was in fact moving upward, not settling. A plot of the differential upward movement along the assemblage track over about 8 years is shown in Figure 2. Figure 2 shows there has been a fairly constant rate of upward movement over the monitoring period of about 0.25 in./yr. The potential for ground swell from moisture absorption was also considered in the design but was underestimated. The ground swell potential was primarily based on testing of the more shallow, less dense, soil-like materials which had higher moisture contents.
