CATASTROPHIC FAILURE OF AN UNDERGROUND DAM

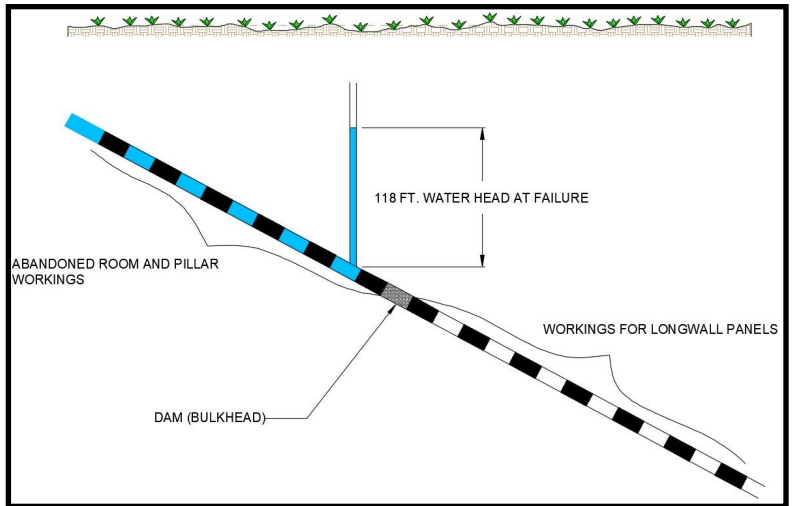
A 730 ft. long dam was installed in an underground coal mine in Southeast Ohio. The purpose of the dam (or hydraulic bulkhead) was to eliminate the downslope groundwater seepage from abandoned workings that was constantly flowing downslope and was collecting at lower elevations where active mining operations were taking place. Consequently, this water had to be continually pumped out and treated in surface facilities before it could be released into a nearby stream. The dam would eliminate these efforts. Figure 1 illustrates the purpose of the bulkhead in eliminating the downslope seepage issues.

FIGURE 1 CROSS-SECTION ILLUSTRATING DAM LOCATION DOWNSTREAM FROM FLOODED ABANDONED WORKS AND UPSTREAM FROM ACTIVE LONGWALLING

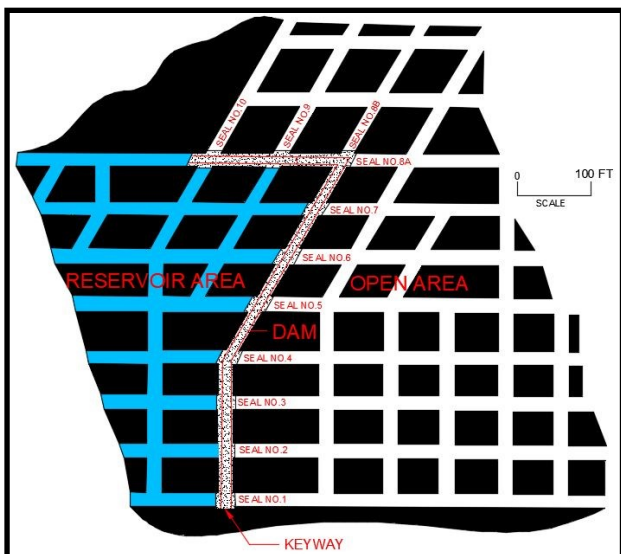
The layout of the concrete hydraulic bulkhead is shown in Figure 2. As can be seen in Figure 2, what was constructed was essentially a continuous concrete (grout) wall from solid coal to solid coal. The bulkhead was made to be 20 ft. thick and filled the mine void space from coal pillar to coal pillar and from roof to floor at the height of about 6 ft. or greater where roof cave existed. The 20 ft. wide dam was seated in a soft floor. In an attempt to cut off underseepage in the soft floor, a 12 ft. wide concrete keyway up to 2 ft. deep into the floor was installed along the alignment of the wall (see Figure 2). The floor in this area was claystone which was heavily fissured, and extended well beyond the depth of the keyway.

FIGURE 2 PLAN VIEW OF THE CONCRETE BULKHEAD

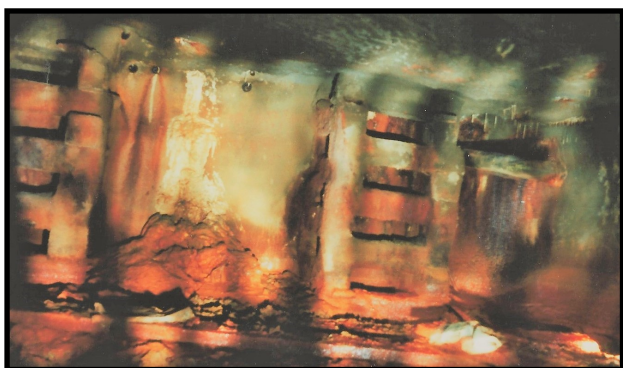
FIGURE 3 DOWNSTREAM SEEPAGE EFFECTS AT SEAL NO. 7. PHOTO TAKEN AFTER FAILURE

After construction, groundwater began collecting behind the bulkhead. Reports of roof, seal, rib, and floor leakage as well as muddy floor conditions were reported throughout the entire time of impoundment. After about 100 days, seepage through Seal No. 7 (see Figure 2) accelerated with seepage rates reaching over 75 gpm with the water only about 20 ft. high (or 8.7 psi water pressure against the wall). Figure 3 shows photographic evidence of the seepage through the roof above Seal No. 7. Remedial grouting in the roof reduced seepage to

pre-accelerated levels of about 10 gpm. As the water pressure continued to build, the Seal No. 7 roof had to be grouted again because of seepage rates similar to before. At this point, the water behind the bulkhead had reached about 95 ft. (41 psi) in 600 days. After reducing the seepage to about 4 gpm, flow immediately began to increase again. Also, it was reported that 4 in. deep water was flowing from Seal No. 10. After the impounded water reached a height of 118 ft., the mine floor blew out at Seal No. 10.

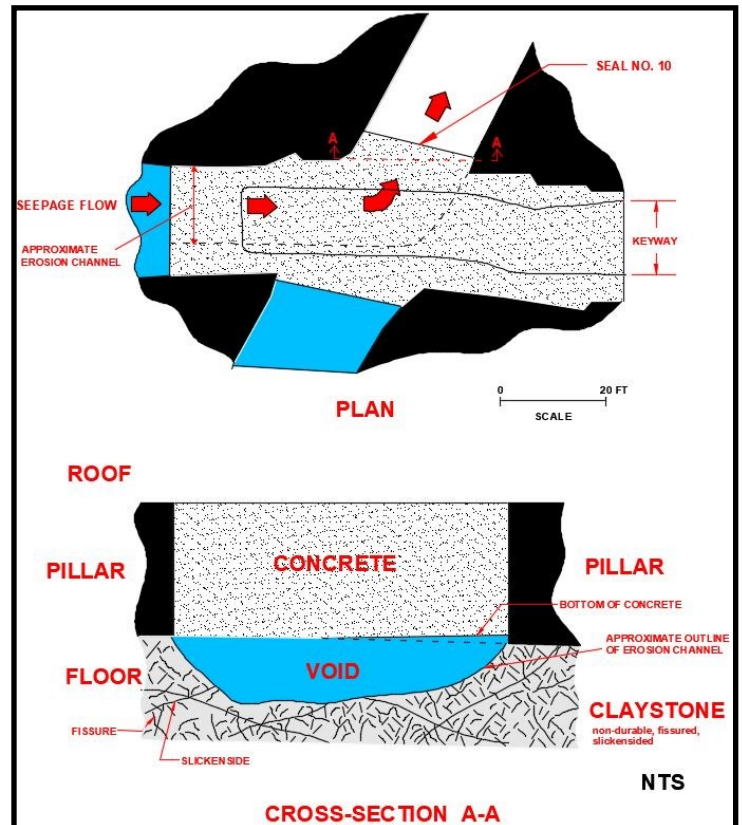
As a result, 1 billion gallons of contaminated underground reservoir water rapidly flowed down through the floor of Seal No. 10 and inundated the active portion of the mine. The area of blowout resulted because of a designed and constructed weak spot in the dam. The failure conditions at Seal No. 10 are illustrated in Figure 4. As can be seen in this figure, the failure was through a fireclay (claystone) floor. This claystone was erodible and was significantly permeable due to the presence of abundant fissures. This combined with a seepage path which could avoid the constructed keyway, and where a coal corner exists, which commonly contains significant fracturing, ultimately caused failure.

FIGURE 4 DAM BREACH CONDITIONS AT SEAL NO. 10

This is a case where the in-house designer was unaware, and they did not recognize the importance of employing a qualified geotechnical consultant when considering the potential impact of failure, even though the up-front costs would be greater. Here was a case where the risk (i.e. likelihood and severity of failure) was misjudged. This was manifested in the constructed conditions, which demonstrated a fundamental lack of understanding of seepage phenomena and effects. Moreover, continued seepage which could not be abated by grouting as the water impoundment height increased should have been recognized as a clear sign of incipient failure.
