DE-ERECTION OF STEEL FRAMED STRUCTURE DUE TO EXCESSIVE SETTLEMENT

MEA
MARINO ENGINEERING ASSOCIATES, INC.

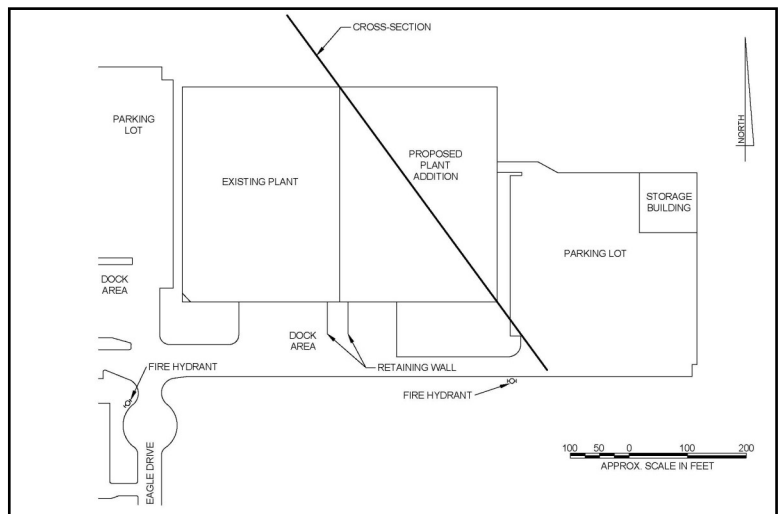
FIGURE 1 BUILDING PLAN

A manufacturing building was proposed in Wisconsin as an addition onto another manufacturing building. The structure was to be placed immediately to the east of the existing building. The structure to be constructed was a 360 ft. by 380 ft., 40 ft. high column supported steel structure (see Figure 1). In order to bring this metal building above flooding limits, the building pad was raised by placing sandy fill from 14 ft. thick in the southeast to 11 ft. toward the northwest corner.

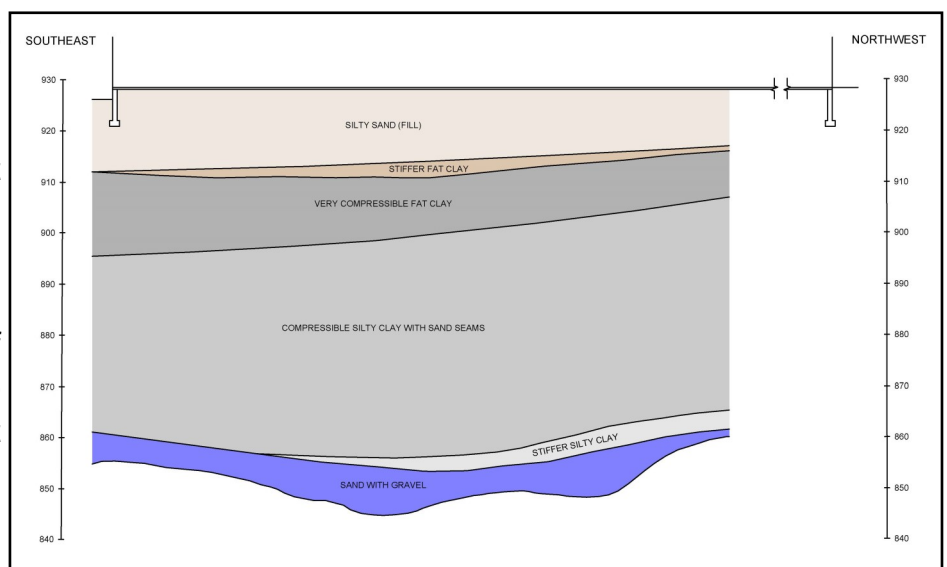
FIGURE 2 SUBSURFACE CROSS-SECTION

Whereas the existing building sat on significant sand deposits, the proposed structure to the east was situated in compressible glacial and post-glacial lake sediments. Note the upper post-glacial sediments appear to be significantly more compressible than the older sediment. An approximate northwest-southeast geologic cross-section through the proposed building is shown in Figure 2. This cross-section shows that there is about a 50 ft. thick zone of mainly soft fine grained sediments with the southeast corner of the building pad containing about 17 ft. of the more compressible later lake sediments compared to less than 9 ft. on the northwest corner (see Figure 2).

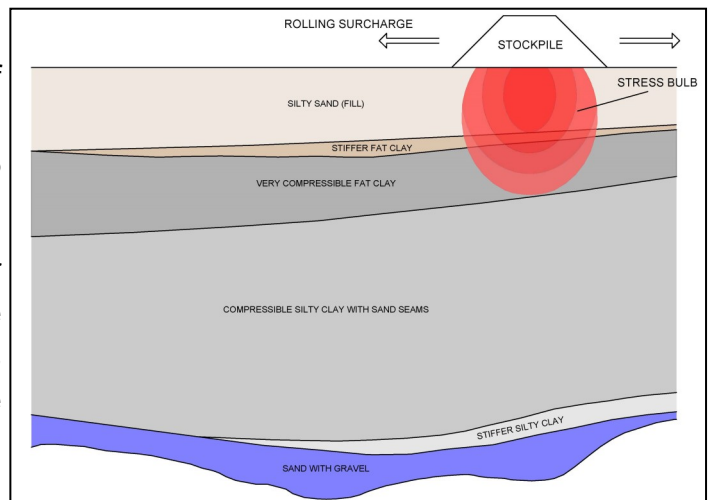
FIGURE 3 ROLLING SURCHARGE ILLUSTRATION

The cause of the excessive settlement was the result of the under-compressed subsoils especially in the southeast corner of the building pad. This resulted from an under-appreciation of how deep the compressible soils were (note design borings were not extended to bottom of soft soils at depths of 50-60 ft. and inadequate surcharging). The rolling surcharge loads were not sustained long enough nor wide enough to load deeper soils (see Figure 3) and were of insufficient coverage (especially in the southeast corner).

When considering pre-compressing thick, soft to very soft clay soils with a rolling surcharge, detailed and well thought out specifications should be developed and field executed (e.g. minimum stockpile size, surcharge completion criteria, stockpile movement criteria, and stockpile slope stability requirements). Ground improvement by rolling surcharge can result in an extended amount of time compared to fully surcharging the site with the use of installed vertical wick or sand drains to expedite the porewater drainage of the saturated clay during compression.

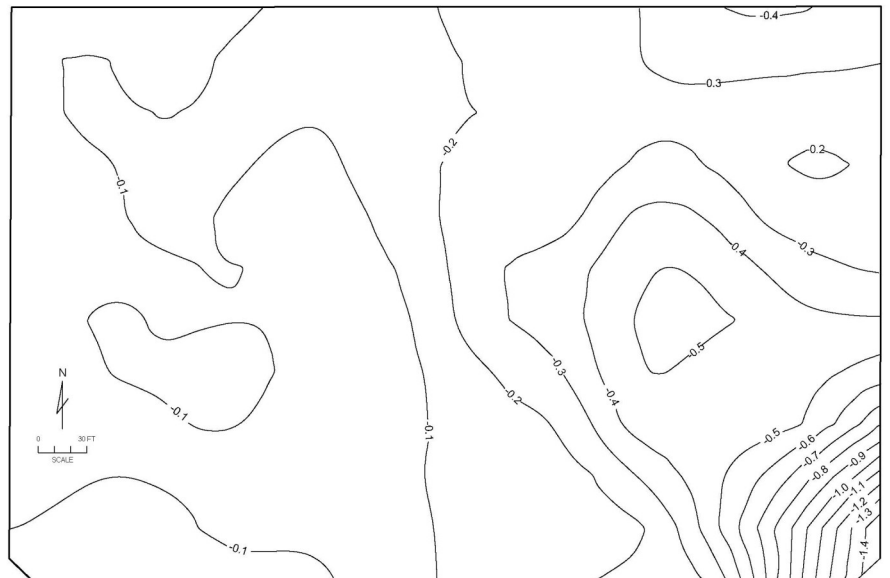
FIGURE 4 BUILDING SETTLEMENT CONTOURS STRUCTURE

After the building was constructed, the structure continued to settle resulting in damage which gradually worsened. After about 4 years, the damage was so severe that the building was considered structurally unsafe to occupy as a result of overstressed-failed steel members. The differential settlement in the southern portion of the building at about this time is shown in Figure 4. As can be

seen in Figure 4, over 1.4 ft. of differential settlement had occurred in the southeast corner of the building with a maximum floor slope of 10 percent (and a maximum angular distortion 1/75 over 80 ft.). There were also floor flatness issues.

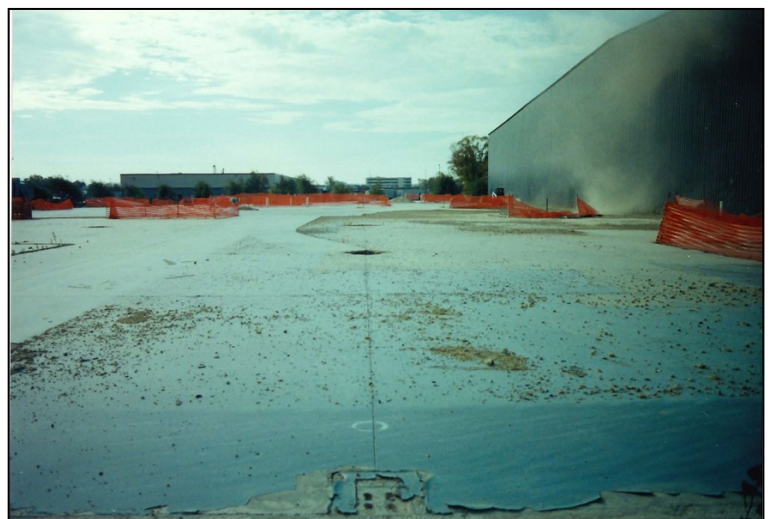
FIGURE 5 SOUTH VIEW OF DISMANTLED STRUCTURE

Because of the unsafe structural condition, other damage and that another up to 1 ft. of future movement was expected the building was dismantled. A photograph of the removed structure to the floor slab is shown in Figure 5.
