MSE WALL FAILURES FROM USE OF NON-DURABLE BACKFILL

This project involved the lane expansion of an Interstate highway. This included lane widening and elevation of the roadway at the overpasses which was accomplished by adding fill and MSE walls on the northbound and southbound lanes. Typical cross-section of this construction is shown in Figure 1.

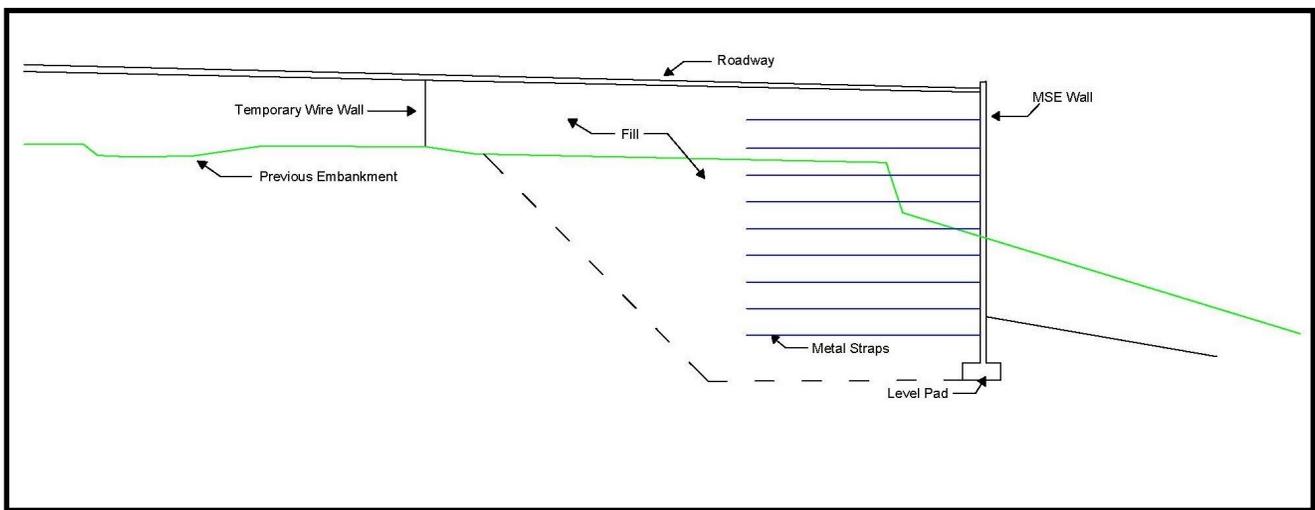
FIGURE 1 TYPICAL CROSS-SECTION OF CONSTRUCTION OF INTERSTATE WIDENING

The basic cross-section across the approaches to the interstate overpasses consisted of the pavement structure, compacted new fill, followed by the old clay embankment fill. The old fill in most places rested on virgin dark clays and then residual clays which transition into a shale bedrock. The new embankment is laterally supported with MSE walls which rested on the old clay fill. The MSE wall was designed using steel straps and a granular backfill with very little fines, thus requiring no wall drainage layer.

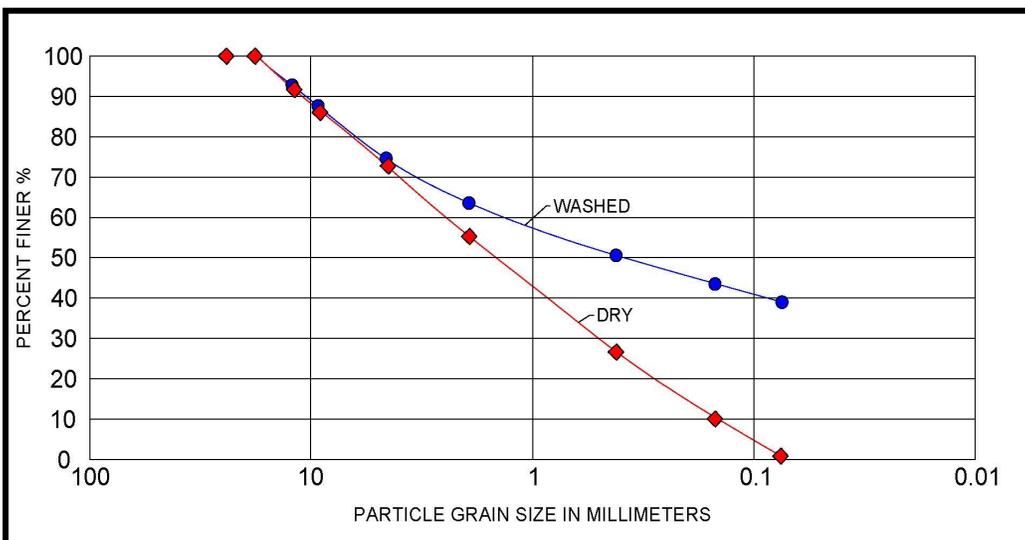
Because of the soft rock-like quality of this material, however, it would undergo additional breakdown when compacted. Laboratory tests show that the caliche particles would break down when

FIGURE 2 GRAIN SIZE CURVES FROM DRY AND WASH SIEVING OF PROCESSED FILL TAKEN FROM THE CHALK QUARRY (MINUS 3/4 IN. FRACTION)

soaked in addition to when compacted. This is illustrated in Figures 2 and 3. This was verified when wet mechanical sieving produced 38% more fines than dry sieving (i.e. 1.8% versus 40.0% fines). However, dry mechanical sieving was specified, and thus these submitted test results which were reviewed and approved.

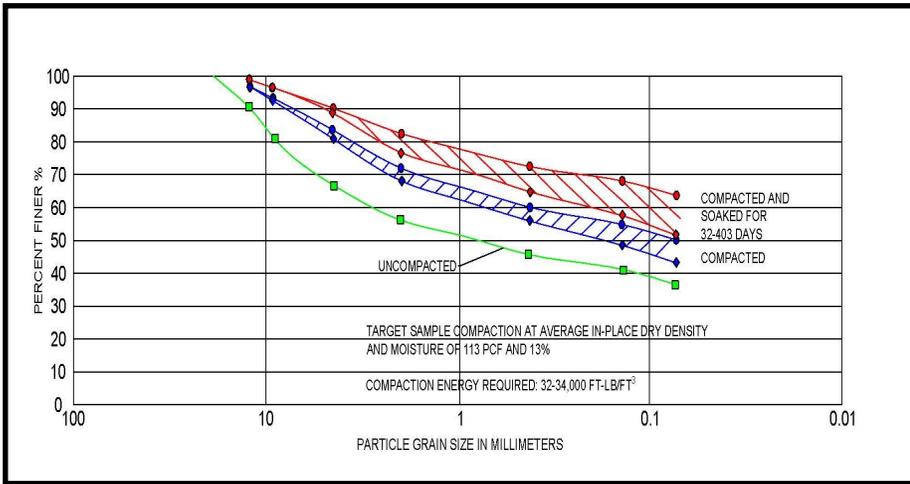
FIGURE 3 GRAIN CURVES AFTER COMPACTION AND SOAKING FOR THE SAME BULK SAMPLES (MINUS 3/4 IN. FRACTION)

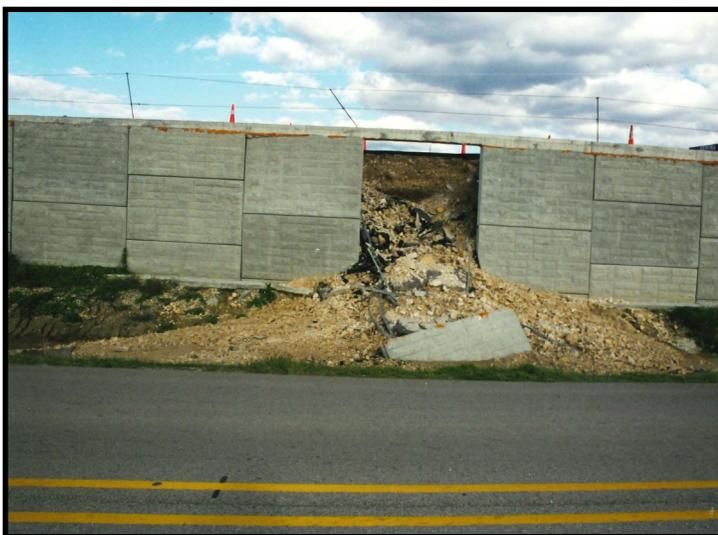
Damage to the MSE walls began during construction. The first wall damage consisted of complete collapse of partially filled MSE walls a couple of panels high and 2-3 panels wide in three areas. These failures appeared to have occurred after rain. Even after several French drains were installed under the level pad footing one of these areas failed again after the wall was completed after a heavy rain. This failure was about 3 panels wide and shown in Figure 4. After noticeable distress, another MSE wall section collapsed. The event again seemed to be precipitated by heavy rains. This failure was a minimum of four panels wide and is shown in Figure 5.

FIGURE 4 COLLAPSE OF MSE WALL SECTION

These wall collapses appear to have been the result of steel strap pullout cause by the breakdown of the fill which in turn, affected the drainage behind the wall and the strength of fill. The lack of sufficient drainage along the walls resulted in excessive hydrostatic pressure against the wall panels ultimately resulting in failure. The Interstate widening project also experienced other MSE wall distress and roadway approach settlement which were at least in part related to the use of the caliche fill.

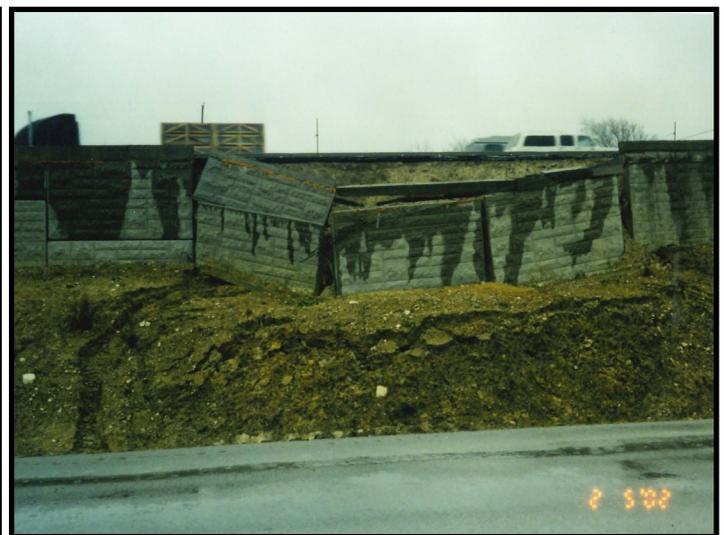
FIGURE 5 COLLAPSE OF MSE WALL SECTION
