MEA MARINO ENGINEERING ASSOCIATES, INC. • Issue 57

FAILURE INVESTIGATION OF A COFFERDAM FAILURE

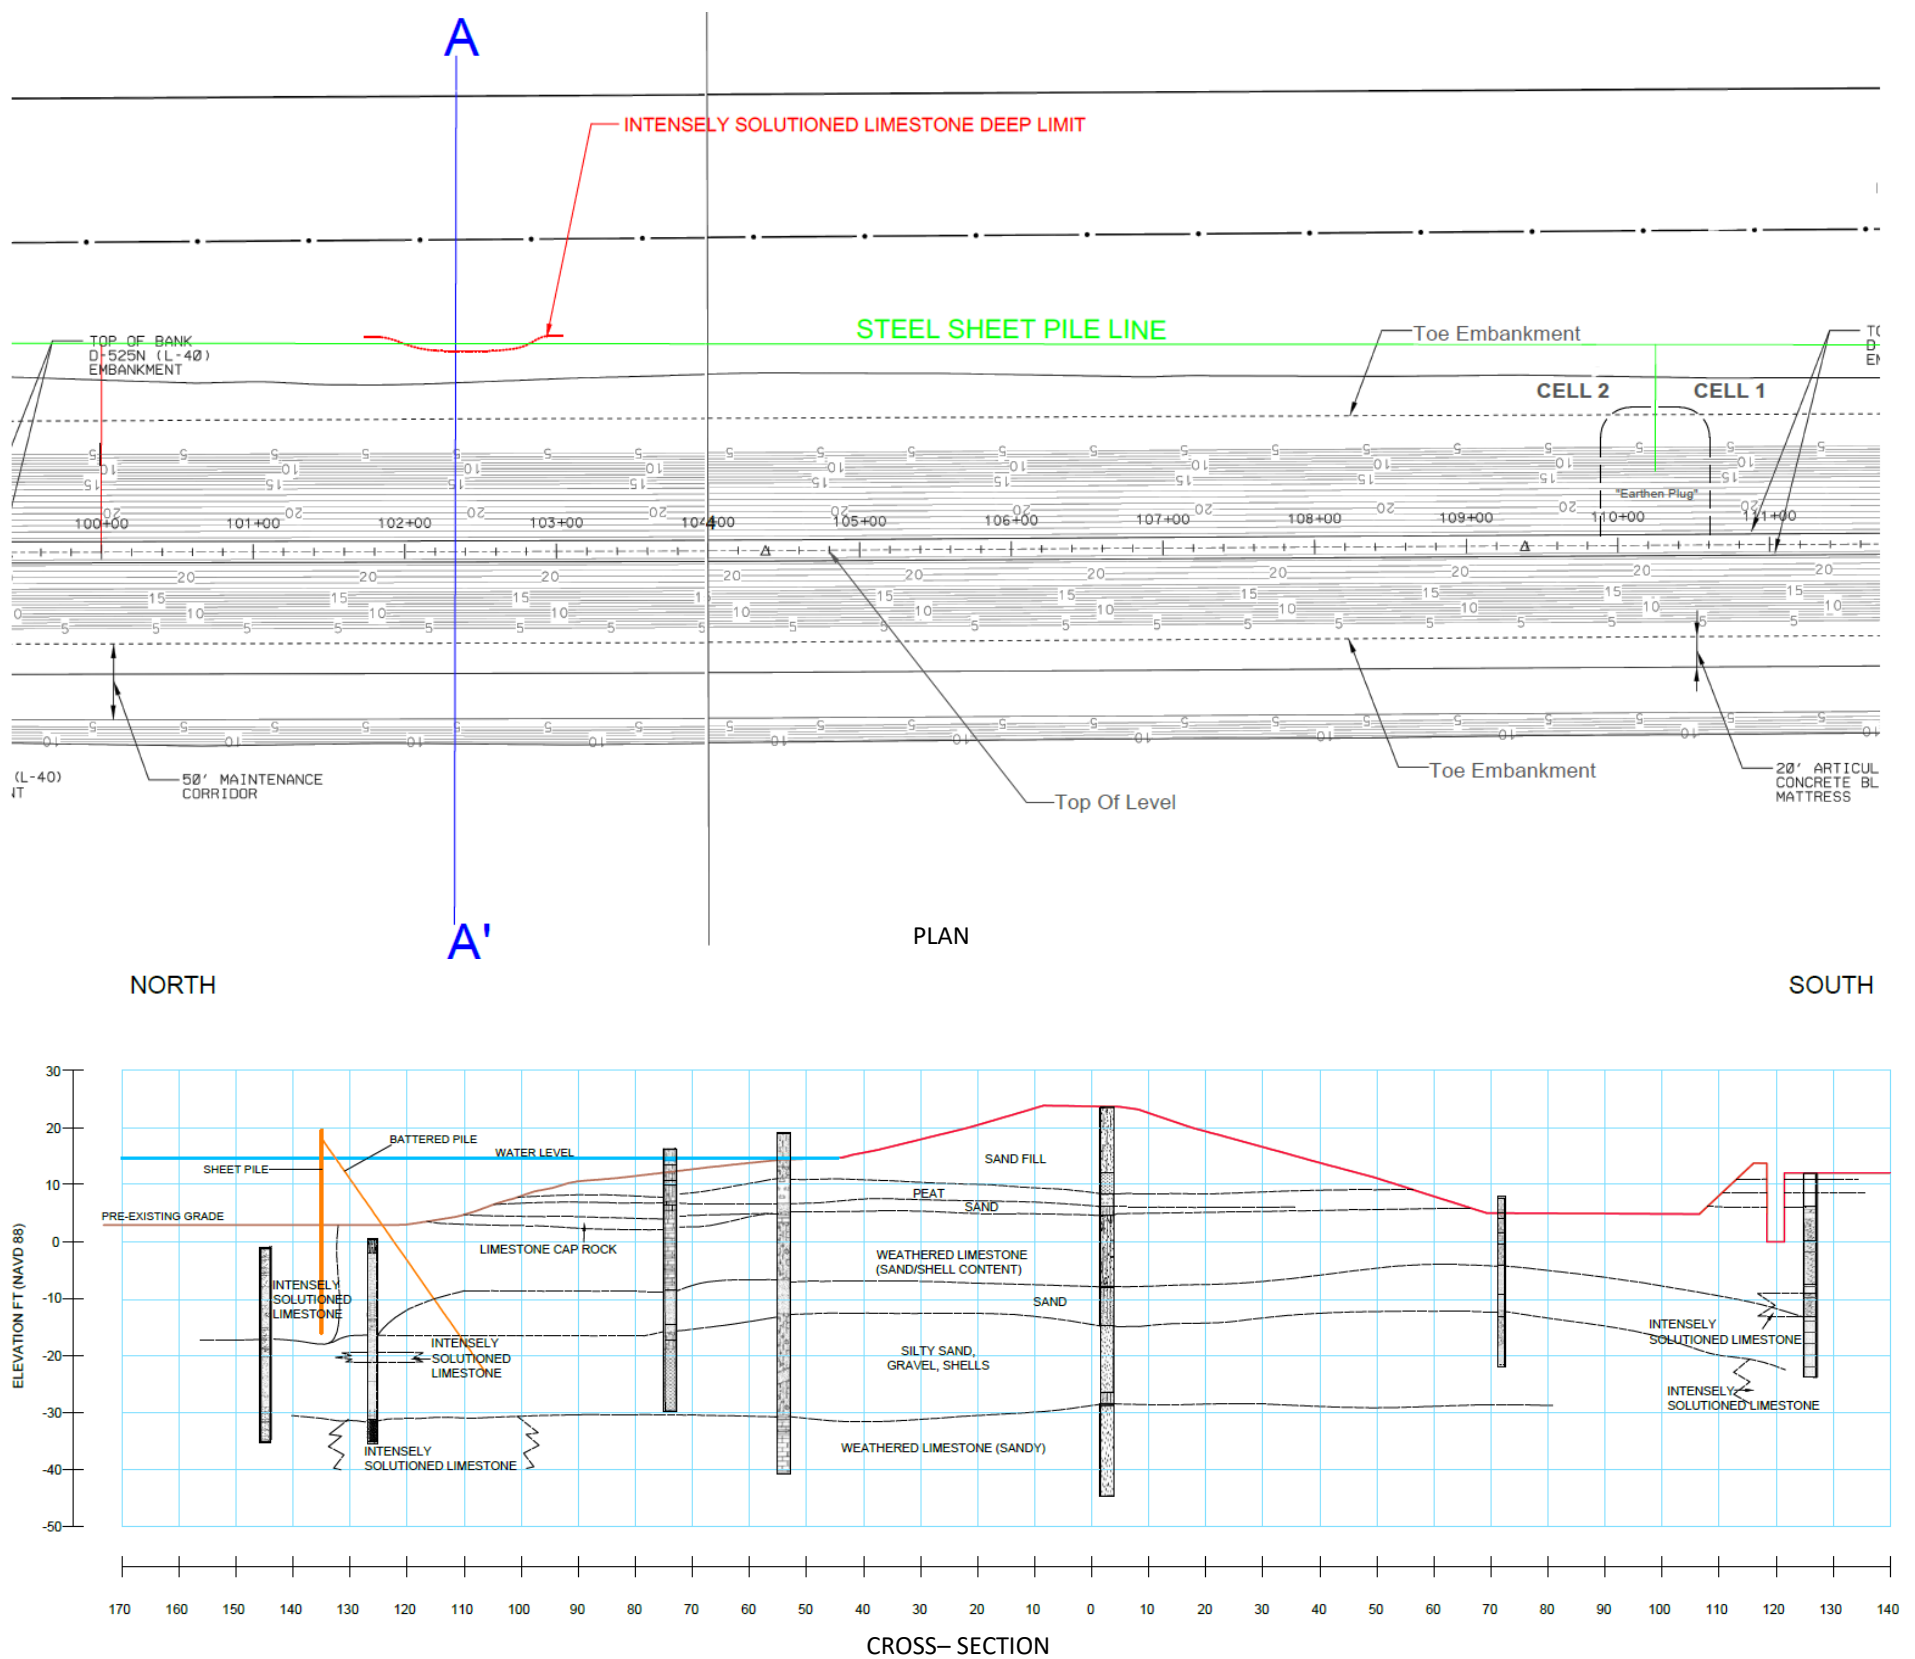
This project consisted of rehab construction of an about 15,000 ft. long earthen levee which was bound by water on one side. Therefore, in order to carry out construction along the levee surface on the west side, successive cofferdams had to be constructed along the existing levee in order to dewater the face for the rehabilitation work to proceed. The cofferdam cells were constructed in phases as the work proceeded. Each cofferdam cell consisted of a brace steel sheetpile wall which is anchored on both ends into earthen dikes which rested on the sides of the levee. See Figure 1. The bracing system was designed to provide lateral support near the top of the wall, in addition to the sheetpile embedment at the bottom wall against the retained water pressure. Inclined or battered steel piles (rakers) were driven into the ground to provide the horizontal support to the top of the wall.

FIGURE 1 COFFERDAM CONSTRUCTION A -A' ALONG THE EXISTING LEVEE

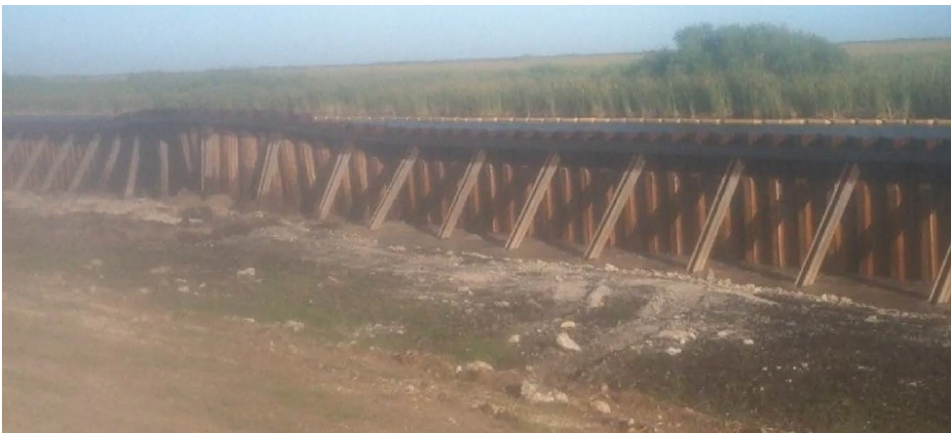
The breach occurred after the second cell was constructed and dewatered and occurred in the second cofferdam cell which was 3,000 ft. long (the first cell was 2,000 ft long, therefore 5,000 ft. of cofferdam had been completed). The breach in a localized area was rapid without forewarning and was a result of underseepage. A video of this failure can be seen in Figure 2. The video shows the severe upward boiling in the dry side of the sheetpile and the associated loss of ground and embedment.

FIGURE 2 VIDEO OF ONGOING BREACH OF THE COFFERDAM DUE TO UNDERSEEPAGE

As a result of the loss of ground, the sheetpile moved inward causing the corresponding rakers to bend backward to practically vertical and in turn rotate upward uplifting the steel sheetpile wall.

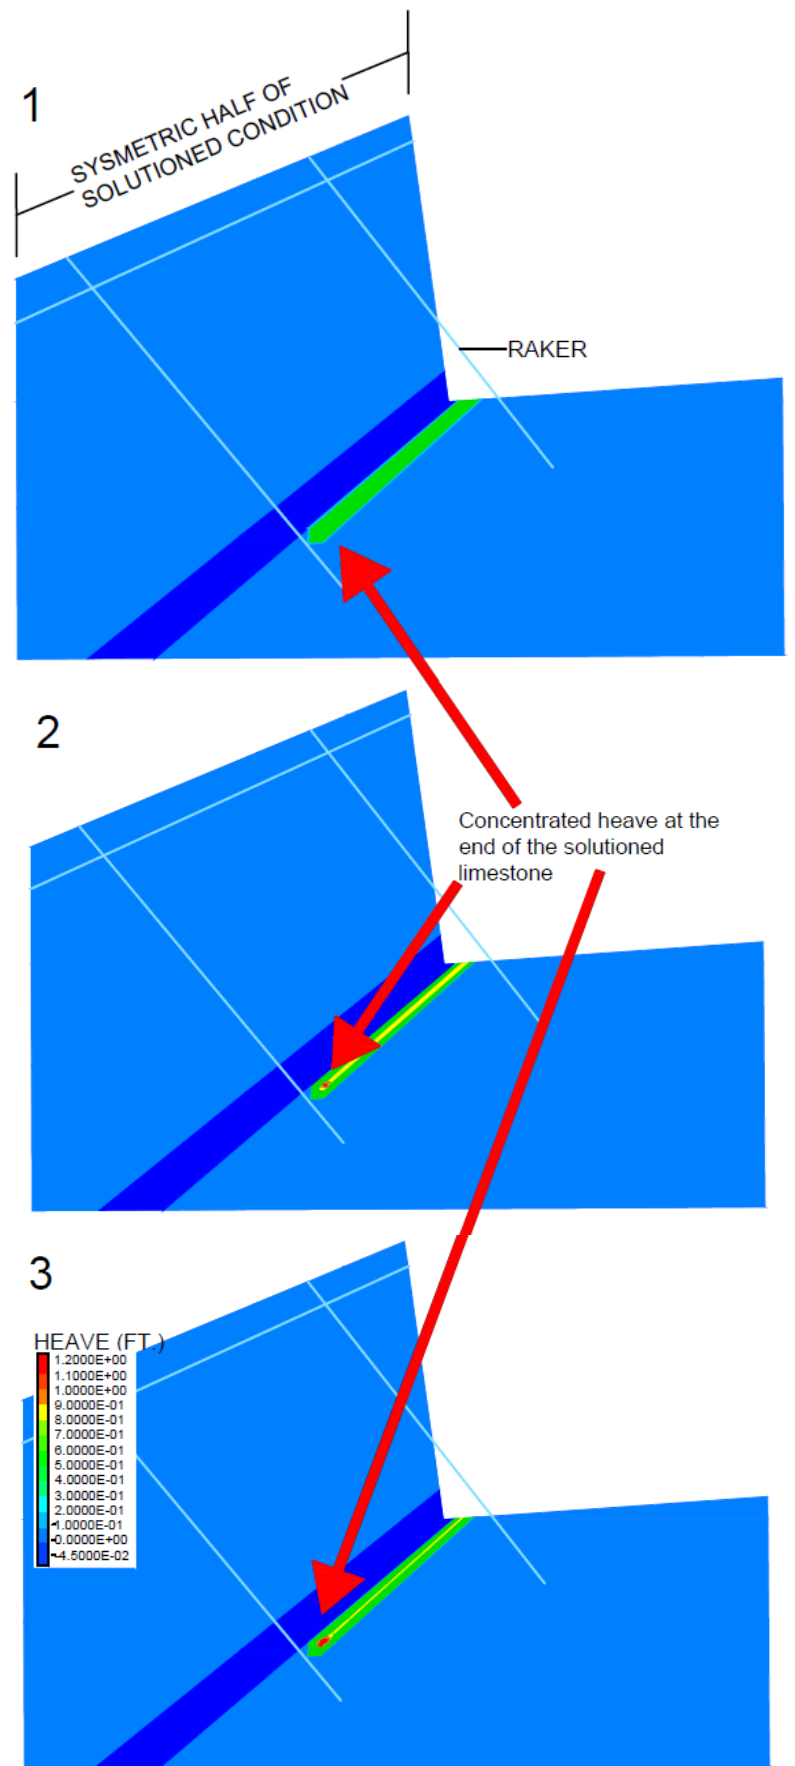
Based on the subsurface investigation, laboratory testing, and engineering analyses, MEA determined that the cofferdam failure was the result of the concentrated and localized underseepage induced piping. This was the result of localized intensely weathered sandy limestone zone which had greater permeability and lower dry density due to solutioning over time. This condition was 3D modeled in FLAC which indicated failure due to piping. This is illustrated in the output from the FLAC model which indicated unstable soil heave adjacent to the sheetpile in the intensely weathered zone. Figure 3 shows the model output at different stages of numerical iteration showing the progression of the failure by the change in color intensity in the area of solutioning along the wall. This model run did not reach a solution as the flow condition was unstable.

FIGURE 3 OUTPUT OF 3D FLAC MODEL SHOWING THE UNSTABLE PROGRESSION OF UNDERSEEPAGE FAILURE IN THE INTENSELY WEATHERED LIMESTONE ZONE
