UPDATE

MEA MARINO ENGINEERING ASSOCIATES, LLC. - A UES COMPANY • Issue 64

INJECTION AND SPREAD OF COAL MINE SLURRY IN AN ABANDONED COAL MINE

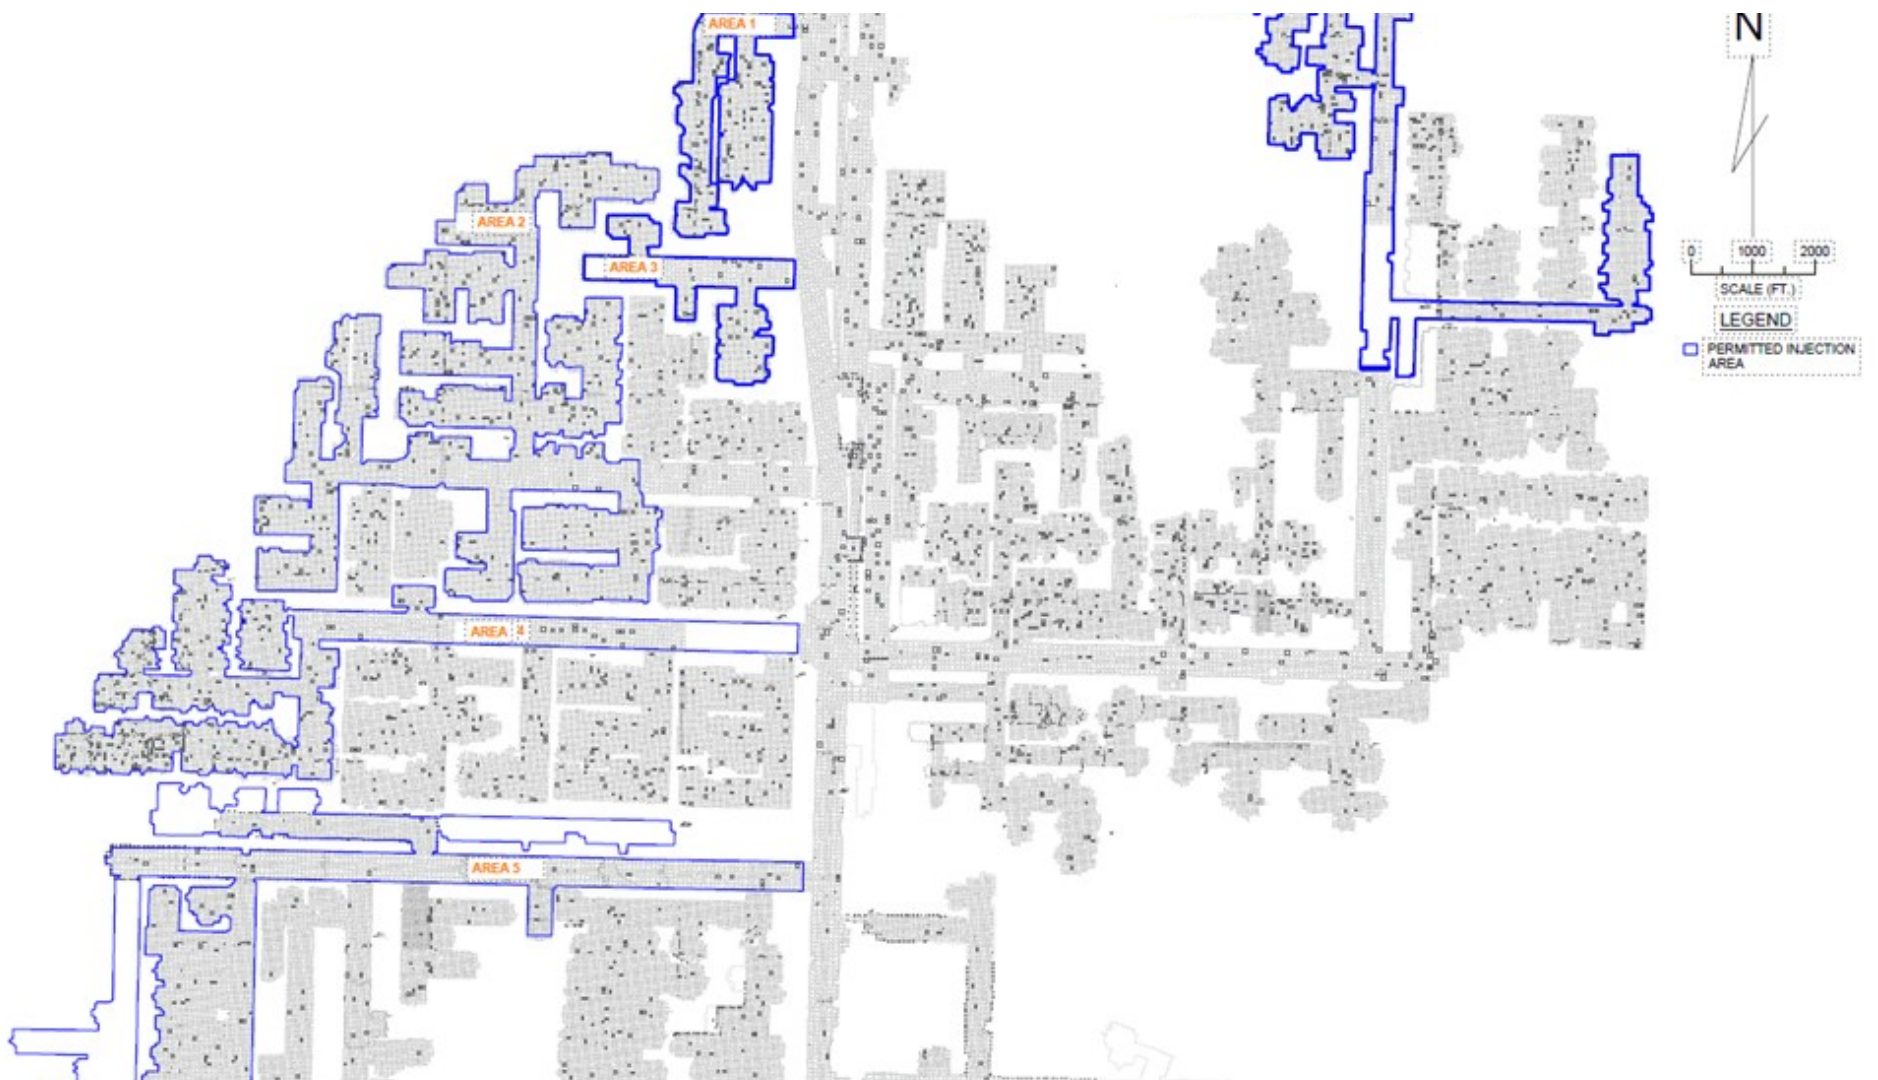
FIGURE 1 PERMITTED INJECTION AREAS IN THE ABANDONED COAL MINE

These permitted injection areas shown in Figure 1 mainly rely on old block mine seals to restrict the flow of the injected slurry into non-permitted areas.

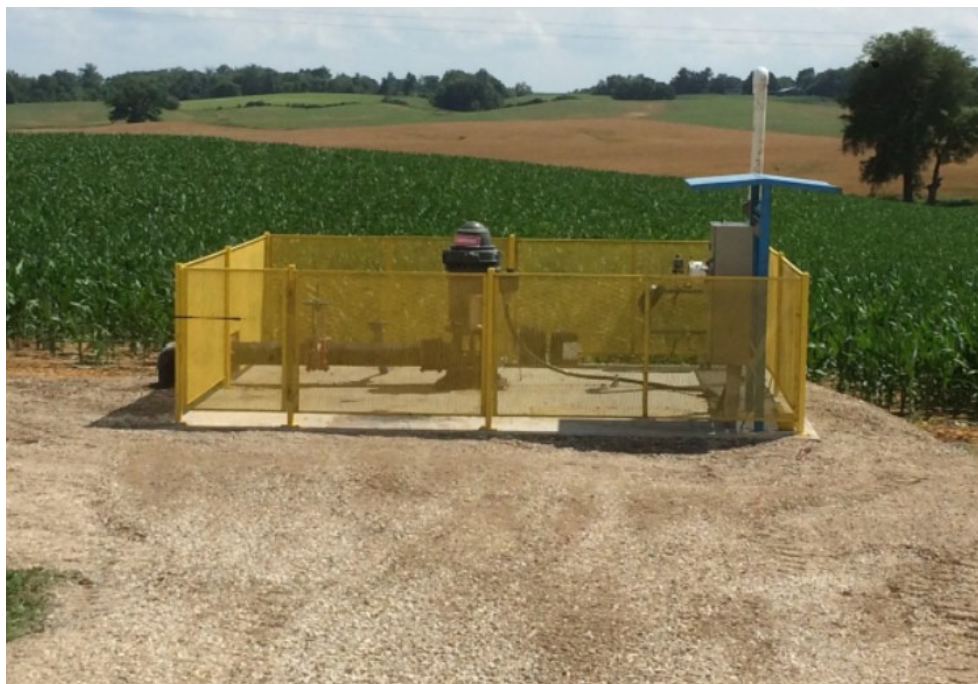
FIGURE 3 SURFACE DECANT HOLE SETUP

in order to fit a greater volume of waste in the old workings, wells were installed into the mine void of each injection area to pump out this bleedwater and allow more slurry to be injected. The decant hole setup on the ground surface is shown in Figure 3.

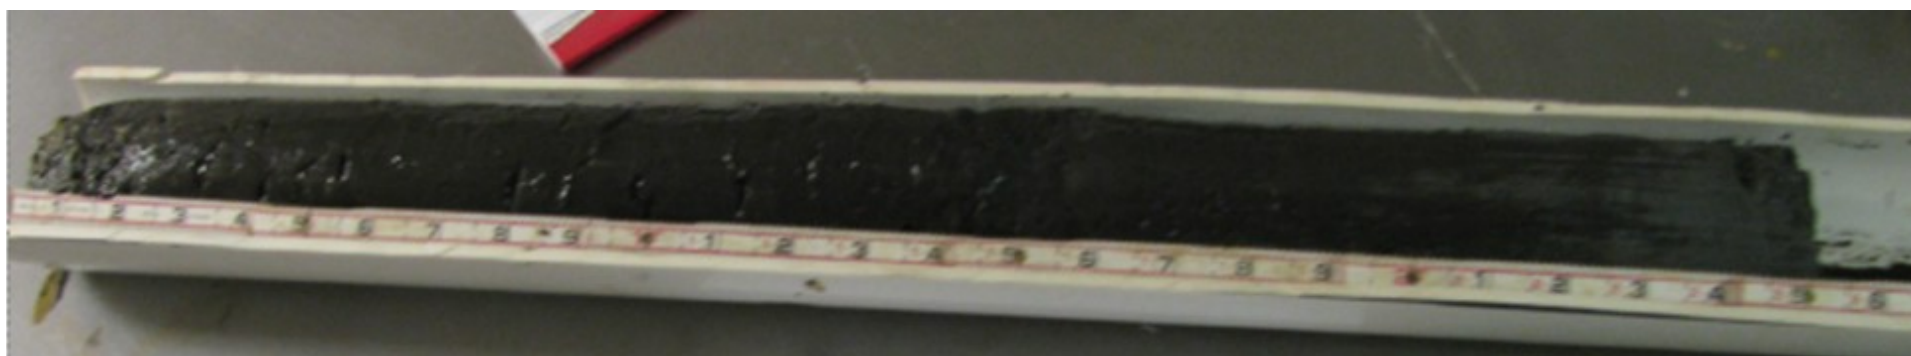
To verify and estimate the extent of the spread of mine slurry, a number of verification borings were drilled outside the permitted area to sample the mine void interval and determine if mine slurry was present. This was done with a sampling tube which was pushed into the clay mine floor several inches to provide a plug so the slurry would not slip out of the tube upon retrieval. Figure 4 shows the slurry that was pushed out of one of these sampling tubes. The measured moisture content and wet density of the sampled mine slurry were 23 to 88% (60% average) and 84 to 95 pcf (90 pcf average).

FIGURE 4 EXTRUDED SAMPLE OF COAL SLURRY TAKEN FROM IN THE MINE OUTSIDE OF THE INTENDED INJECTION AREA

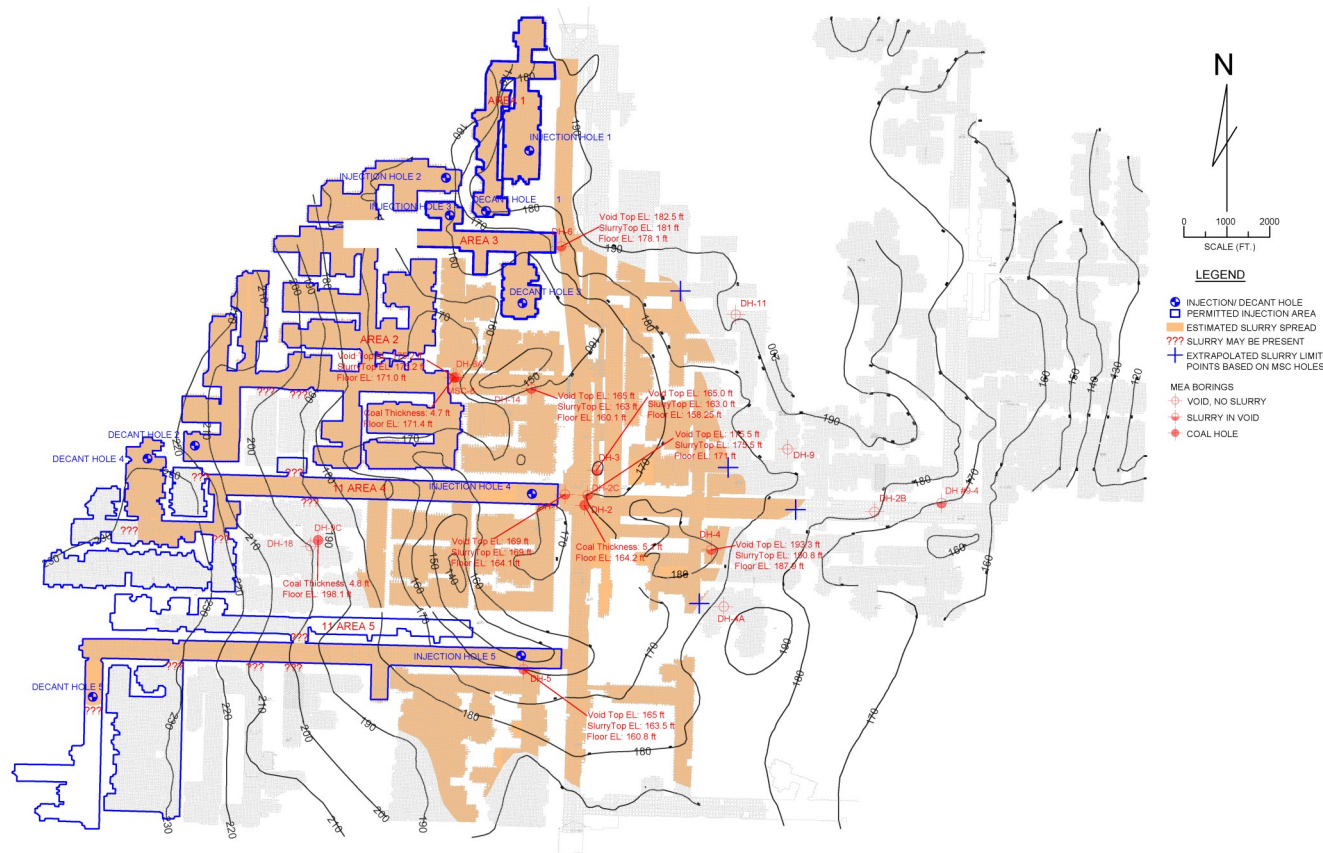
Consequently, these seals were breached causing the slurry to spread into unpermitted areas. This was also evident from the volume of deposited slurry pumped into the mine far exceeding the estimated storage capacity for permitted injection areas.

Based on the above borehole investigation campaign the limit of the slurry spread was extrapolated and is shown in Figure 5. It is estimated that the slurry had spread up to roughly 6,000 ft beyond the breached seals.

FIGURE 5 ESTIMATED SPREAD OF COAL SLURRY INJECTED INTO THE ABANDONED COAL MINE
