INVESTIGATION AND REPAIR OF A FAILED OLYMPIC POOL

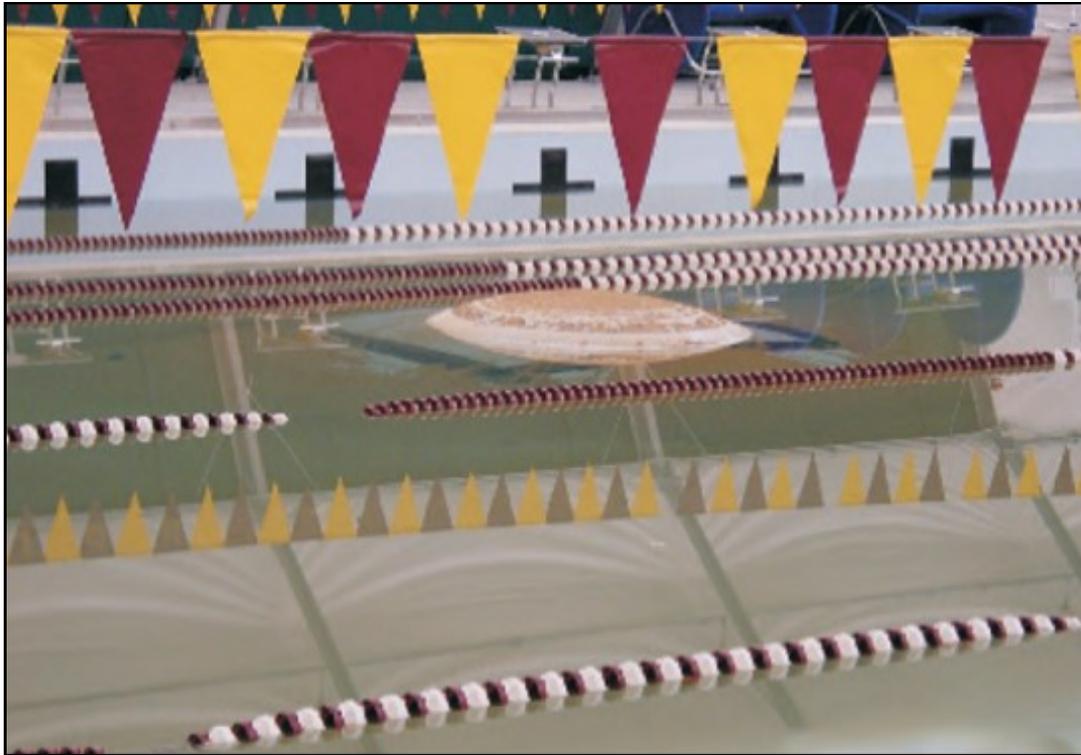
FIGURE 1 VERY LARGE BUBBLE IN THE FLOOR LINER WHICH GREW OUT OF THE WATER DURING THE OPERATION OF THE POOL

From the beginning of the operation of the Olympic Pool in Tennessee there were signs of trouble. The water in the pool would not clear up, the pool liner had bubbles which appeared to grow over time, and the pool floor needed constant vacuuming. Initial thoughts by the contractor who constructed the pool was that filtration plumbing, which was installed below the pool floor, contained a significant amount of construction debris which was making its way into the pool. As the pool continued to operate, the blisters in the liner grew, which was speculated to be the result of a high groundwater table. Eventually one of these bubbles became so large that it rose above the water surface. To deflate this now very significant liner bubble, it was punctured spewing soil and water (see Figure 1).

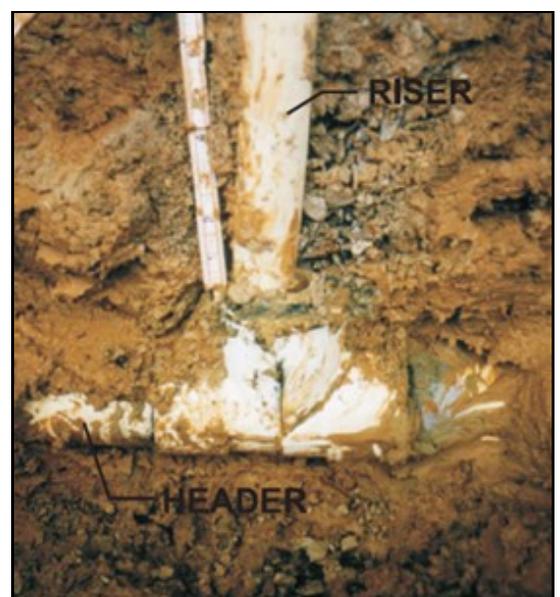
From a borehole camera inspection it was discovered that there was a significant fracturing of the sub-floor plumbing. The fracturing was concentrated at the connector of the rise pipe and header (see Figure 2). Also from manometer survey and photographic information it was established that the pool floor and wall had settled. Normally, such pool settlement would not affect the operation of the pool but the pool floor plumbing was particularly sensitive to compressibility of the fill as the

FIGURE 2 TYPICAL FRACTURING FOUND AT THE RISER/HEADER CONNECTION

Although some had recommended removal and replacement of the entire pool structure, MEA determined the foundation for in-place pool walls could be repaired by pressure grouting under MEA monitoring. This resulted in a savings of several hundred thousand dollars for the owner. The floor subsoil was removed and replaced, as well as the slab and associated plumbing.

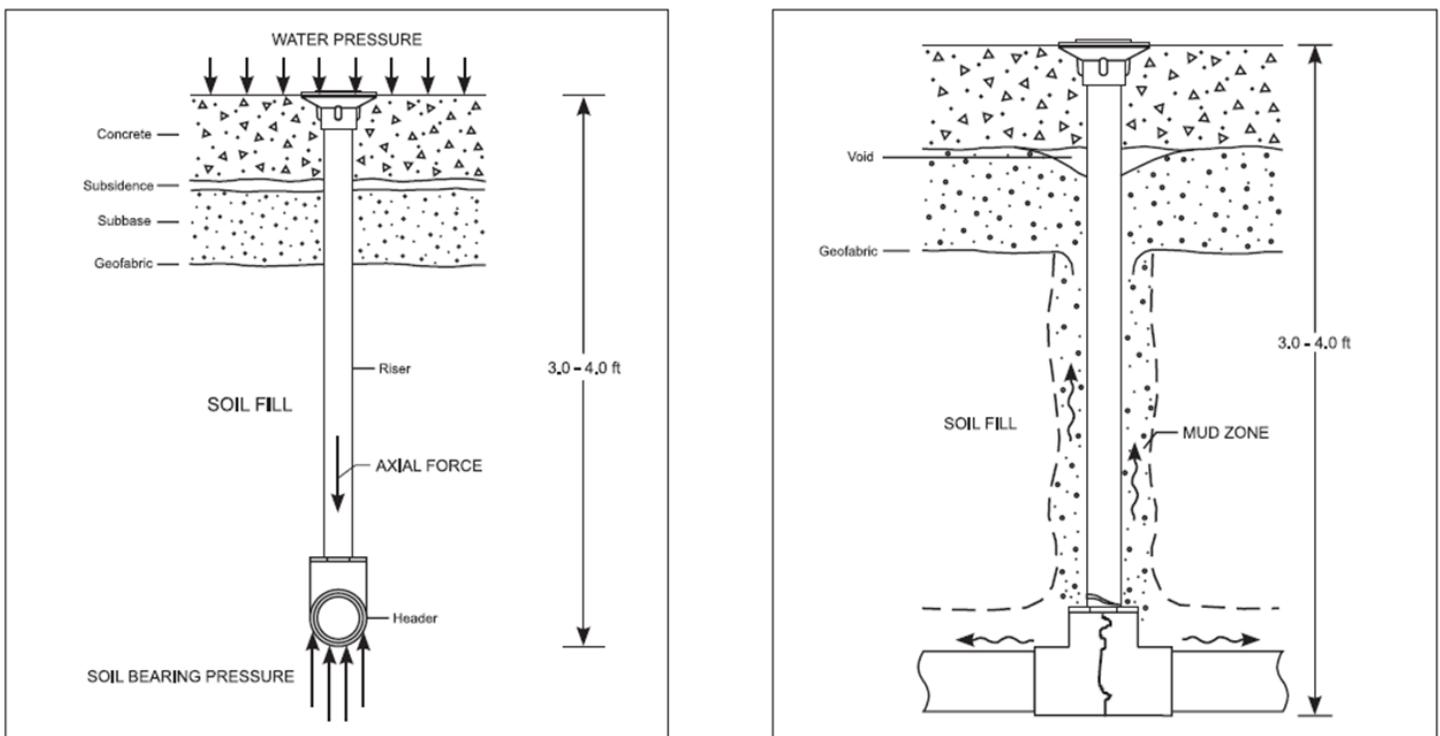
FIGURE 3 LOADING CONDITIONS ON THE WATER FILTRATION RISER/HEADER SYSTEM AND RESULTING DAMAGE

PVC floor plumbing system consisted of about a 3 ft. riser pipe connected to a header pipe (see Figure 3). The system in effect acted as a concrete slab supported by load columns (PVC risers) which were in turn supported by footings (PVC header tees). After drilling and sampling the sub-soils and performing tests in their laboratory, MEA determined that the fill installed beneath the pool floor and wall was improperly placed and caused the pipe failures. Based on this testing and analysis it was further determined that this pipe system would not have failed if the soil fill was compacted to specifications. MEA laboratory tests demonstrated under these placement conditions that the soil was not sufficiently compressible.
