AIRPORT PAVEMENT SUBBASE AND SUBGRADE PREPARATION DIFFICULTIES

An MEA investigation where airport pavement difficulties in Oklahoma were encountered, exemplifies the above and is discussed herein. The project involved the construction of a taxiway and connecting staging area. The taxiway and staging area required 12.5 in. and 7 in. of reinforced concrete. Along the 50 ft. shoulders, 2 in. of hot asphalt concrete was specified. Beneath all pavement areas a 6 in. subbase at 100% compaction or more was required. All soil subgrade and fill required greater than 95% compaction. All subbase stone and subgrade compaction was to be performed within 2% of the optimum water content.

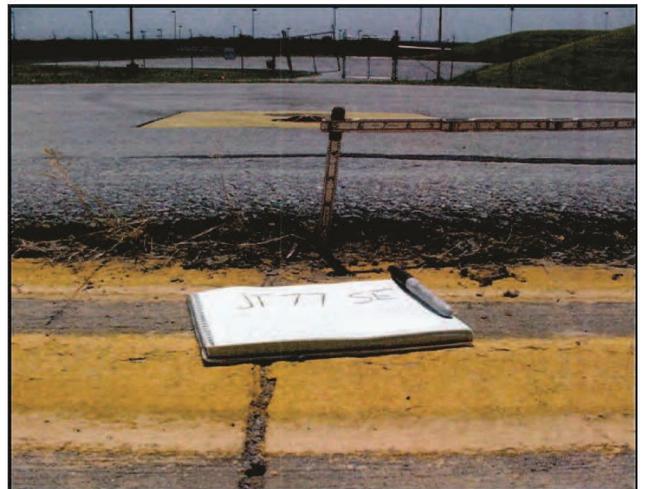
Problems began during pavement construction when the prepared subgrade became wet from precipitation. This resulted in egregious softening and swelling, which destabilized the overlying subbase. The potential for swelling and softening can be seen in constructed pavement with the swelling heave differential of about 1.3 in. between the concrete and asphalt pavement (see Figure 1).

FIGURE 1: DIFFERENTIAL HEAVE OF 1.3 IN. FROM SUBGRADE SWELLING BETWEEN THE TAXIWAY

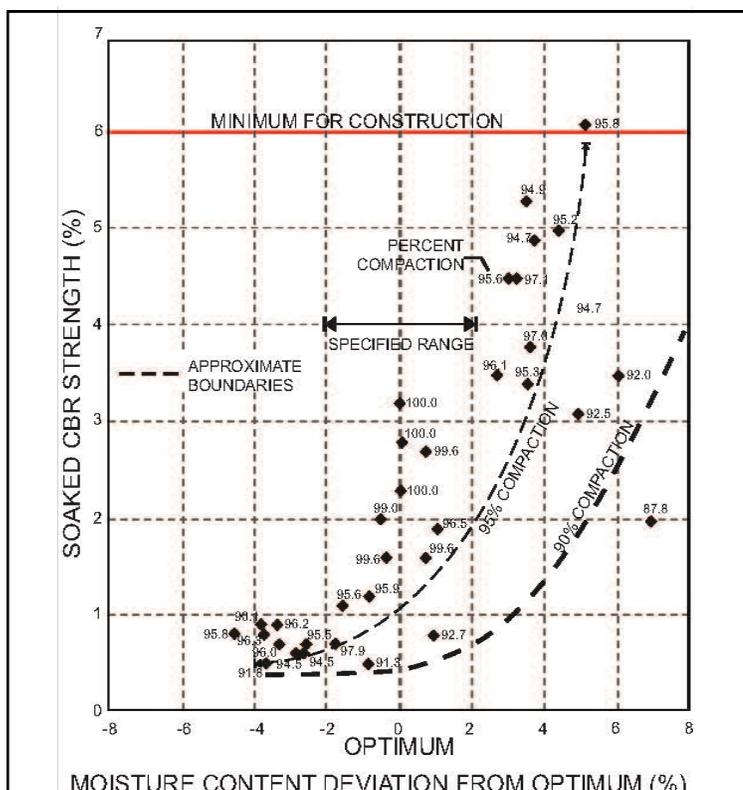
FIGURE 2: MOISTURE CONTENT RELATIVE TO OPTIMUM PLOTTED AGAINST THE SOAKED CBR VALUE FOR ALL COMPACTED SAMPLES

To investigate whether the subgrade specifications would be problematic during construction, a series of strength tests (i.e. CBR tests) were run on compacted site clay subgrade samples. The results, which are shown in Figure 2, were consistent with the difficulties encountered in the field. When the clay soil subgrade was exposed to moisture it became extremely unstable when prepared to within the specified moisture and compaction range and actually showed better performance at greater moistures.

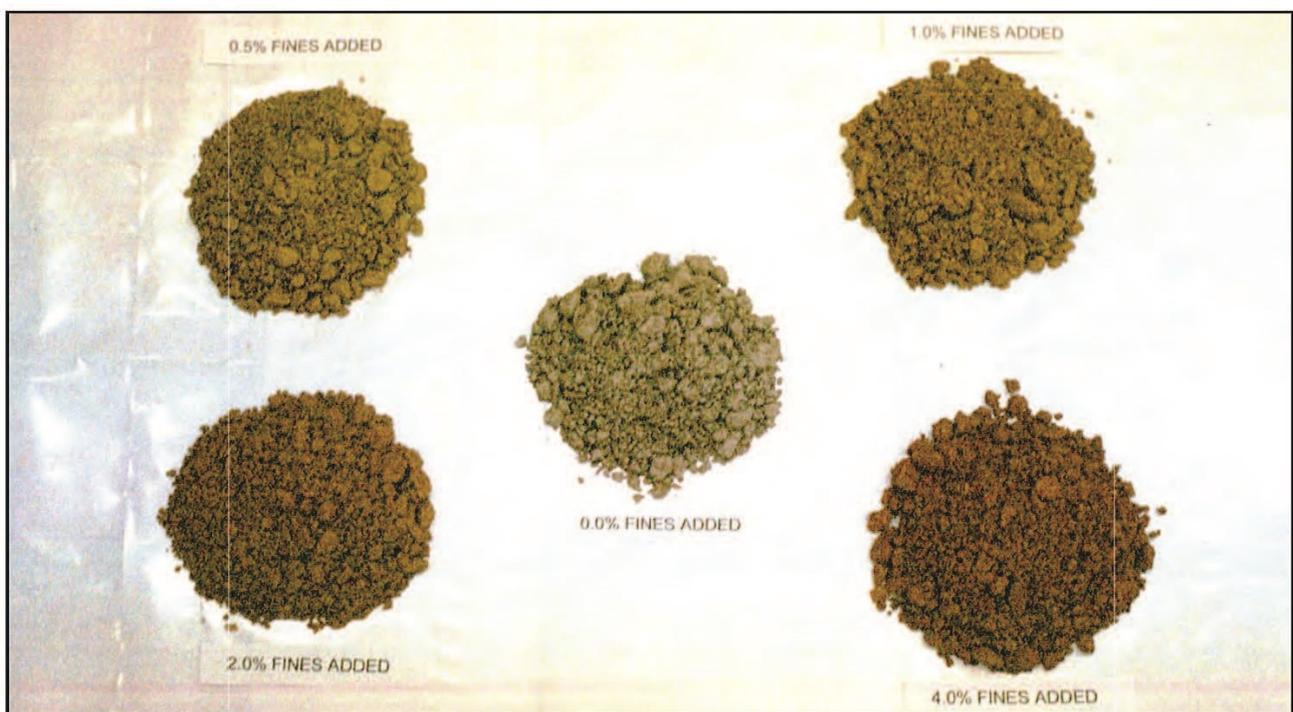
however, identified the wrong target. He contended that the subbase was discolored by the contractor during installation of the subbase and consequently contaminated with the red clay subgrade. From laboratory tests it was found that discoloration was not, in fact, a good measure of contamination. Mixtures of the subbase stone and the red subgrade soil showed that even with the addition of only 0.5% of the subgrade soil, discoloration was achieved (see Figure 3). The subbase stone used by the contractor typically had 7-9% fines and 20% was allowed in the specifications. Consequently, the discolored subbase stone could fall well within the range of the fines allowed and therefore was not a good measure of significant contamination and rejection of the subbase material.

FIGURE 3: PHOTOGRAPH SHOWS DISCOLORATION TEST RESULTS: SUBGRADE FINES ADDED TO THE SPECIFIED BASE ROCK USED ON PROJECT AT PERCENTAGES BY TOTAL DRY WEIGHT OF: 0.5% (UPPER LEFT); 1.0% (UPPER RIGHT); 2.0% (LOWER LEFT); AND 4.0% (LOWER RIGHT). CONTROL SAMPLE (0% FINES ADDED) IS IN THE MIDDLE.
