RISK BASED ANALYSIS RESULTS IN EFFICIENT MINE STABILIZATION

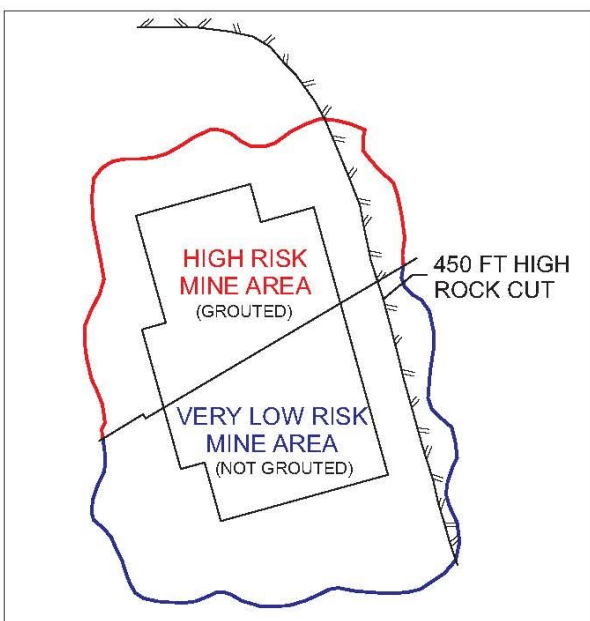
FIGURE 1: SITE LAYOUT WITH ASSESSED MINE COLLAPSE RISK AREAS. STABILIZED ONLY HIGH RISK AREA IN LIEU OF ENTIRE MINE UNDER BUILDING

Based on rock testing and MEA's stability calculations, it was found that the coal mine had limited stability under the northern half of the building which meant there was a high risk of subsidence in the future. However, an acceptable amount of risk existed over the southern portion of the underlying old works (see Figure 1). Therefore, the noted settlement of the building was consistent with the risk analysis performed across the building.

Given the assessed range of risk under the building, the owner chose to only grout stabilize the northern half and saved about \$3 million. This was in lieu of stabilizing the entire mine beneath the structure, which would be conventionally done.

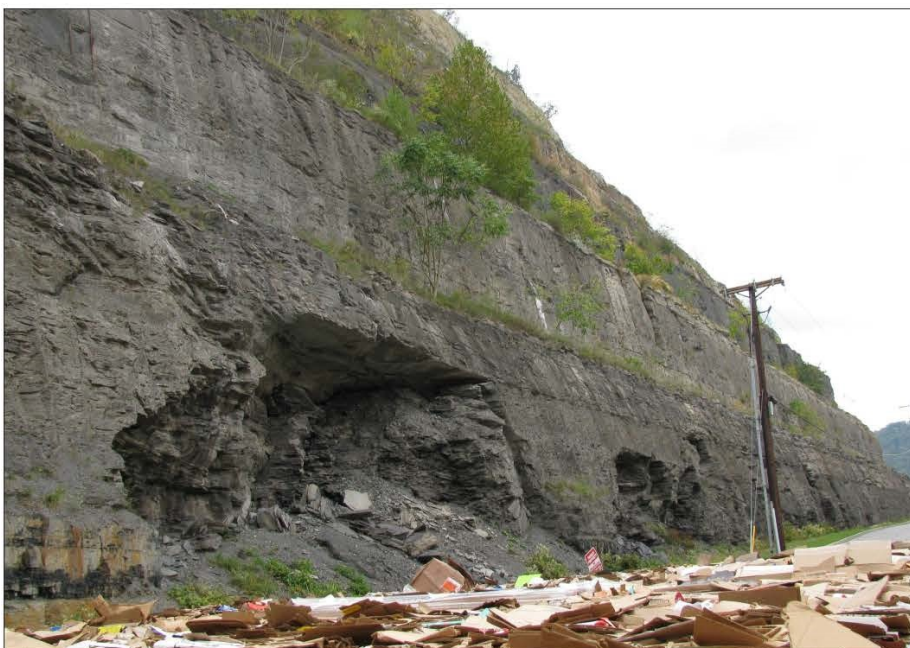
These climatic effects could be seen in the mine roof as it collapsed over time (see Figure 2). To mitigate these deteriorating mine conditions, the open and exposed voids were filled with grout, lift by lift. Where mine openings contained significant collapsed roof materials, the rubble was consolidated by pressure grouting with up to 75 ft. long injection holes drilled into these areas (see Figure 3).

FIGURE 2: MINE OPENINGS IN 400 FT. HIGH ROCK CUT. MINE ROOF CAVED UPWARD OVER TIME.
