DEVELOPER AVOIDS SUBSTANTIAL RISK OF SUBSIDENCE DAMAGE

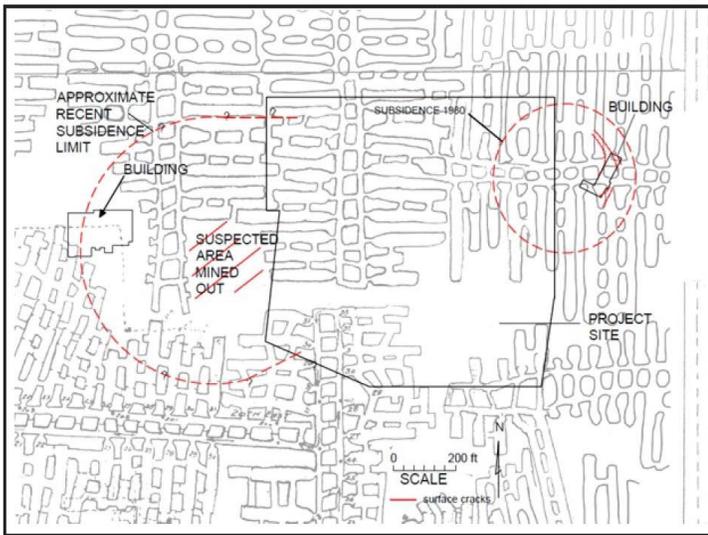
FIGURE 2: HISTORICAL MINE MAP SHOWING ROOMS AND PILLARS WITH LOCATIONS OF SITE AND SURFACE SUBSIDENCE

Also based on our in-house files, it was known that about a quarter of a century ago there was a subsidence event which formed on the east side of the property. Because of this subsidence, a structure was damaged and had to be abandoned and razed (see Figure 2). As a result of the assessed risk, the developer decided to abandon the site due to the related potential liabilities it presented.

Four years after our investigation, a fairly significant subsidence event resulted in substantial damage to another structure just west of the site (see Figure 2). Although no data is available on the former store site, it is likely that this subsidence extended into it. This would have resulted in substantial damage if the store had been built, unless the mine had been stabilized.

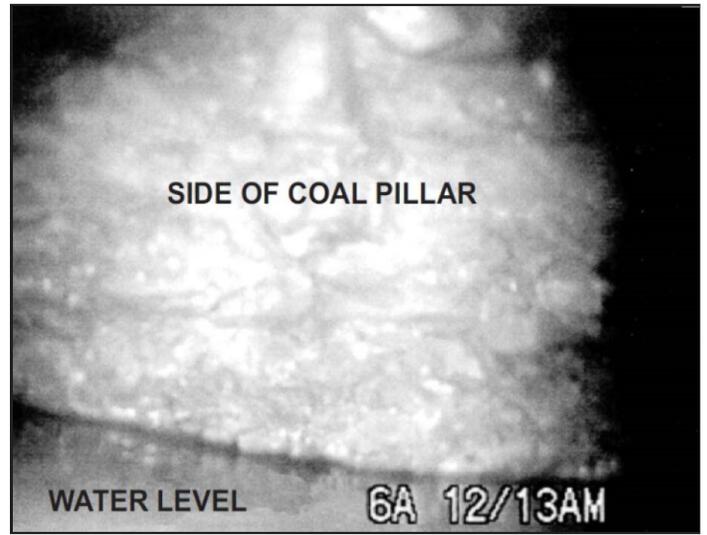
Also, existing conditions of mine voids were inspected with the use of a borehole camera. One of the features which could be seen with the camera was pooled groundwater present in the old works (Figure 3).

From all the information collected, including the subsidence activity in the area and advanced engineering analyses of the stability of these old works it was determined that there was a high risk of future subsidence, and that it was possible that very severe damage could result. What was determined was that the coal pillars did not have firm bearing and would eventually sink into the water softened mine floor.

FIGURE 3: BOREHOLE CAMERA SHOT IN ABANDONED MINE AT A DEPTH OF 211 FT. SHOWING POOLED WATER AGAINST COAL PILLAR
