MOISTURE SOFTENING EFFECTS ON MINE FLOORS

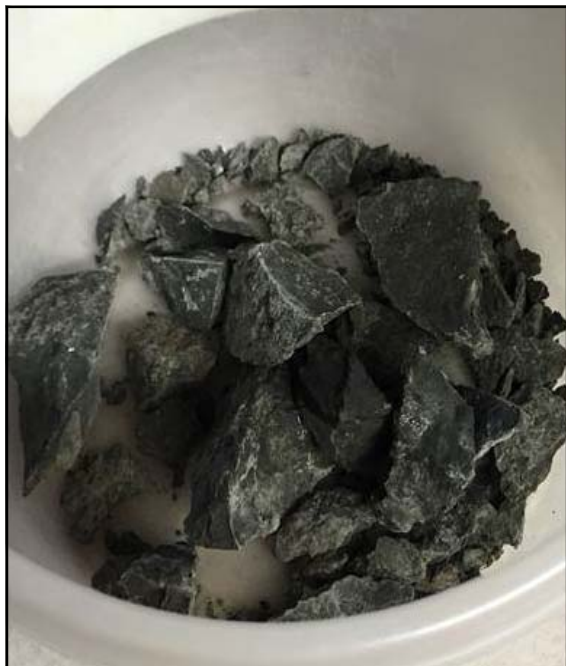
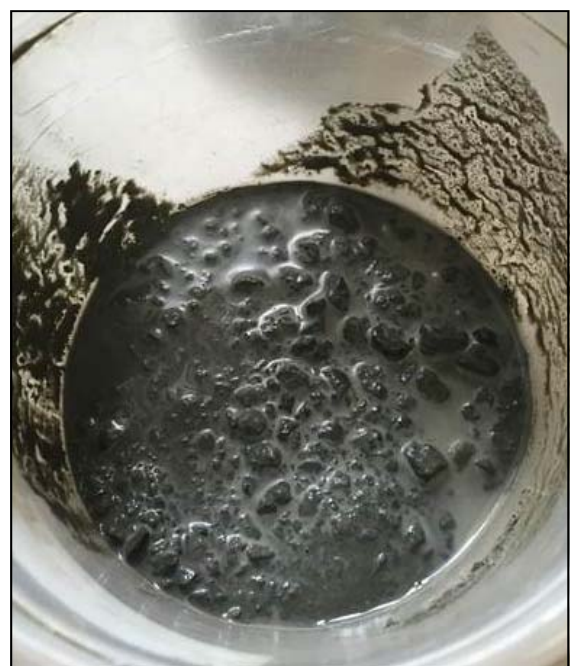
The potential for a floor to soften is dependent on geologic conditions. Here, sufficient strata lay beneath the coal bed (or other mine ore), which are susceptible to deterioration when exposed to moisture. These floor rocks are commonly classified as claystone, mudstone, or clayey shale. An example of the effect exposure to water can have on these materials is shown in Figure 2. But, the degree of the effect that moisture will have on these rocks depends on the mineralogical content. It is, however, important to note that this geological condition is not prevalent under coal beds in many areas. Where there are more durable floor rocks present, floor failure is rarely a concern. In a mine, the area which is most exposed to moisture from groundwater inflows is in the entries (openings), where the water pools onto the floor. Being unrestrained in the mine

FIGURE 2 EXAMPLE OF EFFECT OF WATER EXPOSURE ON MUDSTONE

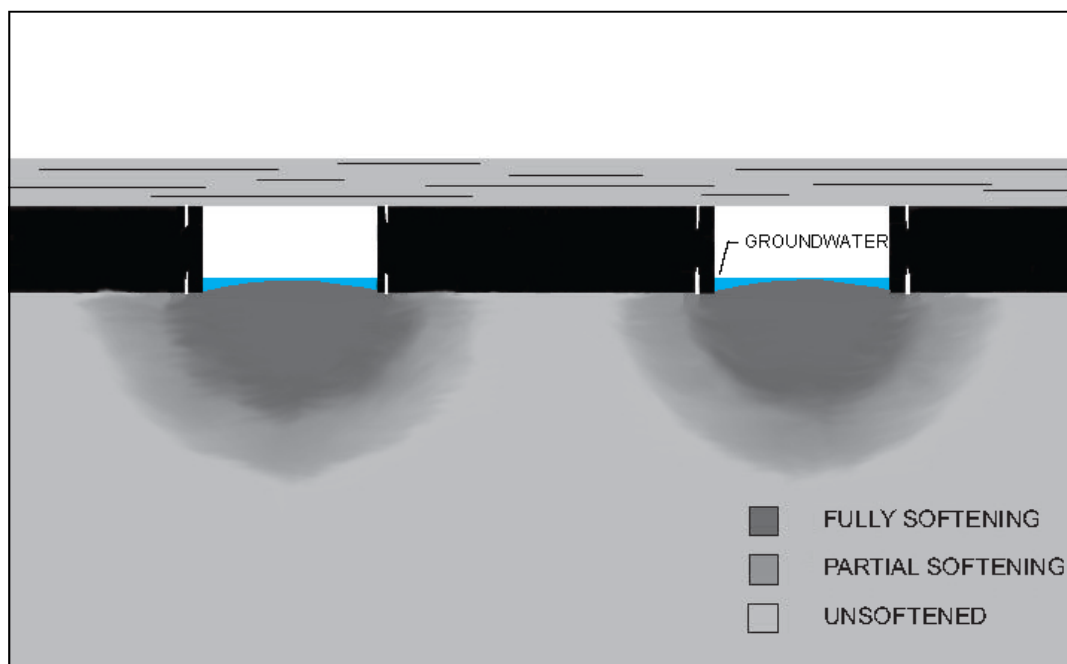
opening, these non-durable rocks can swell upwards and reach a fully softened state. The pooled groundwater not only soaks the floor materials in the opening, but also those under the adjacent pillar. Here, fine-grained rock beneath the pillar absorbs the pooled water, causing it to soften to some degree (i.e. a partial softened condition). See Figure 3. Note that these rocks can exert a swell pressure when exposed to moisture, which is related to a suction potential that can be greater than 500 psi. The suction potential and in turn the degree of softening depends on the rock composition, as well as the restraint applied by the pillar and an underlying resistant rock zone.

FIGURE 3 ILLUSTRATION OF SOFTENING IN FINE-GRAINED ROCKS FROM
