ANATOMY OF CANAL GEO-CONSTRUCTION DIFFICULTIES

PROJECT

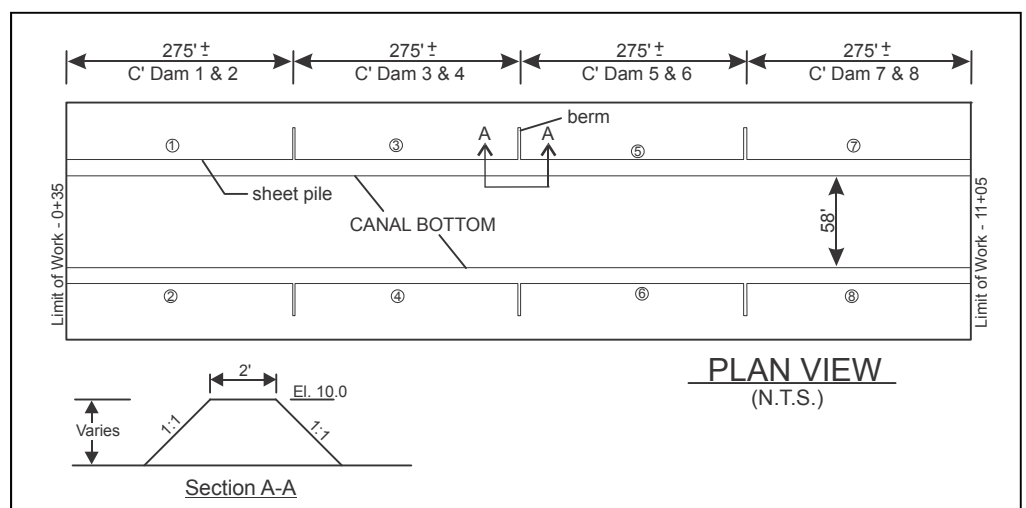
FIGURE 2: COFFERDAMS PLANNED TO BE CONSTRUCTED TO INSTALL CONCRETE APRON ON SLOPE

One of the methods specified under the contract to install the concrete apron was to create cofferdams in order to unwater areas along the canal bank. The cofferdam would be created by driving sheetpiling in the lower part of the canal slope with earthen berms at each end of the piling to create the enclosure. This is the method chosen by the contractor to perform the work. The contractor considered that eight, ± 275 ft long cofferdams would need to be constructed (See Figure 2).

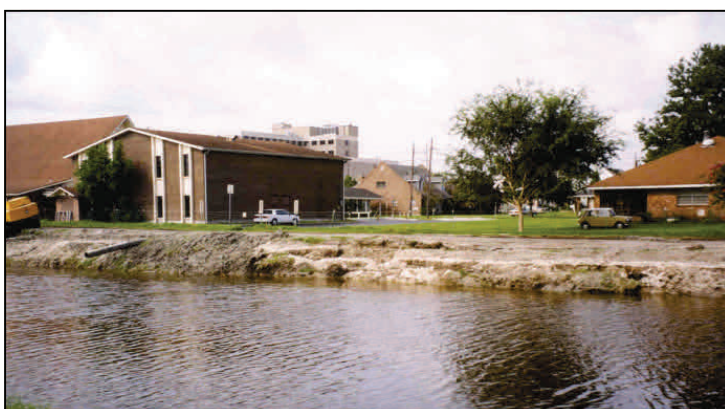
In the initial stages of construction the contractor began excavating the canal bottom in order to install the required geotextile and stone. While performing this work in subaqueous conditions, the canal slopes began to fail (See Figure 3). Because of the unstable conditions

FIGURE 3: FAILED CANAL BANK DURING CANAL BOTTOM CONSTRUCTION

MEA determined that the instability discussed above was the result of overloading of the banks from canal excavation, unwatering and construction loads. The specifications, however, provided no limitation to any of these factors or sequence of work. Yet the engineer performed no investigation to determine whether or not the work was feasible, given the method of construction provided in the plans and specifications. In this case, the owner/engineer considered such a feasibility study during design as an unnecessary effort and left it to the contractor to accomplish the work. In this case, the contractor had much less engineering background to assess the viability of the specified methodology. Despite requiring no engineering submittals, the engineer's response to the difficulties the qualified contractor was having was "means and methods are the responsibility of the contractor".

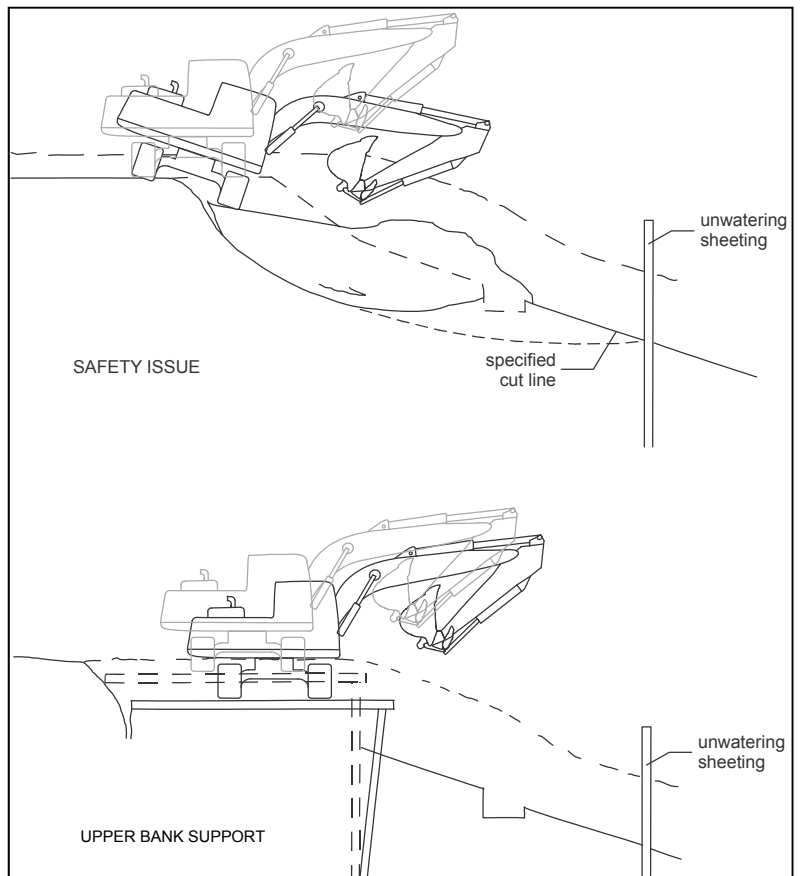
worker safety became an issue, and given that the failure occurred underwater, conditions would only become more adverse once the canal slope was dewatered to install the apron concrete (See Figure 4). This concern resulted in the contractor installing pile supported mats to the equipment on the top of the bank (See Figure 4). Also, because of the instability, even with the use of this upper bank support, the contractor shortened the length of the cofferdams to reduce the exposure to adverse conditions (See Figures 4 and 5). As a consequence, considerably more time and effort was required to complete the project.

FIGURE 4: SAFETY CONCERN OVER UPPER BANK IN STABILITY AND INSTALLED SUPPORT TO ADDRESS THE ISSUE

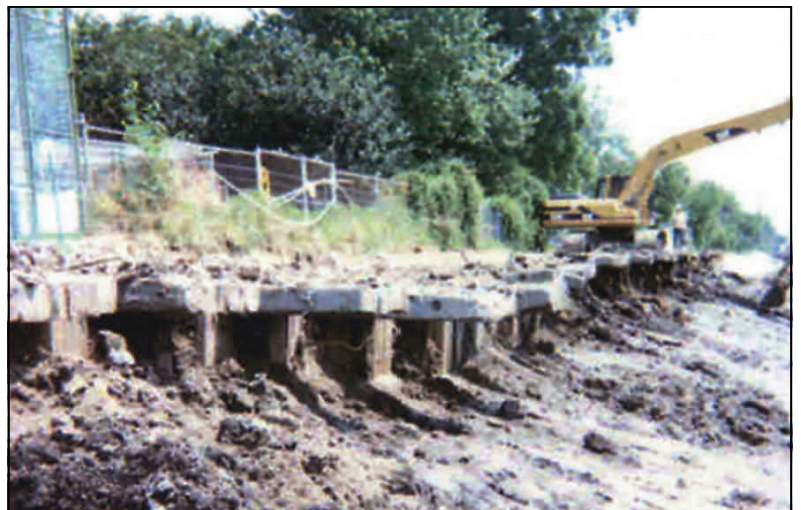
FIGURE 5: EQUIPMENT SUPPORT MOVED DOWNWARD AND OUTWARD DURING DRY SLOPE CONSTRUCTION
