INVESTIGATION OF EXCESSIVE FILL SHRINKAGE FROM EMBANKMENT CONSTRUCTION

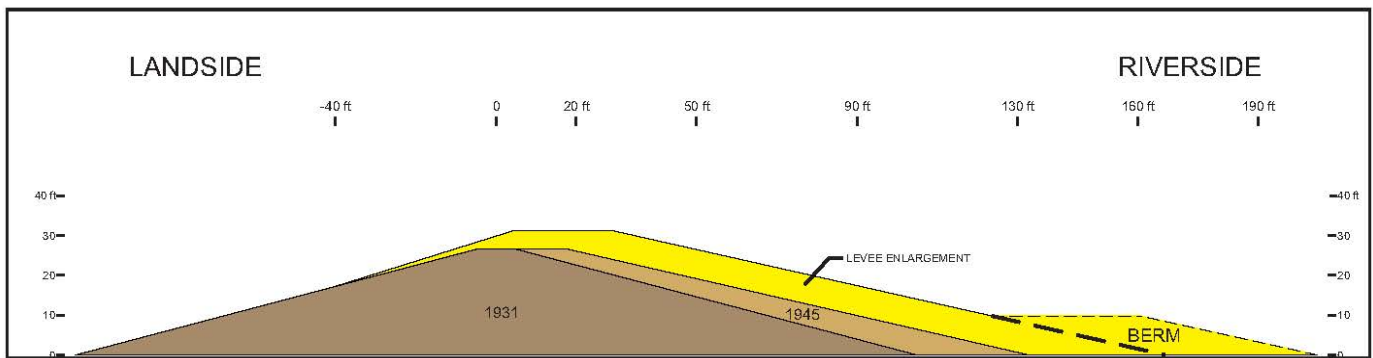
This project involved a 40,940 ft. (7.75 miles) long enlargement of an existing levee located along the east side of the Mississippi River. The enlargement included increasing both width and height of the levee. A cross section of the levee enlargement is shown in Figure 1. Figure 1 also depicts the historical construction of this levee, which was originally placed in 1931 and added to in 1945.

FIGURE 1: TYPICAL EXISTING AND PROPOSED ENLARGEMENT SECTIONS OF 7.75 MILE PROJECT LEVEE

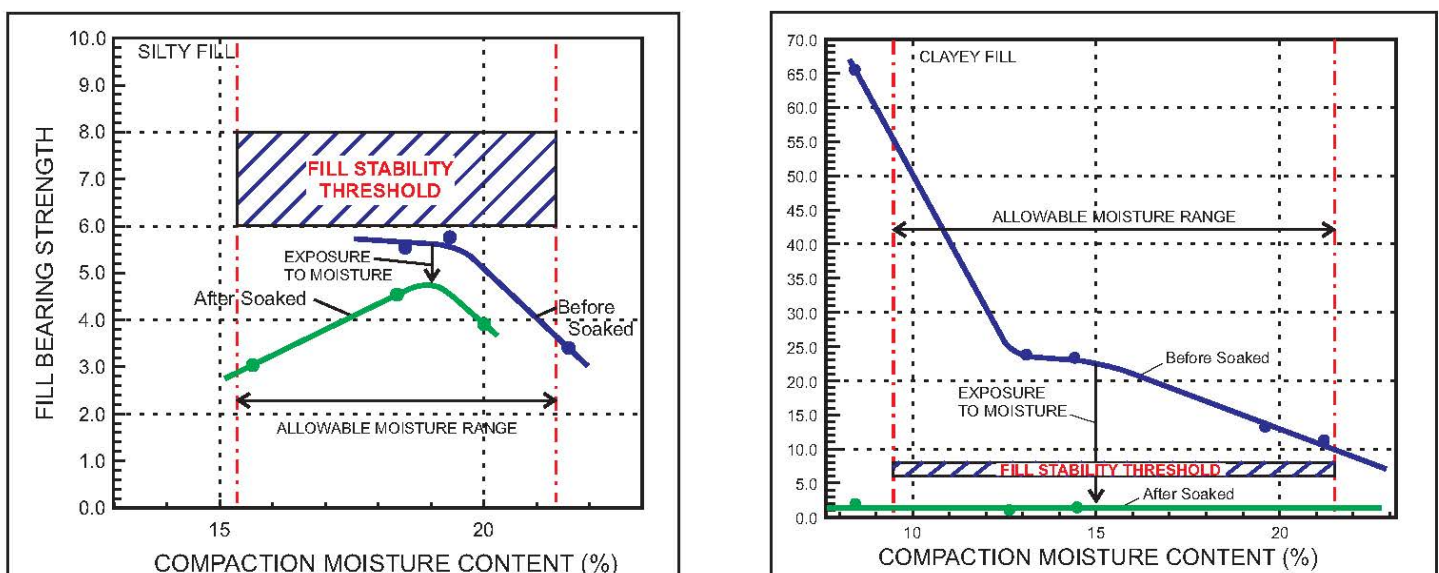
More interesting, however, was the cause for the unexpected and significant foundation settlement and the greater than expected shrinkage from compaction. The culprit was found to be the instability of the placed borrow material, even though it was compacted to specifications. Lab tests showed that when compacted to within specification, the various borrow-to-fill soils would be too weak to support the necessary construction traffic (see Figure 2). This fill instability resulted in the need to extend the wet fill lifts along the entire project

FIGURE 2: FILL STRENGTH WHEN COMPACTED UNDER CONDITIONS ALLOWED IN THE SPECIFICATIONS

included drilling and sampling the levee and foundation soils, and excavating test pits in the existing levee and fill borrow pits. Testing mainly included determining field moisture/density conditions, and fill compaction as well as the associated strength characteristics and soil compressibility of the existing levee and foundation soils in the lab. From examination of all the site characteristics, the two causes for the extraordinary fill shrinkage were found to be compaction of the lighter borrow soils into a denser state and settlement of the levee foundation soils. Based on the site analyses, it is estimated that an additional 16% of borrow was needed, but the main cause for the excessive demand of borrow material was from levee settlement which resulted in 24% of additional volume (see Figure 2).

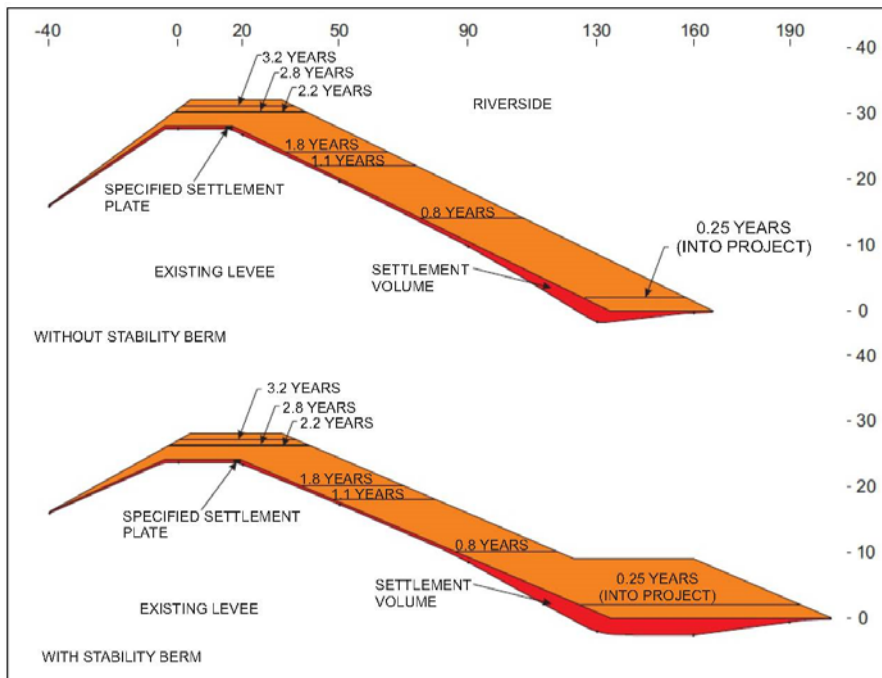
Although thick compressible clayey deposits would be expected along the project reach in this river laid geologic environment, the considerable time that was needed before a levee section could be completed allowed for these clay soils to be compressed and the levee to settle. This resulted in much greater borrow volume to complete a section of the enlargement. Measuring the volume of fill required to compensate for the settlement which occurred during embankment placement can be problematic with the use of one settlement plate. Yet, in the specifications, the instructions to quantify added embankment volume from underlying settlement were based on measuring one settlement plate in the riverside crown of the old embankment. At this location the underlying foundation soils were much stiffer from long term compression under the weight of the old levee. Therefore, measurements from this one specified plate location severely underestimated the fill volume loss from foundation settlement under the riverside toe and beyond (see Figure 3). In other words, the distribution of settlement, especially when significant time dependent movement is present, is not directly proportional to the height of the fill placed as the specified settlement plate method assumed.

FIGURE 3: CALCULATED TOTAL SETTLEMENT DUE TO THE LEVEE ENLARGEMENT
