## MINE SUBSIDENCE DAMAGE DURING CONSTRUCTION OF MEDICAL CENTER AND REMEDIAL MEASURES

A ground subsidence event occurred during construction of a medical center after a shallow foundation system, and utilities for a surgery center extension were installed. MEA was contacted to perform an emergency engineering evaluation and subsidence remediation for the building site of the medical center located in Fort Smith, Arkansas.

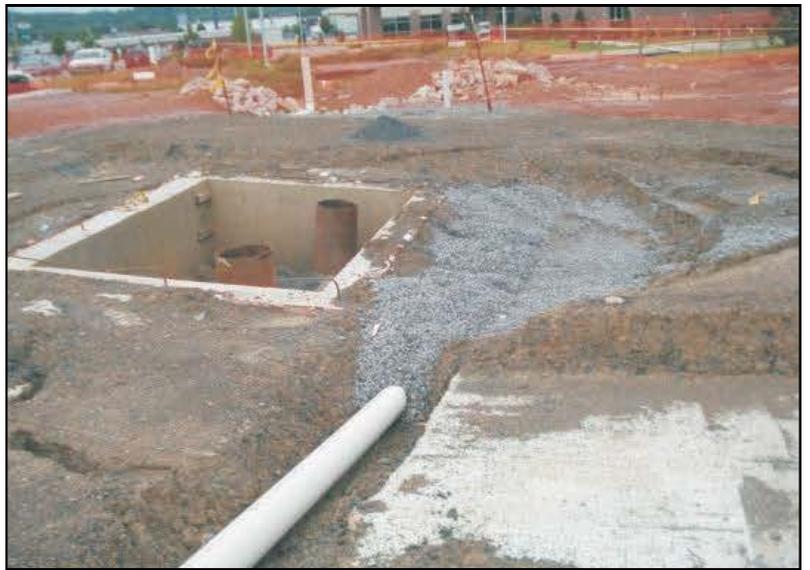
The subsidence that occurred at the building site resulted from an underground room-and-pillar coal mine from the early 1900s. No mine map was available and, consequently, any stabilization considered would have to be done in the “blind”. The drilling data indicated that mine was 20 to 37 feet deep with rooms that averaged 10 feet wide to over 25 feet in some places and were flooded with groundwater 7 to 13 feet deep. From site drilling, it was determined that the support pillars were narrow and less than 20 feet wide. The estimated extraction ratio of coal was about 50% (based on all the drilling done on the site). The subsidence during construction from underground coal mining occurred when the elevator pit tilted and settled up to 20 inches and the neighboring footings tilted toward the sag center about 1 inch from the surface subsidence (see Fig. 1). In order to determine how the subsidence problem could be remediated, an engineering evaluation was conducted focusing on mine roof stability. Subsurface investigation, soil and rock mechanics laboratory testing, and mining and subsidence conditions investigations in and around the site were performed to determine a possible foundation solution.

FIGURE 1: PICTURE SHOWING SAG SUBSIDENCE WHICH FORMED DURING CONSTRUCTION AND ENCOMPASSED AN ELEVATOR PIT

It was determined that mine grouting was required in order to provide support to the existing roof rock and stabilize already subsided, rubblized areas. Also, to mitigate future settlement of the footings from previously disturbed collapsed areas, a deep foundation system was essential. The shallow foundation system installed prior to the subsidence event consisted of conventional perimeter and interior footings.

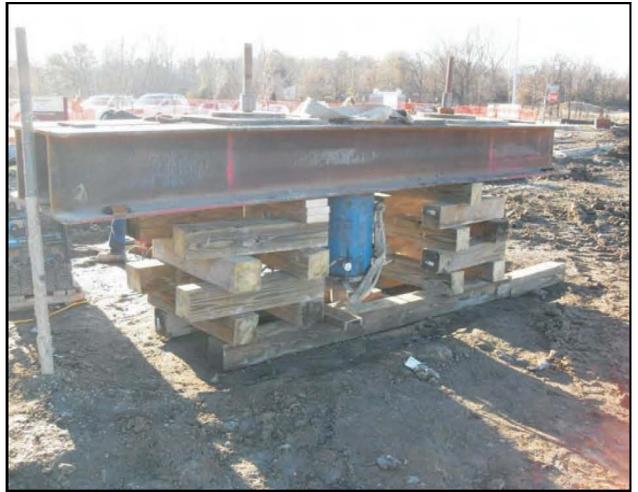
The procedure consisted of drilling the hole, driving the pile casing in, grouting the hole and, lastly, inserting the reinforcing bar with centralizers. To verify this pile construction procedure and the adequacy of the design of the pile system, pile verification tests were performed prior to the installation of production piles (see Fig. 2). The verification tests met the design criteria (i.e., the deformation at Design Load (DL) should not exceed 0.5 inches and the slope of the load-deformation curve should be within 0.15 mm/kN). Proof tests were also performed to verify the adequacy of the installation of production piles. As in the verification tests, the proof tests also met the requirements.

FIGURE 2: PILE VERIFICATION TEST SETUP

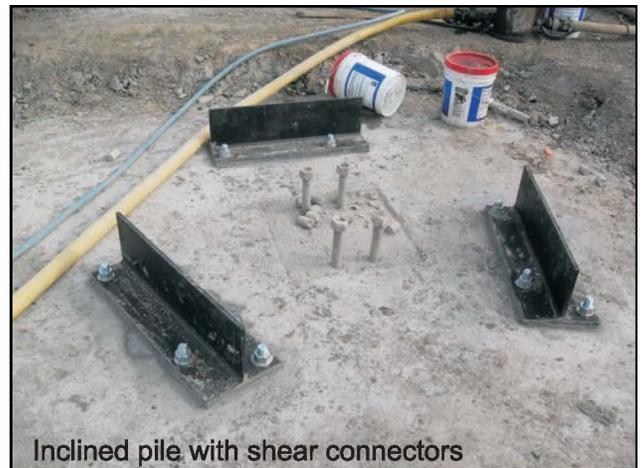
The design of the micropile was based on the structural load being transferred by friction into mine floor rock in order to support these loads safely. Because excessive mine subsidence occurred over the building footprint, it was assumed that the overburden to the bottom of the coal layer was not reliable and could not be used to provide significant structural support by friction for the micropile proposed system. Therefore, frictional load transfer from the micropiles was considered to take place 2 feet below the mine coal layer. Also, due to disturbed overburden from adjacent mining, no load transfer from the pile to the surrounding soil was assumed. Coring of the 30 foot rock beneath the coal mine bottom showed that the floor material had a 4,500 psi to 10,000 psi uniaxial compressive strength. A nominal grout-to-ground bond strength of 8.50 tsf was verified during the field verification test. A factor of safety of 2.5 was used to estimate the bond length. Based on structural load application for each footing, three different pile types were used (Type I, Type II, and Type III) which have different capacities. Also, two different types of pile installation (vertical and inclined) were used based on the lateral design load condition. The number of vertical piles was estimated based on the pile capacity when the lateral load was less than 7 kips. When the lateral load exceeded this value, a set of three batter piles was used to provide the lateral resistance through the horizontal component of the pile axial load.

FIGURE 3: FOOTING SUPPORTED ON THREE PILES

Based on structural load application for each footing, three different pile types were used (Type I, Type II, and Type III) which have different capacities. Also, two different types of pile installation (vertical and inclined) were used based on the lateral design load condition. The number of vertical piles was estimated based on the pile capacity when the lateral load was less than 7 kips. When the lateral load exceeded this value, a set of three batter piles was used to provide the lateral resistance through the horizontal component of the pile axial load.
