ANATOMY OF CANAL GEO-CONSTRUCTION DIFFICULTIES

MEA was selected to investigate a project dealing with the improvement of the canal system in the New Orleans area. The canal improvement involved widening of the canal and lining the canal bottom with stone and the sides with a concrete apron. Along the crest canal a short floodwall was to be constructed. The basic design is shown in Figure 1. Construction of this 1,150 ft. long canal improvement was to be done while the canal remained in operation.

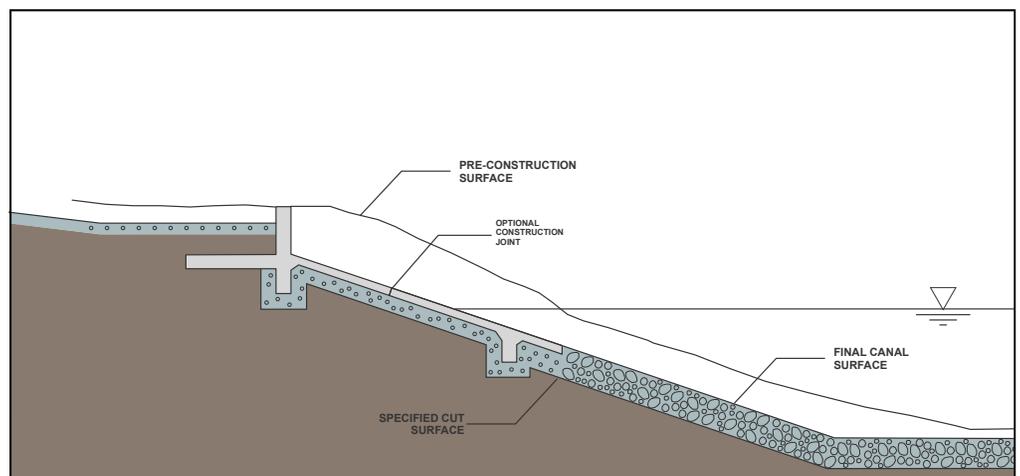
FIGURE 1: CANAL IMPROVEMENT TO BE CONSTRUCTED

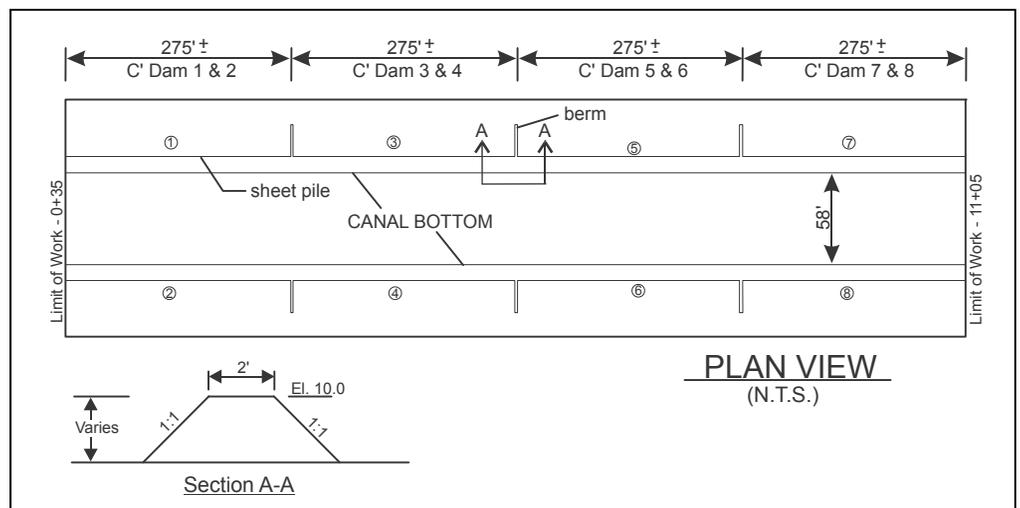
FIGURE 2: COFFERDAMS PLANNED TO BE CONSTRUCTED TO INSTALL CONCRETE APRON ON SLOPE

One of the methods specified under the contract to install the concrete apron was to create cofferdams in order to unwater areas along the canal bank. The cofferdam would be created by driving sheetpiling in the lower part of the canal slope with earthen berms at each end of the piling to create the enclosure. This is the method chosen by the contractor to perform the work. The contractor considered that eight, ± 275 ft. long cofferdams would need to be constructed (See Figure 2).

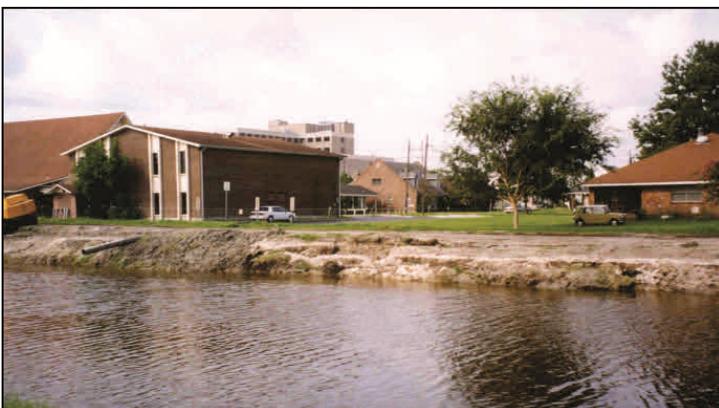
In the initial stages of construction the contractor began excavating the canal bottom in order to install the required geotextile and stone. While performing this work in subaqueous conditions, the canal slopes began to fail (See Figure 3). Because of the unstable conditions

FIGURE 3: FAILED CANAL BANK DURING CANAL BOTTOM CONSTRUCTION

MEA determined that the instability discussed above was the result of overloading of the banks from canal excavation, unwatering and construction loads. The specifications, however, provided no limitation to any of these factors or sequence of work. Yet the engineer performed no investigation to determine whether or not the work was feasible, given the method of construction provided in the plans and specifications. In this case, the owner/engineer considered such a feasibility study during design as an unnecessary effort and left it to the contractor to accomplish the work. In this case, the contractor had much less engineering background to assess the viability of the specified methodology. Despite requiring no engineering submittals, the engineer's response to the difficulties the qualified contractor was having was "means and methods are the responsibility of the contractor".

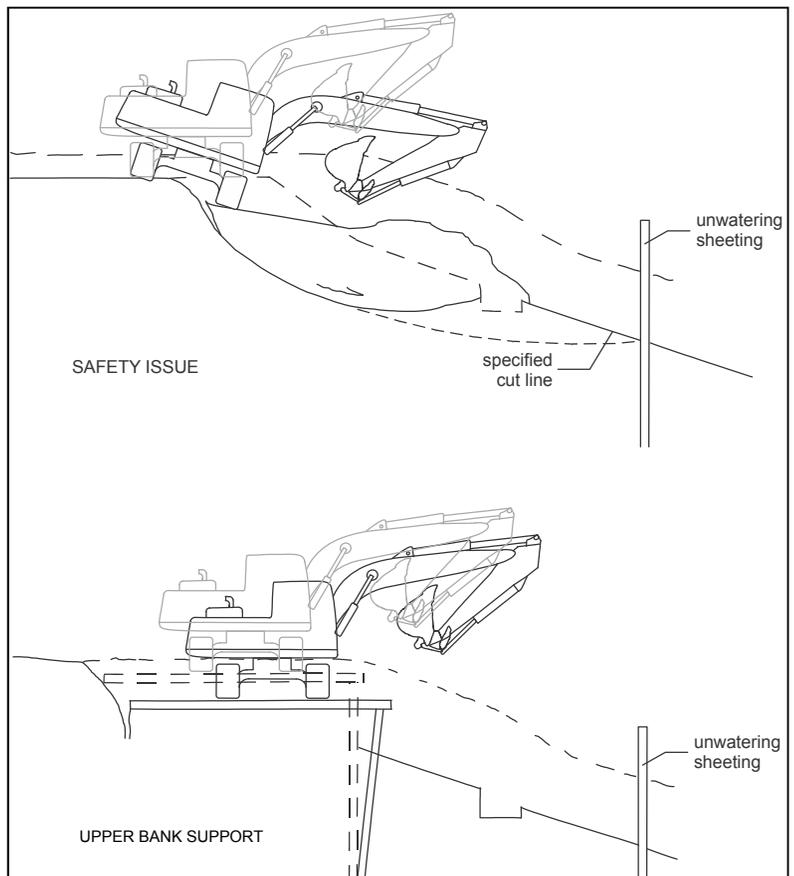
worker safety became an issue, and given that the failure occurred underwater, conditions would only become more adverse once the canal slope was dewatered to install the apron concrete (See Figure 4). This concern resulted in the contractor installing pile supported mats to the equipment on the top of the bank (See Figure 4). Also, because of the instability, even with the use of this upper bank support, the contractor shortened the length of the cofferdams to reduce the exposure to adverse conditions (See Figures 4 and 5). As a consequence, considerably more time and effort was required to complete the project.

FIGURE 4: SAFETY CONCERN OVER UPPER BANK IN STABILITY AND INSTALLED SUPPORT TO ADDRESS THE ISSUE

MEA determined that given the circumstances of this project, the engineer, in developing the plans and specifications, should have answered the question as to whether or not the work, the anticipated means and methods were feasible, and under what restrictions it should be performed.

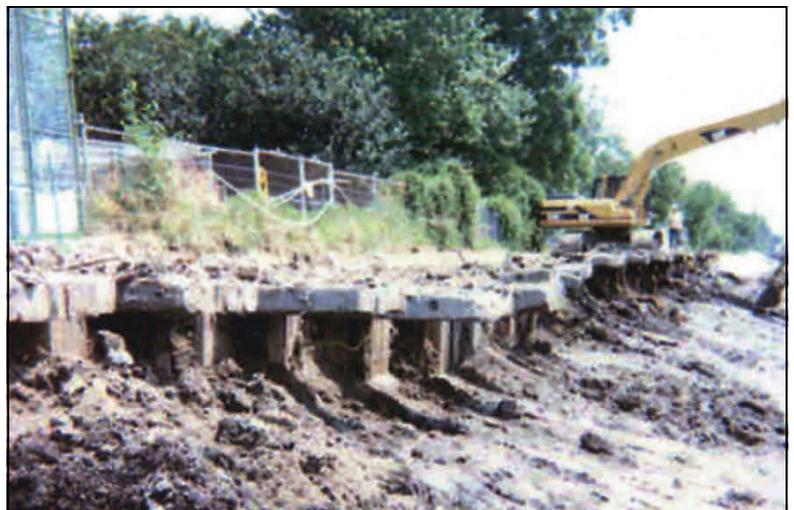
FIGURE 5: EQUIPMENT SUPPORT MOVED DOWNWARD AND OUTWARD DURING DRY SLOPE CONSTRUCTION
