INVESTIGATION OF PAVEMENT PERFORMANCE

MARINO ENGINEERING ASSOCIATES, INC.

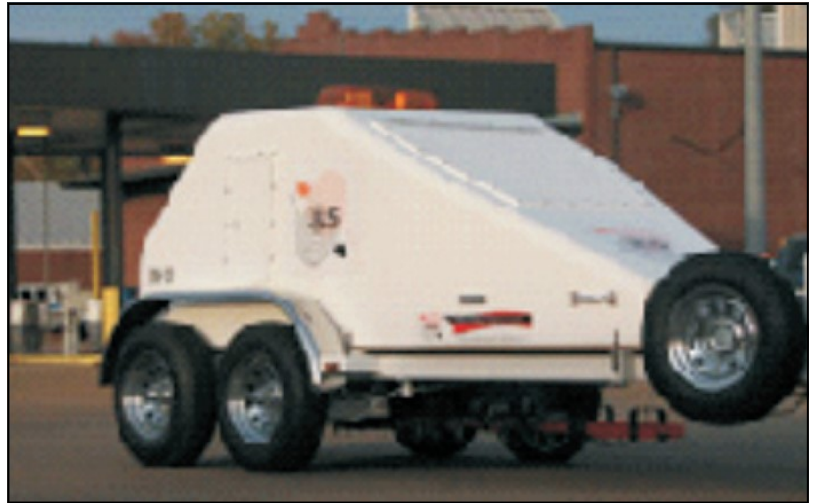
An integral part of the analyses involved performing the Falling Weight Deflectometer (FWD) testing. FWD testing consists of vertically loading the pavement structure and measuring how much it deflects. This test data can actually quantify the capacity of the pavement and substructure to determine its present structural condition and whether it meets design expectations.

FIGURE 1: FALLING WEIGHT DEFLECTOMOETER (FWD) IN USE

The FWD unit and setup is shown in Figures 1 and 2. The principal findings of the site investigation indicated: the property owner's contracted geotechnical engineering firm misclassified the dominant soil type as mostly clayey silt, which actually contradicted their own mechanical gradation tests that show silt as the smallest soil fraction present. The actual dominant subgrade materials were sandier than considered in the design and, in fact, provided more support than the design anticipated. This
