MINE SUBSIDENCE DAMAGE DURING CONSTRUCTION OF MEDICAL CENTER AND REMEDIAL MEASURES

A ground subsidence event occurred during construction of a medical center after a shallow foundation system, and utilities for a surgery center extension were installed. MEA was contacted to perform an emergency engineering evaluation and subsidence remediation for the building site of the medical center located in Fort Smith, Arkansas.

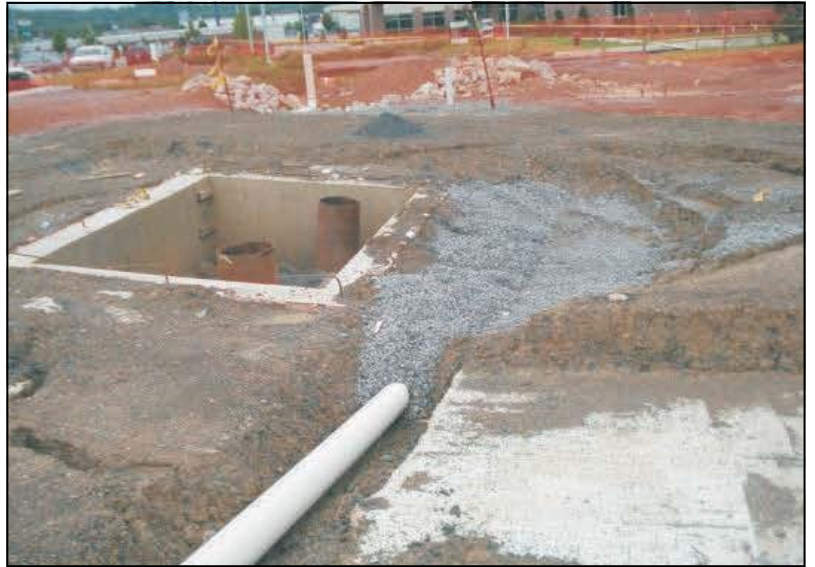
The subsidence that occurred at the building site resulted from an underground room-and-pillar coal mine from the early 1900s. No mine map was available and, consequently, any stabilization considered would have to be done in the “blind”. The drilling data indicated that mine was 20 to 37 feet deep with rooms that averaged 10 feet wide to over 25 feet in some places

and were flooded with groundwater 7 to 13 feet deep. From site drilling, it was determined that the support pillars were narrow and less than 20 feet wide. The estimated extraction ratio of coal was about 50% (based on all the drilling done on the site). The subsidence during construction from underground coal mining occurred when the elevator pit tilted and settled up to 20 inches and the neighboring footings tilted toward the sag center about 1 inch from the surface subsidence (see Fig. 1). In order to determine how the subsidence problem could be remediated, an engineering evaluation was conducted focusing on mine roof stability. Subsurface investigation, soil and rock mechanics laboratory testing, and mining and subsidence conditions investigations in and around the site were performed to determine a possible foundation solution.

FIGURE 1: PICTURE SHOWING SAG SUBSIDENCE WHICH FORMED DURING CONSTRUCTION AND ENCOMPASSED AN ELEVATOR PIT

It was determined that mine grouting was required in order to provide support to the existing roof rock and stabilize already subsided, rubblized areas. Also, to mitigate future settlement of the footings from previously disturbed collapsed areas, a deep foundation system was essential. The shallow foundation system installed prior to the subsidence event consisted of conventional perimeter and interior footings.

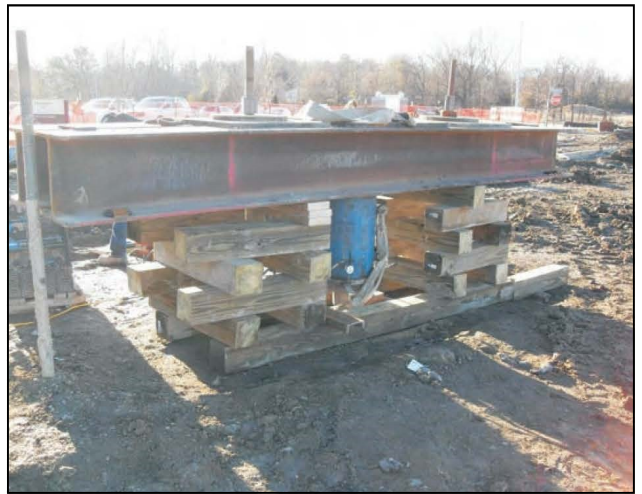
The procedure consisted of drilling the hole, driving the pile casing in, grouting the hole and, lastly, inserting the reinforcing bar with centralizers. To verify this pile construction procedure and the adequacy of the design of the pile system, pile verification tests were performed prior to the installation of production piles (see Fig. 2). The verification tests met the design criteria (i.e., the deformation at Design Load (DL) should not exceed 0.5 inches and the slope of the load-deformation curve should be within 0.15 mm/kN). Proof tests were also performed to verify the adequacy of the installation of production piles. As in the verification tests, the proof tests also met the requirements.

FIGURE 2: PILE VERIFICATION TEST SETUP

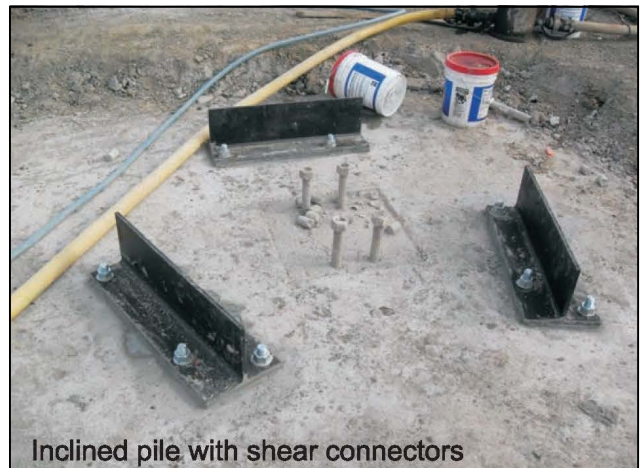
The design of the micropile was based on the structural load being transferred by friction into mine floor rock in order to support these loads safely. Because excessive mine subsidence occurred over the building footprint, it was assumed that the overburden to the bottom of the coal layer was not reliable and could not be used to provide significant structural support by friction for the micropile proposed system. Therefore, frictional load transfer from the micropiles was considered to take place 2 feet below the mine coal layer. Also, due to disturbed overburden from adjacent mining, no load transfer from the pile to the surrounding soil was assumed. Coring of the 30 foot rock beneath the coal mine bottom showed that the floor material had a 4,500 psi to 10,000 psi uniaxial compressive strength. A nominal grout-to-ground bond strength of 8.50 tsf was verified during the field verification test. A factor of safety of 2.5 was used to estimate the bond length. Based on structural load application for each footing, three different pile types were used (Type I, Type II, and Type III) which have different capacities. Also, two different types of pile installation (vertical and inclined) were used based on the lateral design load condition. The number of vertical piles was estimated based on the pile capacity when the lateral load was less than 7 kips. When the lateral load exceeded this value, a set of three batter piles was used to provide the lateral resistance through the horizontal component of the pile axial load.

FIGURE 3: FOOTING SUPPORTED ON THREE PILES

Based on structural load application for each footing, three different pile types were used (Type I, Type II, and Type III) which have different capacities. Also, two different types of pile installation (vertical and inclined) were used based on the lateral design load condition. The number of vertical piles was estimated based on the pile capacity when the lateral load was less than 7 kips. When the lateral load exceeded this value, a set of three batter piles was used to provide the lateral resistance through the horizontal component of the pile axial load.
