## ANATOMY OF CANAL GEO-CONSTRUCTION DIFFICULTIES

### PROJECT

MEA was selected to investigate a project dealing with the improvement of the canal system in the New Orleans area. The canal improvement involved widening of the canal and lining the canal bottom with stone and the sides with a concrete apron. Along the crest canal a short floodwall was to be constructed. The basic design is shown in Figure 1. Construction of this 1,150 ft. long canal improvement was to be done while the canal remained in operation.

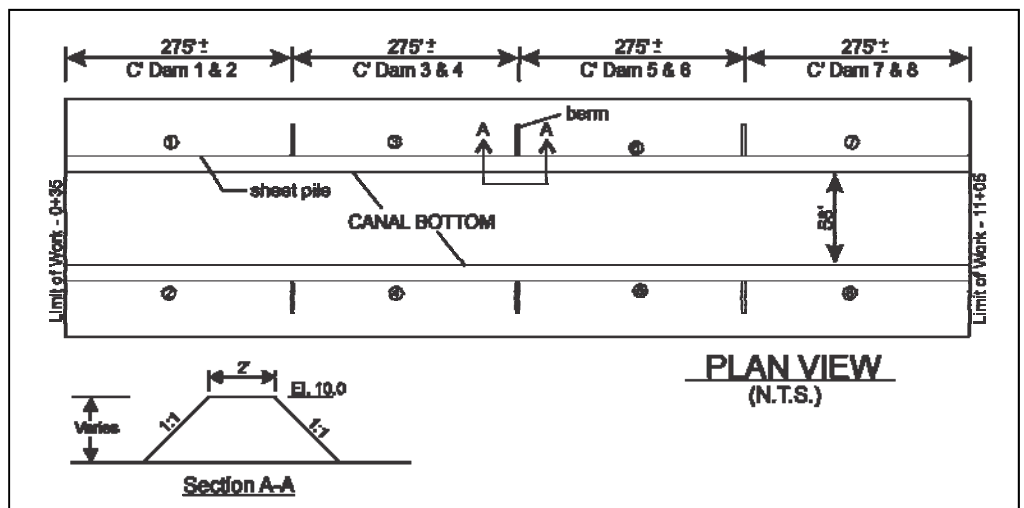
FIGURE 2: COFFERDAMS PLANNED TO BE CONSTRUCTED TO INSTALL CONCRETE APRON ON SLOPE

One of the methods specified under the contract to install the concrete apron was to create cofferdams in order to unwater areas along the canal bank. The cofferdam would be created by driving sheetpiling in the lower part of the canal slope with earthen berms at each end of the piling to create the enclosure. This is the method chosen by the contractor to perform the work. The contractor considered that eight, ± 275 ft. long cofferdams would need to be constructed (See Figure 2).

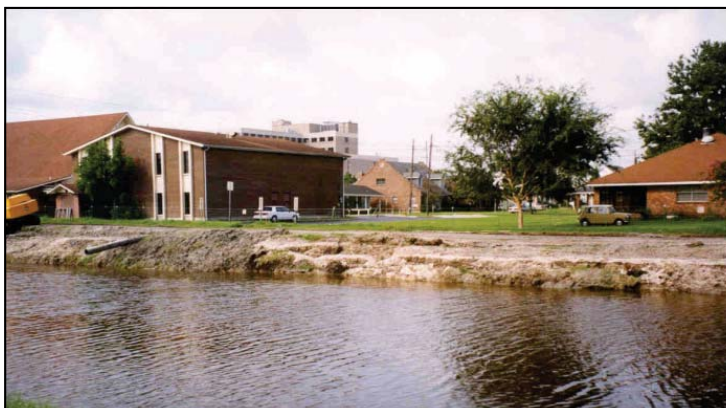
In the initial stages of construction the contractor began excavating the canal bottom in order to install the required geotextile and stone. While performing this work in subaqueous conditions, the canal slopes began to fail (See Figure 3). Because of the unstable conditions

FIGURE 3: FAILED CANAL BANK DURING CANAL

MEA determined that the instability discussed above was the result of overloading of the banks from canal excavation, unwatering and construction loads. The specifications, however, provided no limitation to any of these factors or sequence of work. Yet the engineer performed no investigation to determine whether or not the work was feasible, given the method of construction provided in the plans and specifications. In this case, the owner/engineer considered such a feasibility study during design as an unnecessary effort and left it to the contractor to accomplish the work. In this case, the contractor had much less engineering background to assess the viability of the specified methodology. Despite requiring no engineering submittals, the engineer’s response to the difficulties the qualified contractor was having was “means and methods are the responsibility of the contractor”.

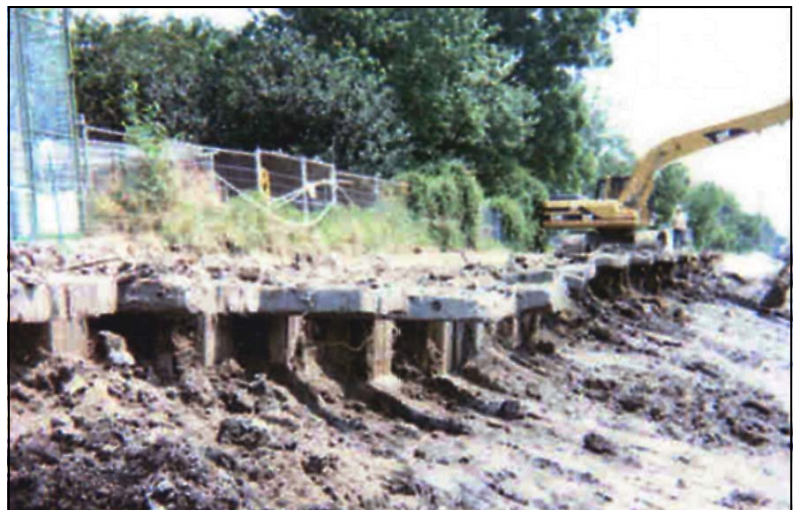
**FIGURE 5: EQUIPMENT SUPPORT MOVED DOWNWARD AND OUTWARD DURING DRY SLOPE CONSTRUCTION**

worker safety became an issue, and given that the failure occurred underwater, conditions would only become more adverse once the canal slope was dewatered to install the apron concrete (See Figure 4). This concern resulted in the contractor installing pile supported mats to the equipment on the top of the bank (See Figure 4). Also, because of the instability, even with the use of this upper bank support, the contractor shortened the length of the cofferdams to reduce the exposure to adverse conditions (See Figures 4 and 5). As a consequence, considerably more time and effort was required to complete the project.
