## SUBSIDENCE MITIGATION BY COMBINING FOUNDATION TREATMENT WITH DEEP MINE GROUTING

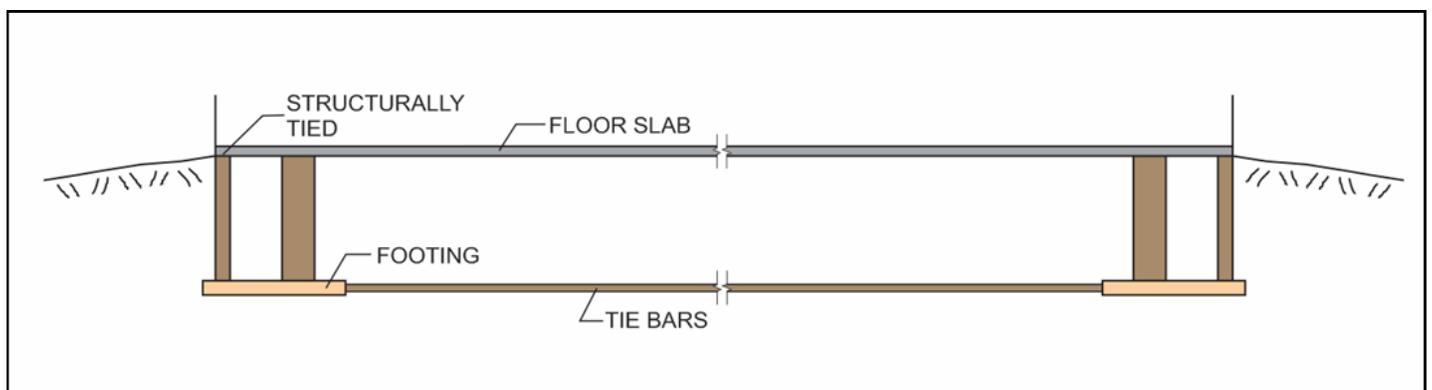
FIGURE 1 CROSS-SECTION OF FOUNDATION SCHEME USED TO RESIST LATERAL BUT LIMITED SUBSIDENCE GROUND MOVEMENTS

MEA worked with the structural engineers for the project to develop an appropriate foundation design for the project. A conceptual sketch showing the adopted design is given in Figure 1.

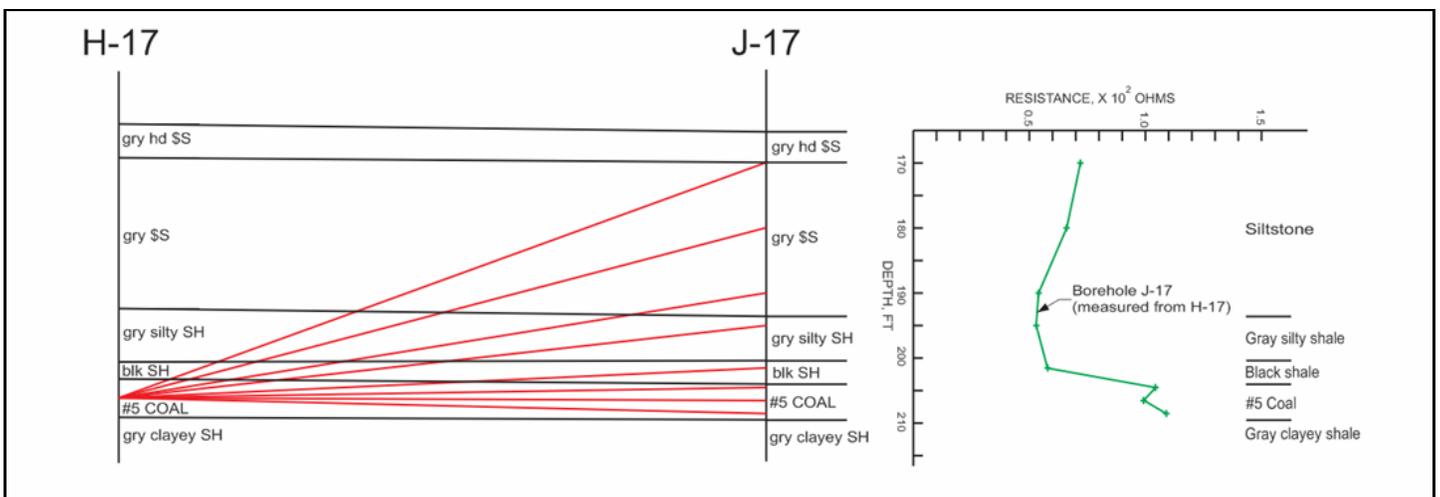
Hole to hole grout flow was monitored by measuring changes in electrical resistance at mine level. Grout return has a distinct electrical resistance. Grout detection in open drill holes allowed these holes to be water flushed prior to the grout setting up and eliminated redrilling of those holes. Also a meter was manufactured to conveniently measure the cross-hole resistivity. Using these measurements, an indication of the presence of solid coal, grouted rubble, or an open mine void could be obtained (see Figure 2).

FIGURE 2 CROSS-HOLE RESISTANCE MEASUREMENTS

Probably the most important feature of this cross-hole work is the ability to assess solid coal between the holes especially in older mines. Even if available, older mine maps typically do not show the proper pillar locations. Note on this project only main haulways are shown (see Figure 3). With cross-hole solid coal measurements unnecessary, injection holes can be eliminated and more confidence can be obtained in the layout of pillars and consequently in the grouting results.

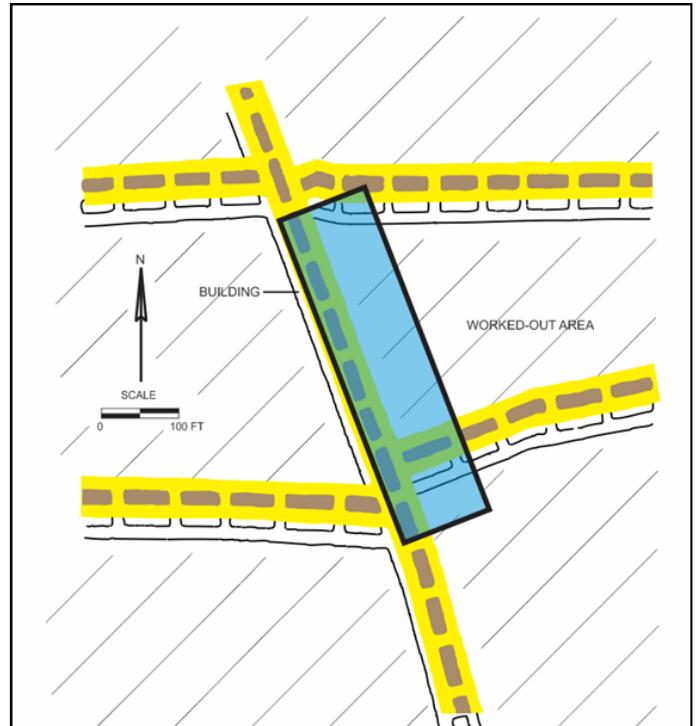
FIGURE 3 PLAN OF MINED-OUT AREA BENEATH SITE AND A BUILDING LOCATION
